NEW ZEALAND POWER FAILURES LESSONS TO BE LEARNT

June 2022

This document summarises the webinar by Daniel Müller CMEngNZ and Geoff Hunt DistFEngNZ.

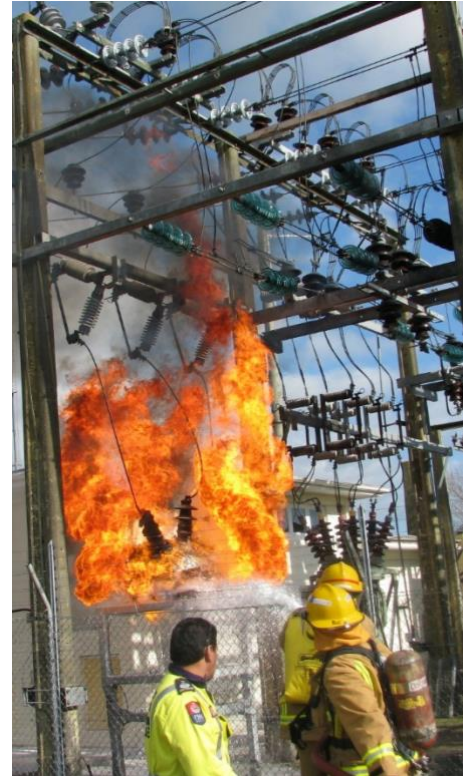
Substation fire. Source: Bruce Mills

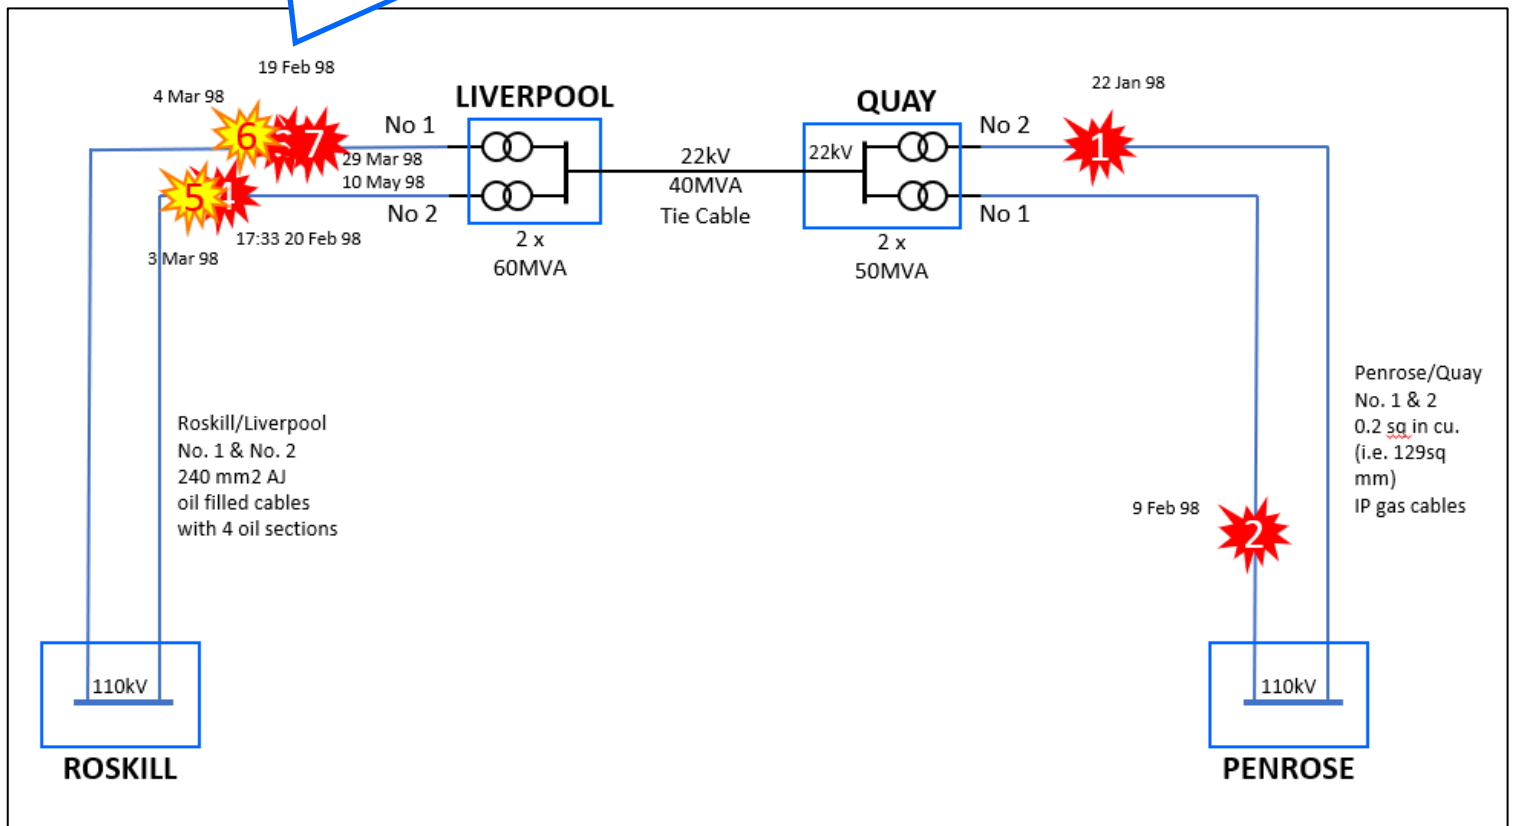
In Auckland, it had been a hot dry summer, and the cables were carrying heavy electricity loads. The cables progressively failed over a number of days. The actual failure mode was thermal expansion leading to mechanical failure at the joints.

This diagram shows the cables on the Mercury Energy network and the cables that progressively failed over a number of days. There were attempts made to repair 5 and 6, but the recovery was short lived.

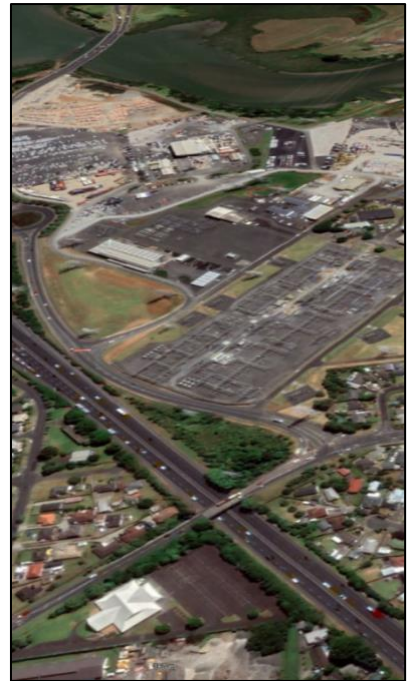
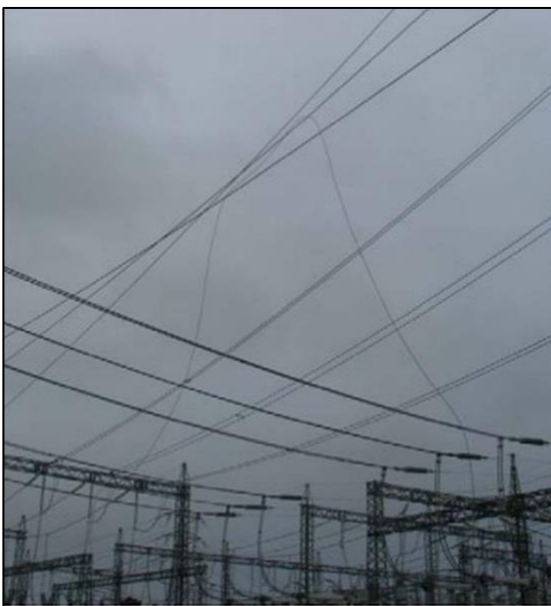
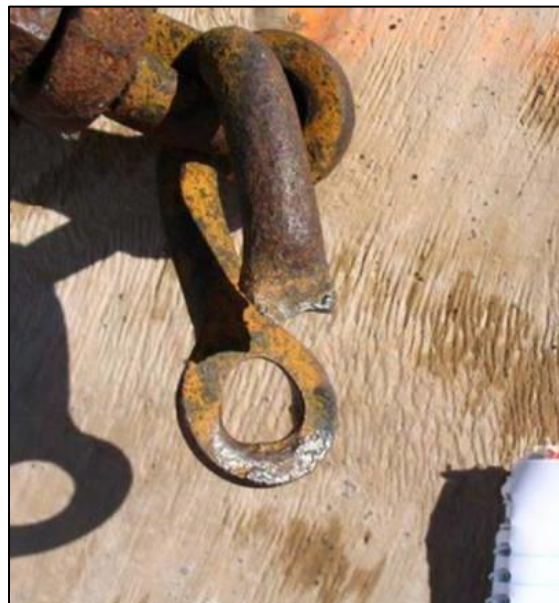
At Transpower's Otahuhu substation, two D-shaped connector shackles broke in a 90km/h wind, allowing the wires to fall and make contact with 220kV and 110kV conductors.

This incident highlights the importance of maintenance, and the impact of not addressing even minor maintenance issues, such as replacing \$25 shackles.

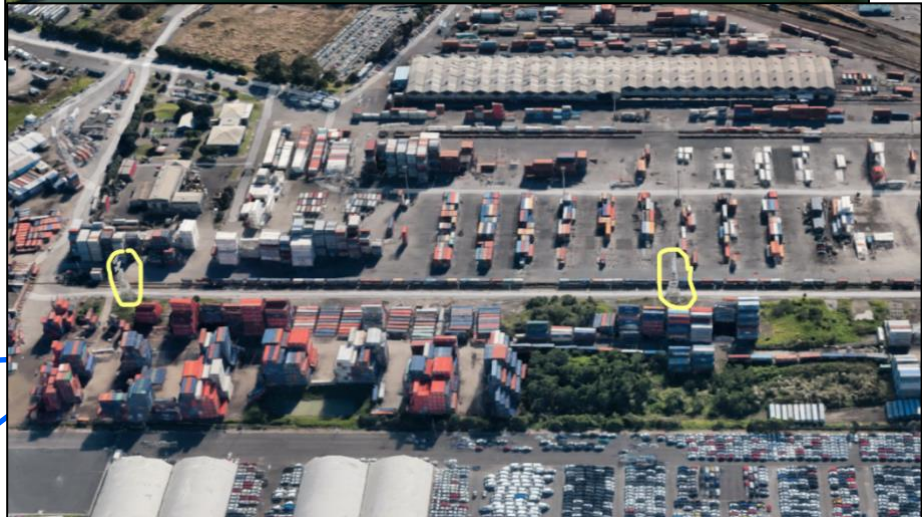
A forklift truck carrying a container struck a 220 kV transmission line. It was the only power line working at the time, as the other was undergoing maintenance.

The image shows where the forklift trucks, with a high reach, need to move under.

This incident highlights the risk of vehicles travelling under lines. With containers on a forklift truck stacked high, there is a very high risk of a significant incident. All the neighbours along the transmission line should have been informed of the scheduled service of one of the feeders and alerted to the increased vulnerability of the power supply which was relying in the sole operational feeder.

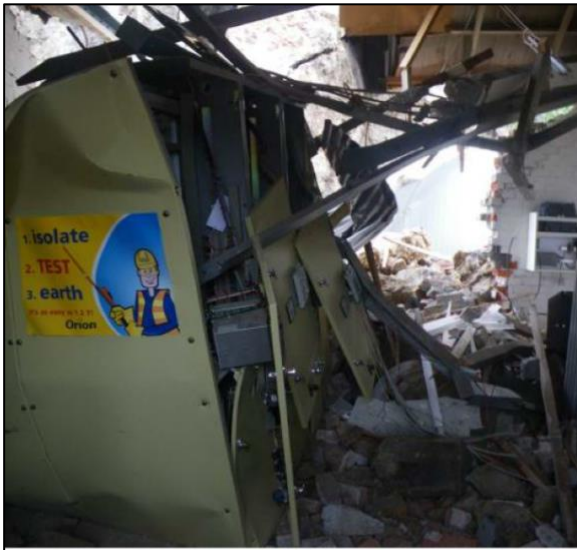
Figure 4: *Sumner substation boulder damage.*

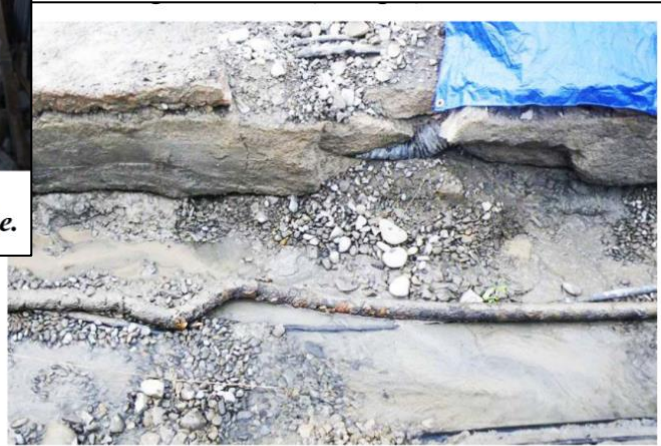
Figure 6: *Earthquake damaged 11 kV steel and lead armoured cable, and above embedded in fractured concrete, a damaged 66 kV oil-filled cable.*

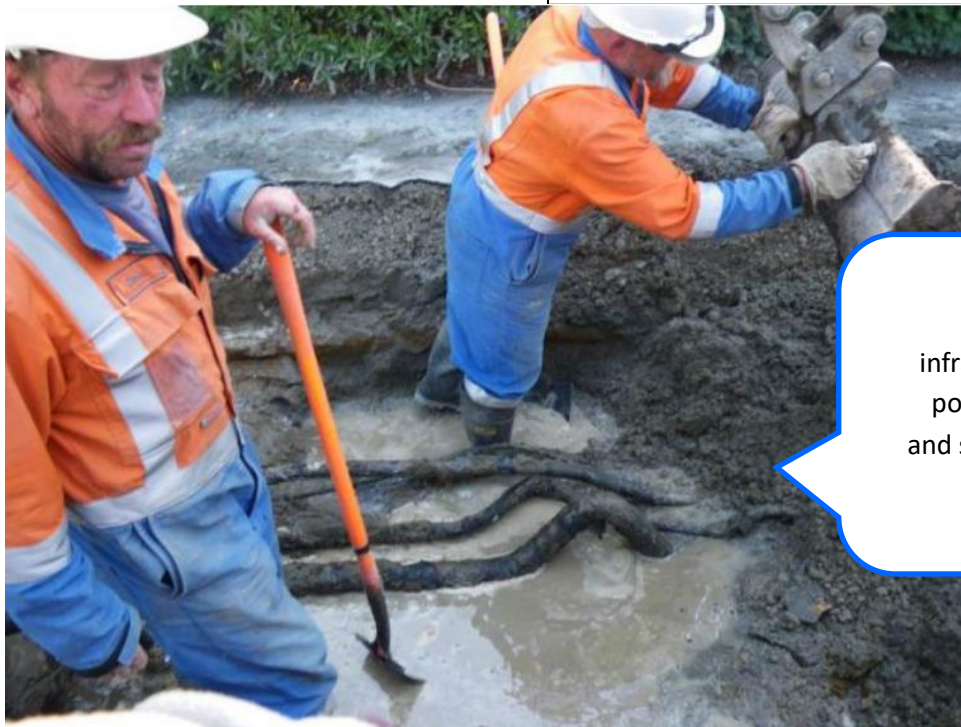
Note how infrastructure, such as power cables, water and sewerage pipes was damaged.

Figure 16: *Digging up multiple faulty 11 kV cables.*

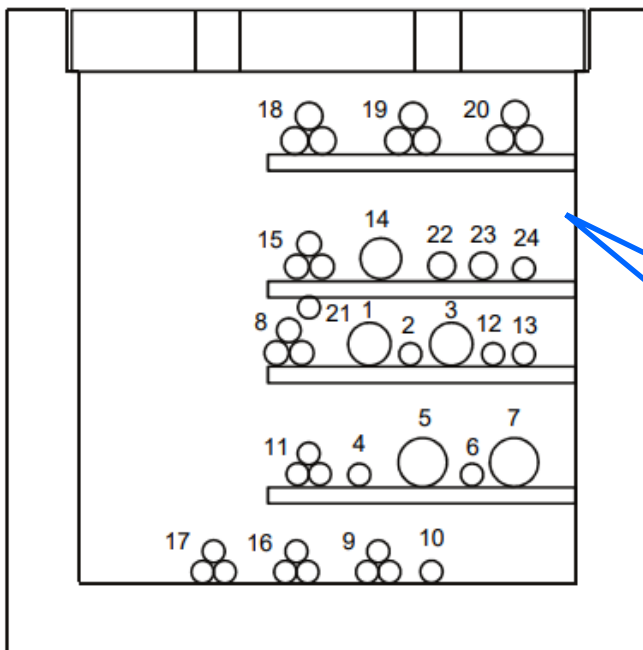
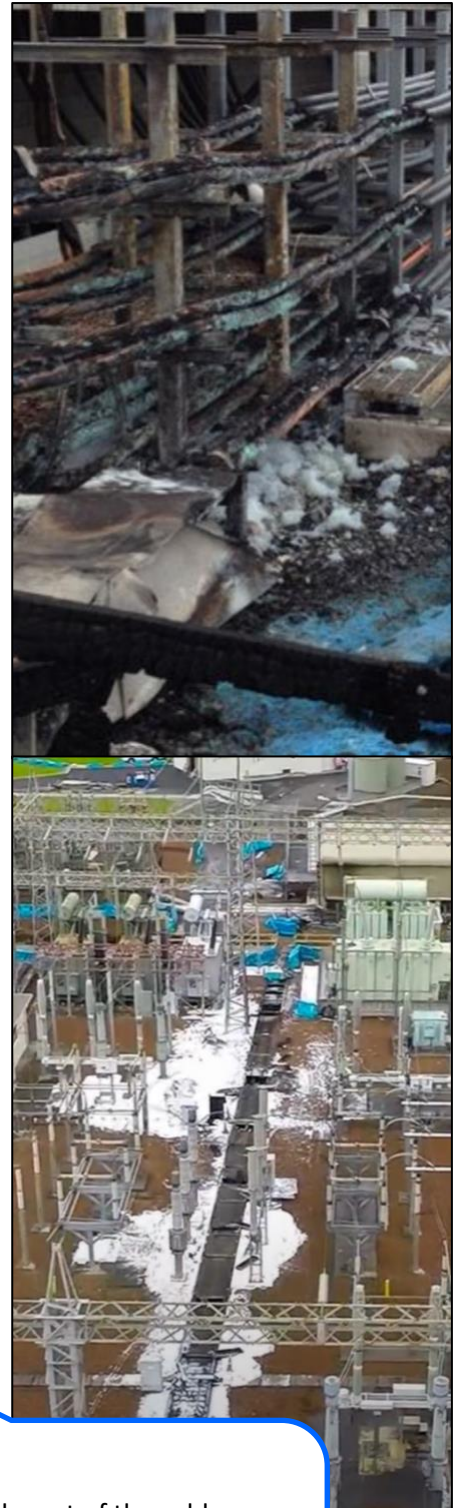
There was an early morning fire at Transpower's Penrose Substation due to an electrical failure of a cable joint in an MV power cable owned by Vector.

When a cable (1966 vintage) leaked, and a new piece was spliced in. But the new piece was too long and was bow shaped, leading to joint failure. This became an ignition source.

At the time of the fire, there were twelve 33 kV circuits, two 22 kV circuits and six 11 kV circuits installed in the cable trench (as shown in the following diagram). These cables supplied substations to the east of the Penrose site, primarily from the 33 kV busbars. There were also four 33 kV cables installed on the above-ground cable racks that were damaged in the fire - even though they were not installed in the cable trench that caught fire.

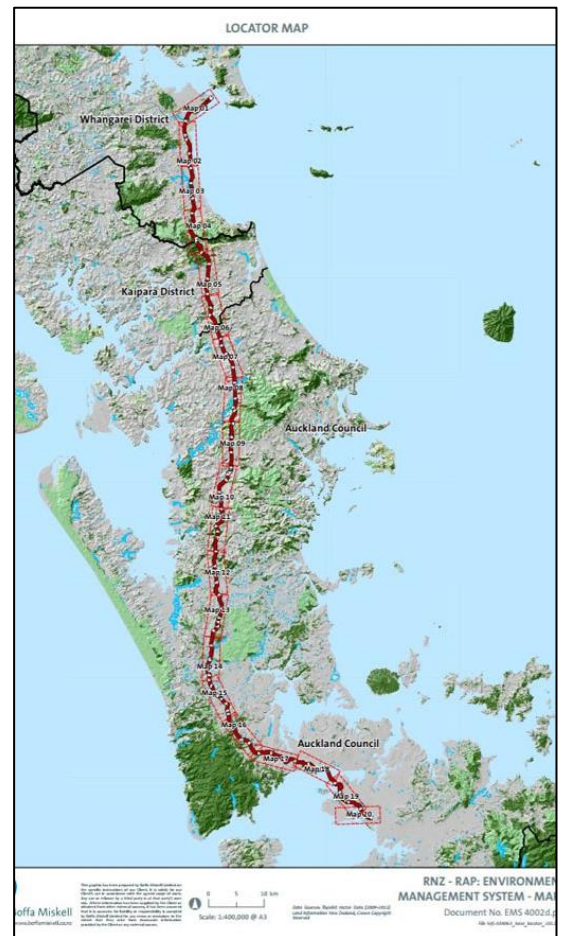
The pipeline was damaged by a digger (who didn't report it at the time) and about three years later the pipeline failed under pressure. Once the rupture in the pipeline was found, it needed repair.

The site of the pipe rupture.

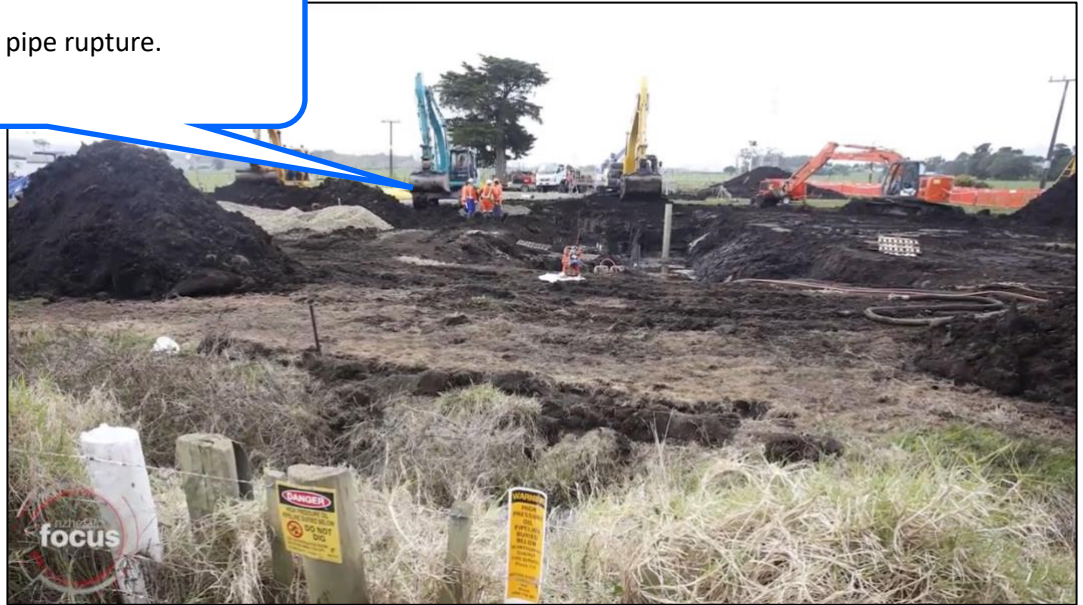
The scrape marks where the pipe was damaged by the digger.
