ENGINEERING FAILURES LESSONS TO BE LEARNT

August 2022

**engineering
new zealand**
te ao rangahau

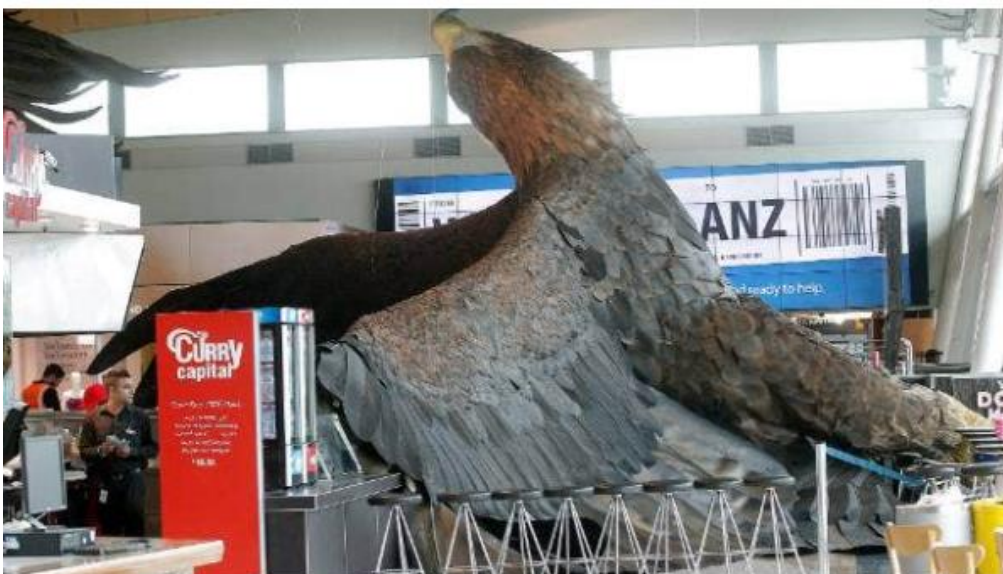
In 2014, a one-ton model of an eagle (created by Wētā Workshop) collapsed from the ceiling of Wellington Airport onto the food court during a relatively moderate earthquake. Fortuitously it was late afternoon and only one small group was affected, and they suffered only minor injuries.

This collapse is a good example of the Swiss cheese model. Although the design was carried out by a competent Wellington consultant there were a range of factors contributing to the failure as follows.

- There was a design mistake in that four of the nine wires holding up the eagle were stressed beyond the recognised safety limit for the wires.
- Wētā Workshop decided that they didn't need a consultant to supervise construction and would install it themselves:
 - they didn't install one of the wires at all, and
 - used a faulty crimping tool that did not crimp the wires properly.
- Wellington Airport applied and was granted an exemption for a building consent, on the grounds that this one-ton eagle was artwork.

Artwork on public display that weighs a ton should be properly supervised when installed.

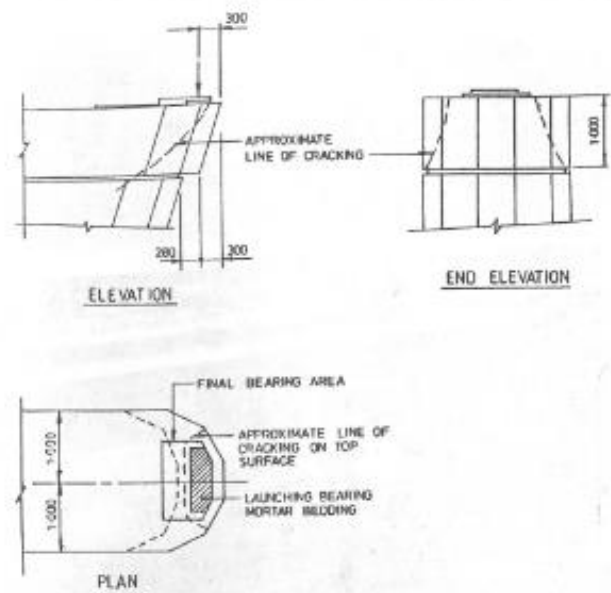
FIGURE 4 LOCATION OF CRACKING IN PIER CAP OF NORTHBOUND BRIDGE

Despite all these checks, one pier on the northbound bridge cracked at the beginning of the incremental launching process. Construction was delayed three months while the northbound piers were strengthened.

Cracking had occurred in the corners from the peak loads experienced during launching. The designers had to come up with a method of strengthening the piers in situ before launching could start again.

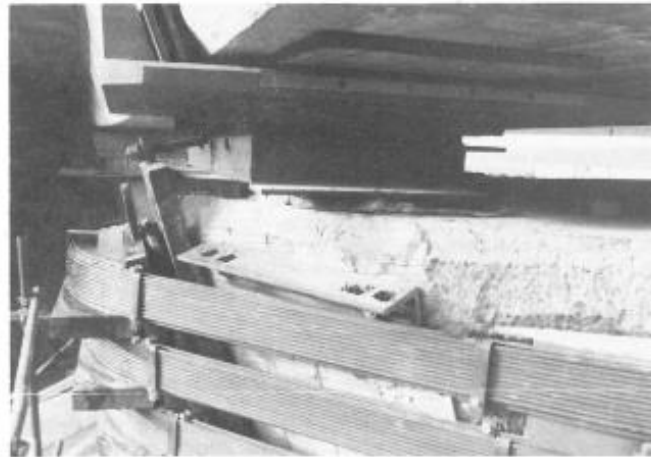
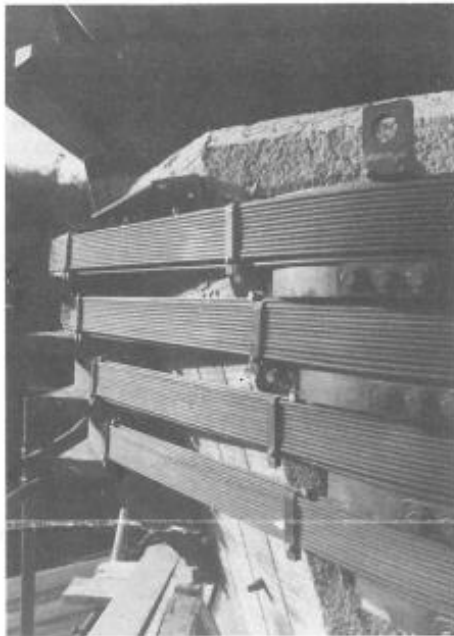
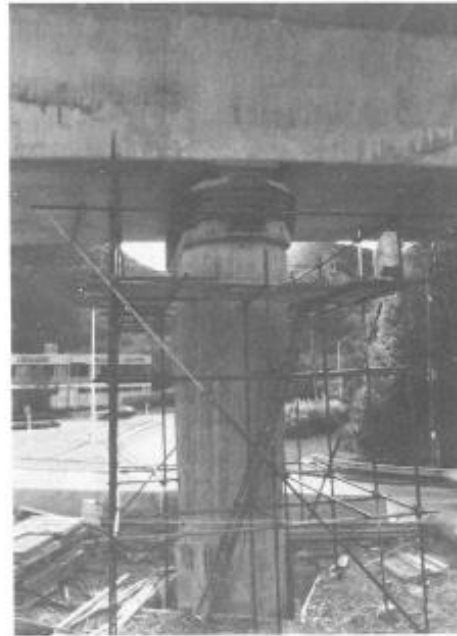
STRENGTHENING PIER CAPS — NGAURANGA OVERBRIDGE

This photo shows the work carried out to strengthen the pier caps. External pre stressing was carried out with a large number of seven millimetre wires installed hard against machine steel surfaces, which had been epoxy glued to the piers. The pre stressing was the post tensioned by inflating two 600 millimetre flat jacks at each end of the pier with Epirez epoxy resin. A concrete cover was then cast around the external post tensioning, so the strengthening wasn't visible in the finished bridge

Small cracks appeared in the cap of pier 3 during a launch of the bridge. The external prestressing shown in the photos encircles the pier cap and bears against machined plates epoxy glued with Epirez 133 to the existing concrete. The prestressing wires were tensioned by two 600 ml flat jacks positioned at each end of the pier and inflated with Epirez 8859 to a pressure of 11.5 MPa.

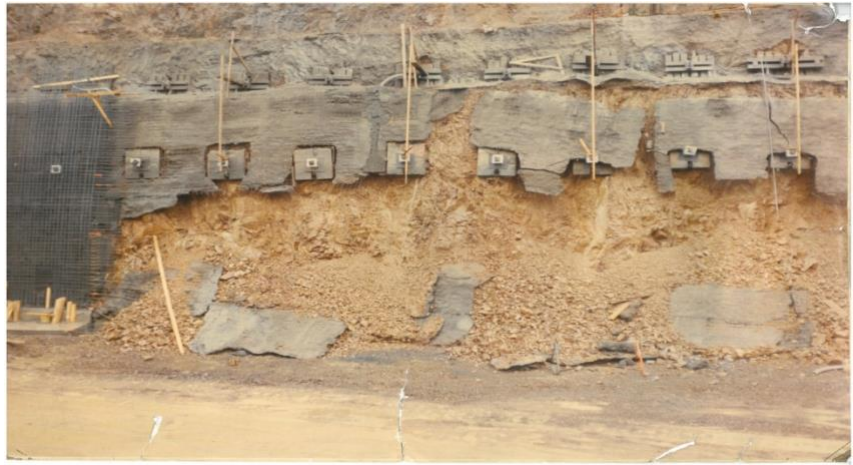
D32 bars at a 100-millimetre centres around each anchor. This section is 14 metres high.

Unfortunately, the pre-cast anchor blocks were not connected to the shotcrete. During the winter of 1976, the ground slipped behind the shotcrete and the wall fell down. This wall was supposed to only be 600 millimetres thick but, in some places, it's two metres thick as it was cast without a back shutter up against the earth.

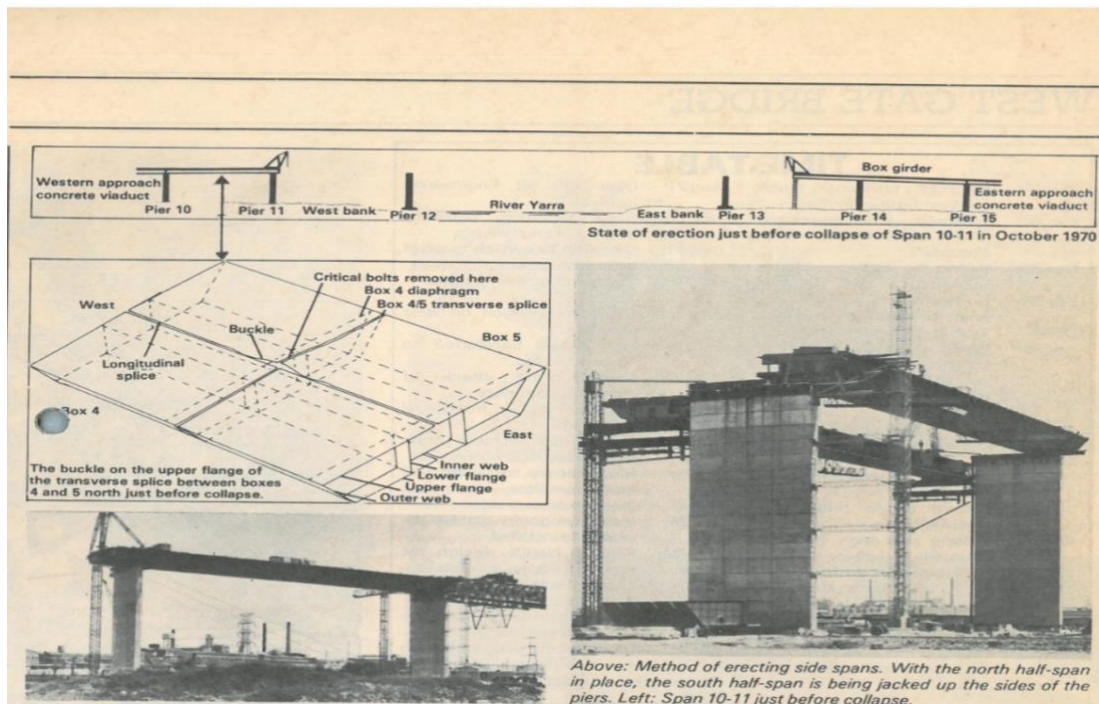
The West Gate Bridge in Melbourne collapsed in 1970, resulting in 35 fatalities.

A big problem was that the Melbourne temperatures were causing the top flange to be a lot higher than the bottom flange, so the flanges were distorted. With the site engineer's approval, they used large concrete blocks to try and move the flanges so they could be bolted together.

The design was also under strength.

The reason there were so many fatalities was that the lunch huts for the workers were underneath the span that collapsed.

The construction method of joining a large steel box girder span in mid-air was flawed due to the effects of differential temperatures between the top and bottom of the box girder. This method is no longer used – other methods e.g. incremental launching are much safer.

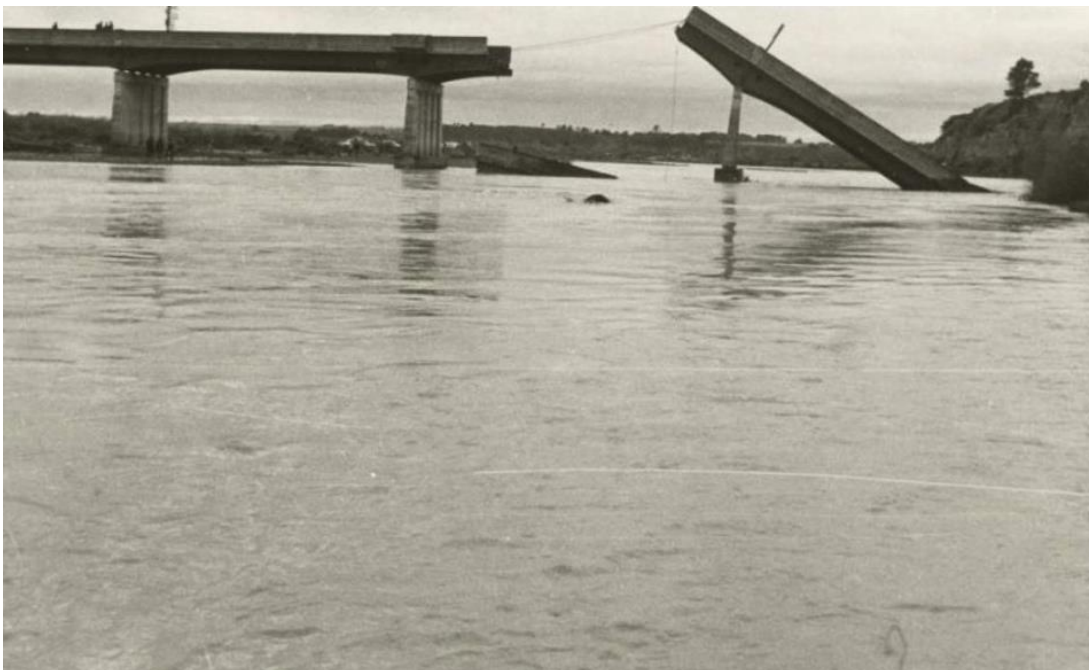
A section of the Bulls Bridge, on State Highway 1 in New Zealand, collapsed in June 1973. At the time while a bus was driving over. Fortunately, the driver was able to swim to the bank and be rescued by two locals. So, there were no fatalities.

The section of the bridge collapsed during a storm, due to pier scour failure.

Transit New Zealand (now Waka Kotahi) completes regular scour measurements to ensure that this sort of accident doesn't occur again.

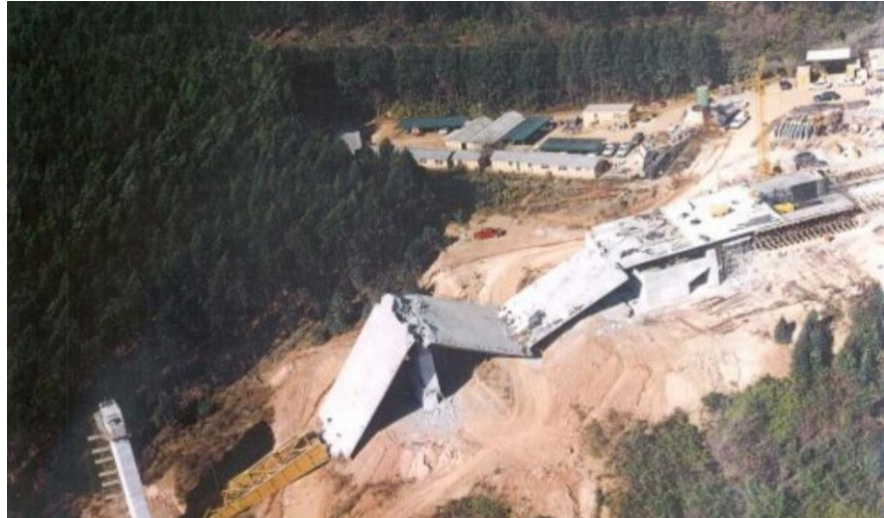
But like all collapses, there was more to it than that. The main cause of the collapse was that the launch bearings were incorrectly placed.

Like the Ngauranga Bridge launch in Wellington, the Injaka Bridge was launched over the piers using stainless steel bearings and Teflon pads, which are fed in to reduce the friction. At Injaka, the launch bearings for some reason were installed underneath the bottom of the box, which is much weaker. This is the wrong place for the bearings and was not noticed.

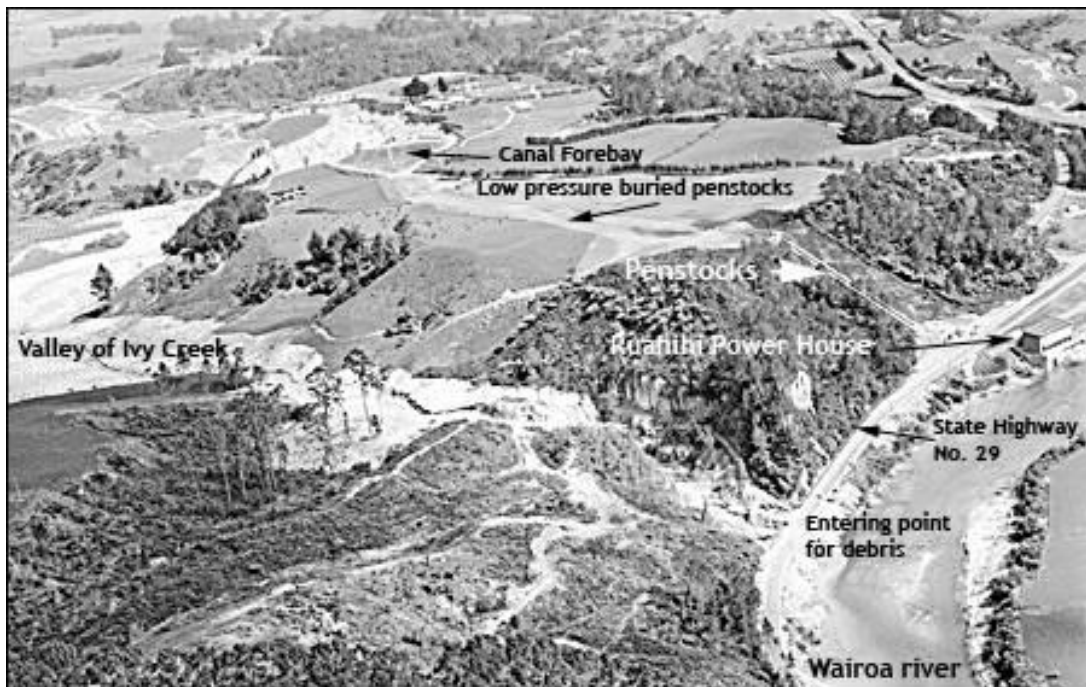
The failure occurred on Sunday 20 September 1981. Only 24 hours after the official opening, an area of the canal failed, eroding 200 linear metres, and causing 1.5 million cubic metres of earth and water to wash downhill and block the Tauranga to Hamilton State Highway. Fortunately, there was no loss of life.

The original canal design was lined in concrete, but to save costs, the design was changed to an unlined canal – to be formed using compacted-sensitive volcanic soils. Note: the canal had been in use for four months and the area that failed had persistent leaks prior to the collapse.

Aerial view of Ruahihi Canal after collapse on 20th September 1981 *Photo: David de la Hyde*

Repairs involved shortening the canal by 500 metres and lining the canal with plastic and concrete pavers. These repairs took two years and cost \$17 million, not including the loss of generation from the 20MW power station over that time.

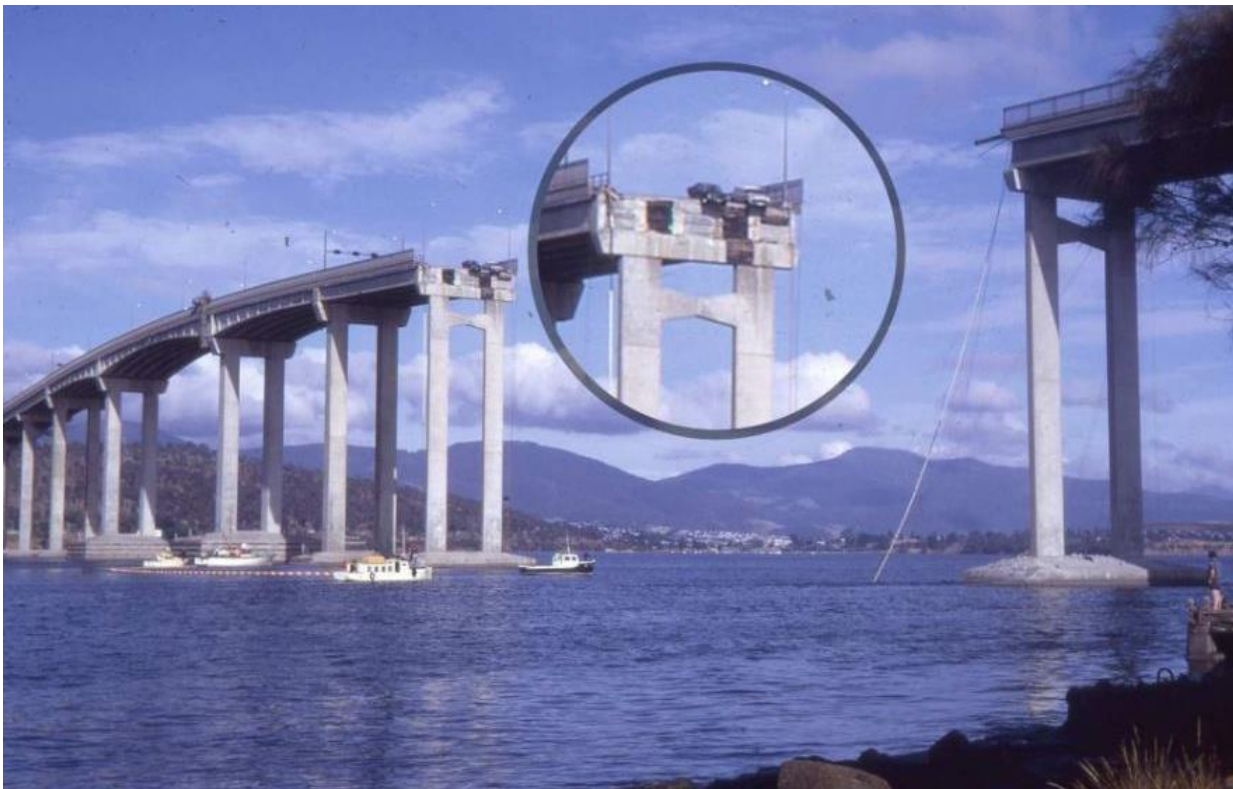
- There was a strong outgoing tide.
- There were foggy conditions at night.
- The captain of the boat was having trouble controlling the boat and it hit one bridge pier.

When designing bridges, ensure the piers are protected from potential risk from being hit by a ship. This is shown in the next example of Incheon Bridge in South Korea.

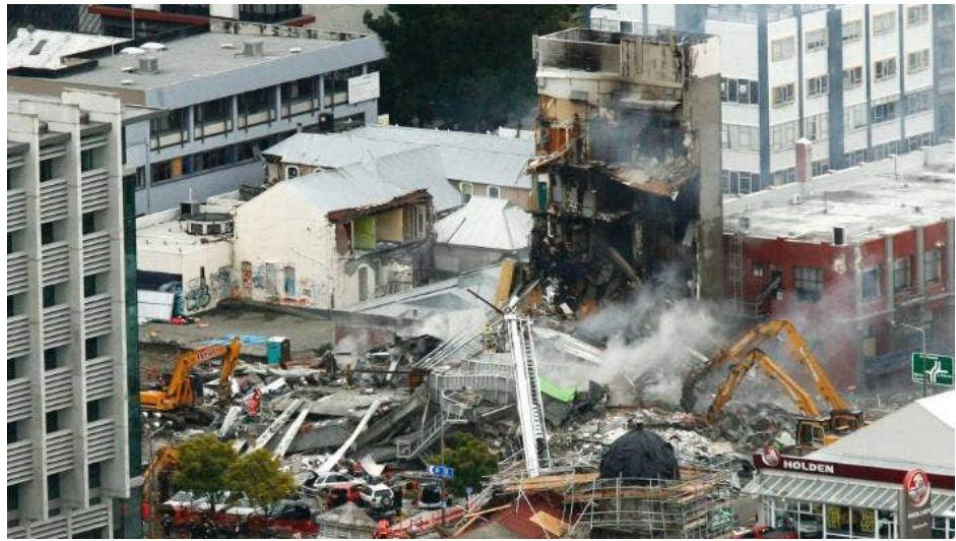
The CTV building in Christchurch collapsed in February 2011 as a result of the earthquake resulting in 115 fatalities.

The building took nearly all seismic lateral load on the end lift tower. Note: the lift tower at the end of the building, which was designed to take all the seismic load, survived the collapse.

- The designers were Alan Reay Consultants.
 - The design had defects. For example, the column stirrups were only six millimetre in diameter at 250 millimetre centres.

The Royal Commission, who investigated this failure, recommended that designers focus on beam-column joints, connections of floors working as diaphragms and ensuring columns have adequate confinement to ensure ductility.

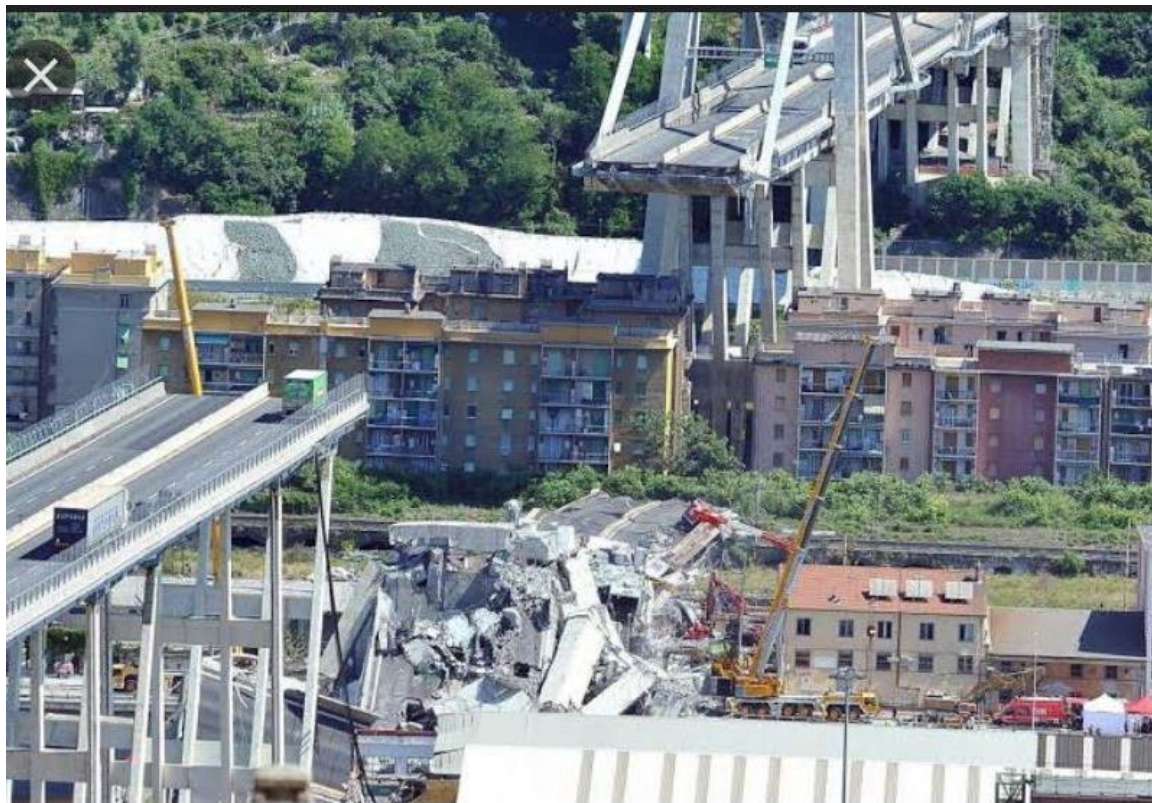
- The bridge was structurally redundant, and all the stress was carried in one large member.
- The other significant factor were deck cracks that were noticed two weeks before the collapse.
- The lack of maintenance was determined as the primary cause.

Firms responsible for bridge maintenance need to ensure that they're competent, which would include regular checks.

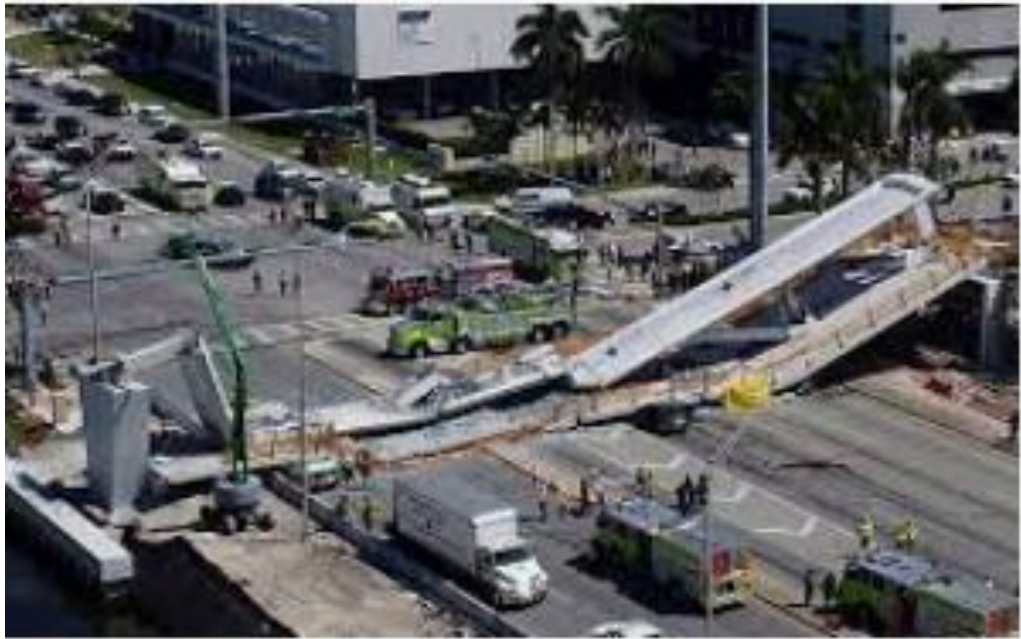
The Miami Bridge collapsed in 2018, five days after it opened. It had a very long bridge span - across eight lanes of traffic. When it collapsed, there were eight fatalities and ten injuries.

- During erection, the north end cracked after some temporary pre stressing was released. The contractor advised the designer of the cracking issue.
 - Figg Engineers didn't know why the cracks occurred but expressed no safety concerns.
 - Two days before the collapse Figg Engineers proposed remedial work but didn't consider it necessary to close the road or prop the bridge.
 - The Engineer of Record advised an engineer at the Florida Department of Transport (FDOT) in a voice message of a minor safety issue. Unfortunately, that FDOT engineer was on one weeks leave.
- At the time of the collapse over the live highway, Figg Engineers were meeting with FDOT. The lead engineer at Figg Engineers advised that the structural integrity of the bridge was not compromised and that no safety concerns existed! The bridge collapsed during this meeting.

A subsequent inquiry concluded the bridge had design deficiencies, had an inadequate peer review, and that the severe cracking was wrongly ignored by the Engineer of Record. The inquiry also concluded that one node on the truss was grossly under designed.

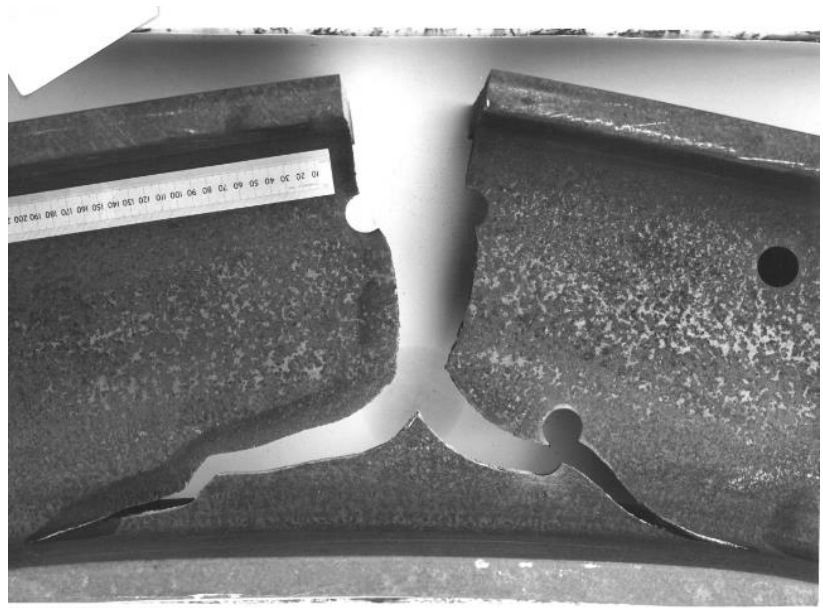
This photo is of a 250mm by 250mm by 90 kilogram universal column section used to form an arch for the Terrace Tunnel.

When we investigated this failure, we took a sample of the actual steel and discovered that it was well in excess of the 0.3% carbon that is allowable for mild steel.

We checked the test results that had been supplied with this steel which said that the steel was compliant. It wasn't!

A key lesson from the Terrace Tunnel was on standards. In particular, the importance of specifying materials and then ensuring that the materials used meet those standards.

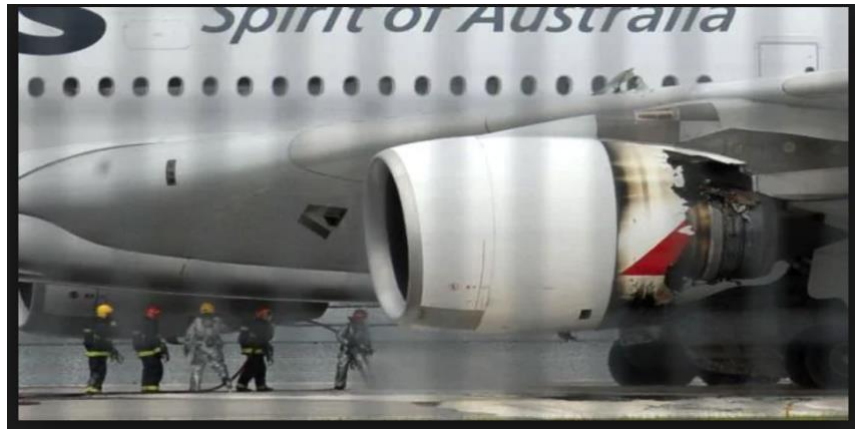
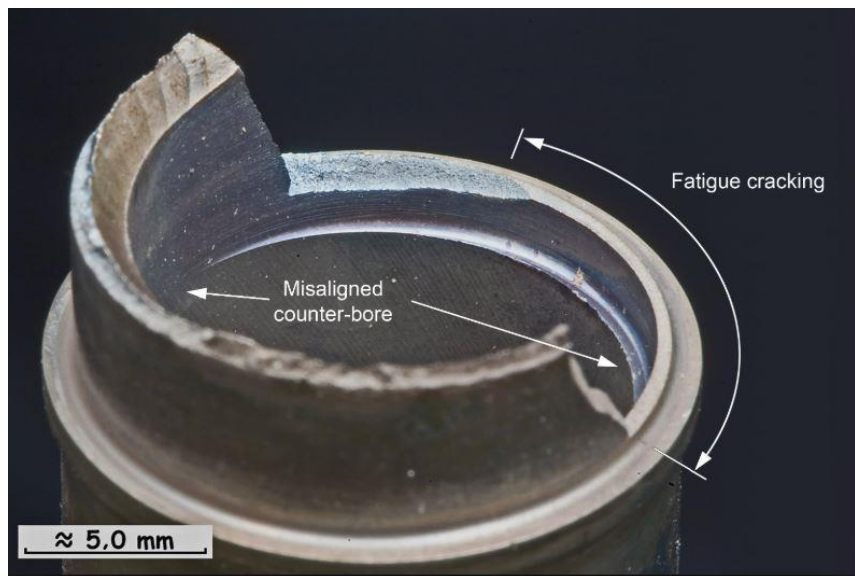
A critical 12-millimetre stub oil copper pipe had been manufactured improperly. Instead of its wall thicknesses being symmetrical, on the left-hand side it was almost three millimetres thick and on the other side, it was paper thin, only 0.3 millimetre thick.

The plane successfully landed even though it was running over speed, 50 tons overweight, with no flaps. It burst three tires during the landing and leaked large volumes of fuel onto white hot disc brakes on the wheels.

The Qantas plane was subsequently repaired at a cost of \$130 million, which was paid by the insurers. Qantas also grounded all their planes.
