SAYANO- SHUSHENSKAYA HYDROPOWER PLANT DISASTER LESSONS TO BE LEARNT

September 2022

On August 17th, 2009, there was a catastrophic failure of unit 2 of the plant. This resulted in the death of 75 workers.

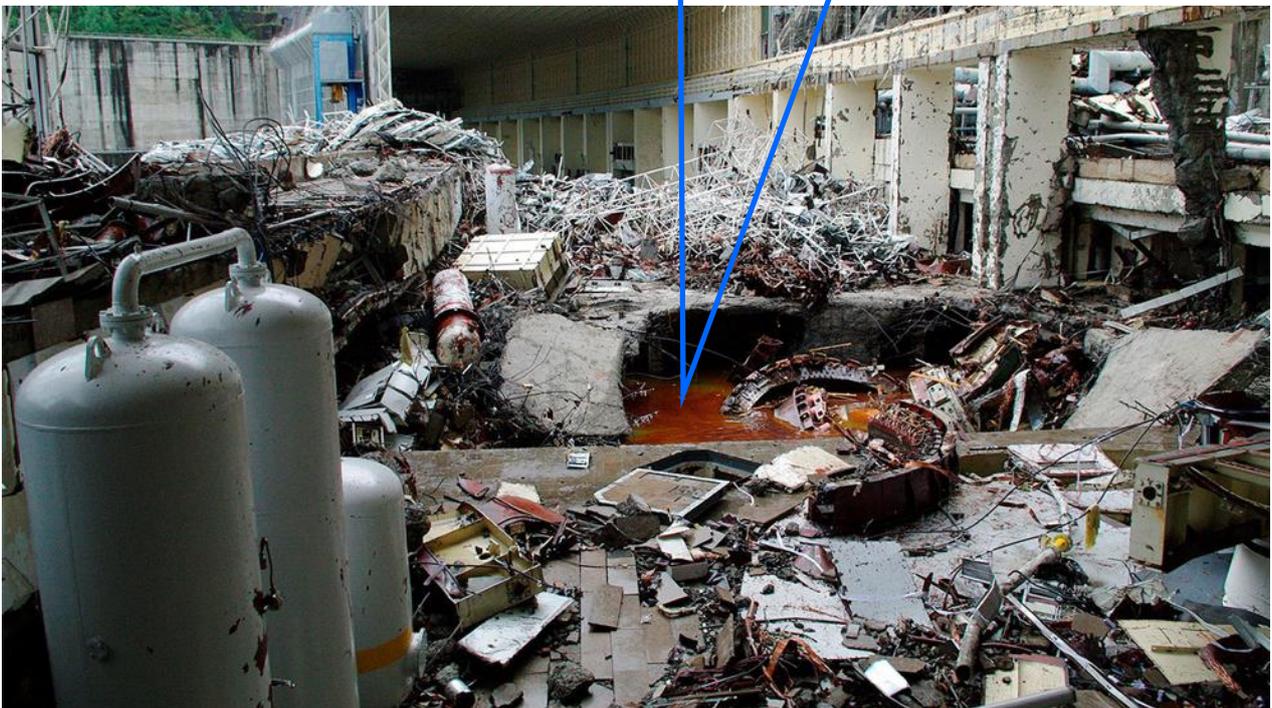
The hole from Unit 2 in the powerhouse gallery.

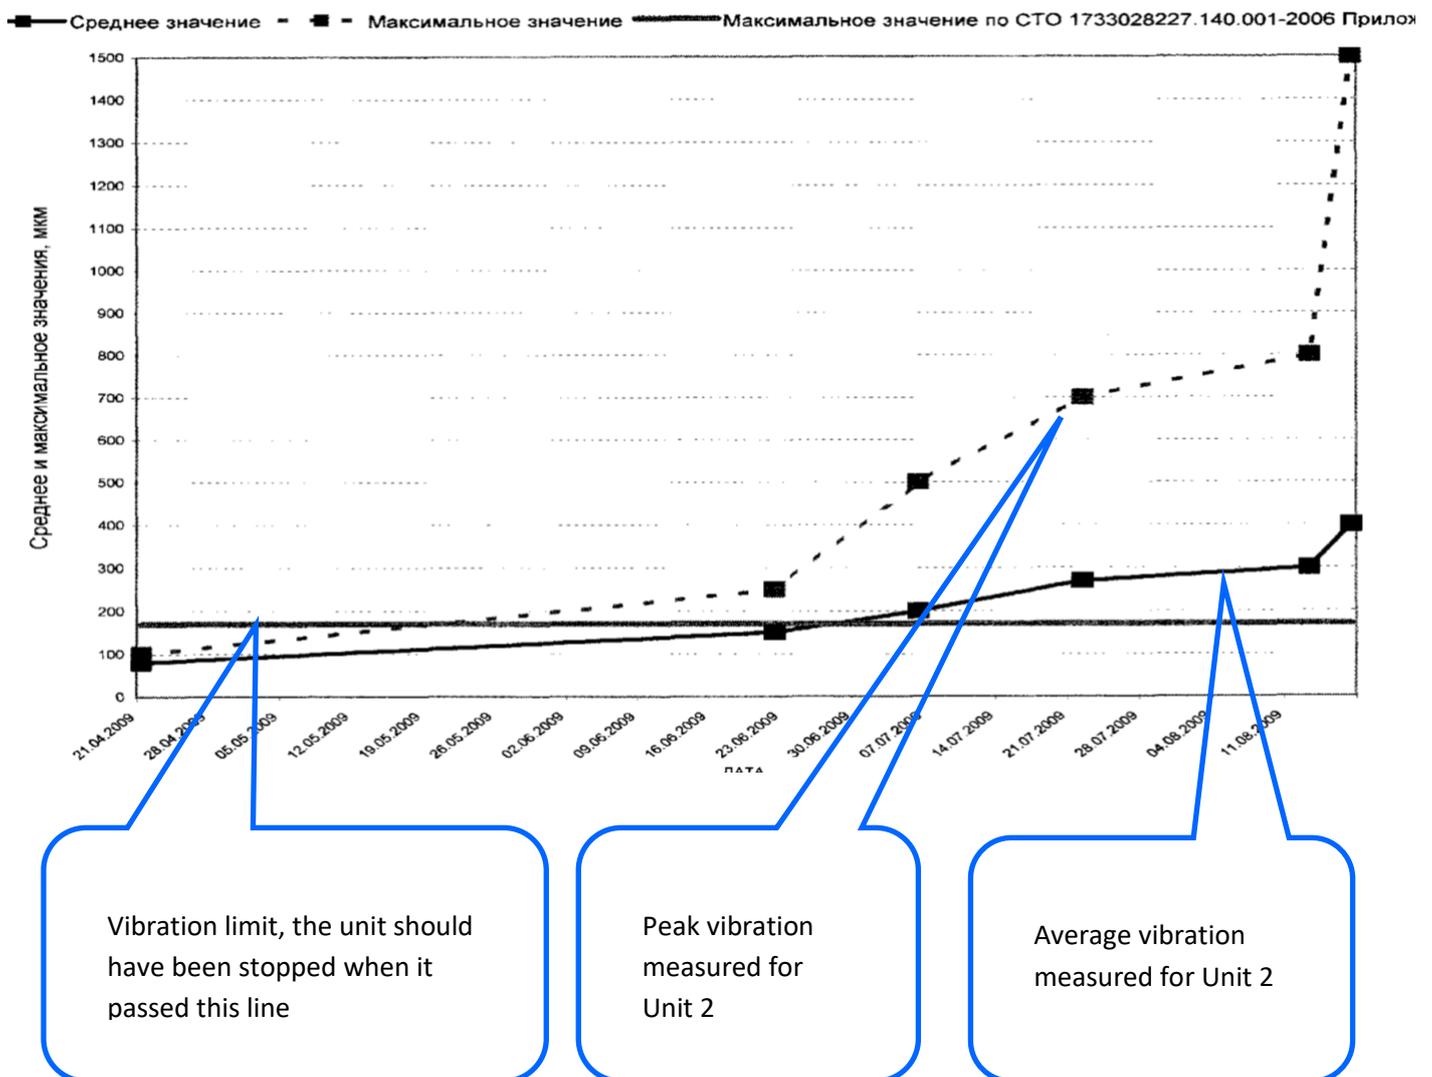
Increase of Unit 2 turbine bearing vibration from April 2009 to August 2009.

Although Unit 2 had been refurbished earlier in the year in April, a month after this refurbishment the unit started to show an increasing rate of vibration in the machine.

The solid line in the graph below shows the vibration limit and the unit should have been stopped when it passed this. This is at a little under 200 micrometres, which is the peak amplitude vibration.

As you can see in the graph, in August, the vibration amplitude started climbing quickly. (In fact, many of the 75 people who died were part of an engineering team investigating the increasing vibration.)

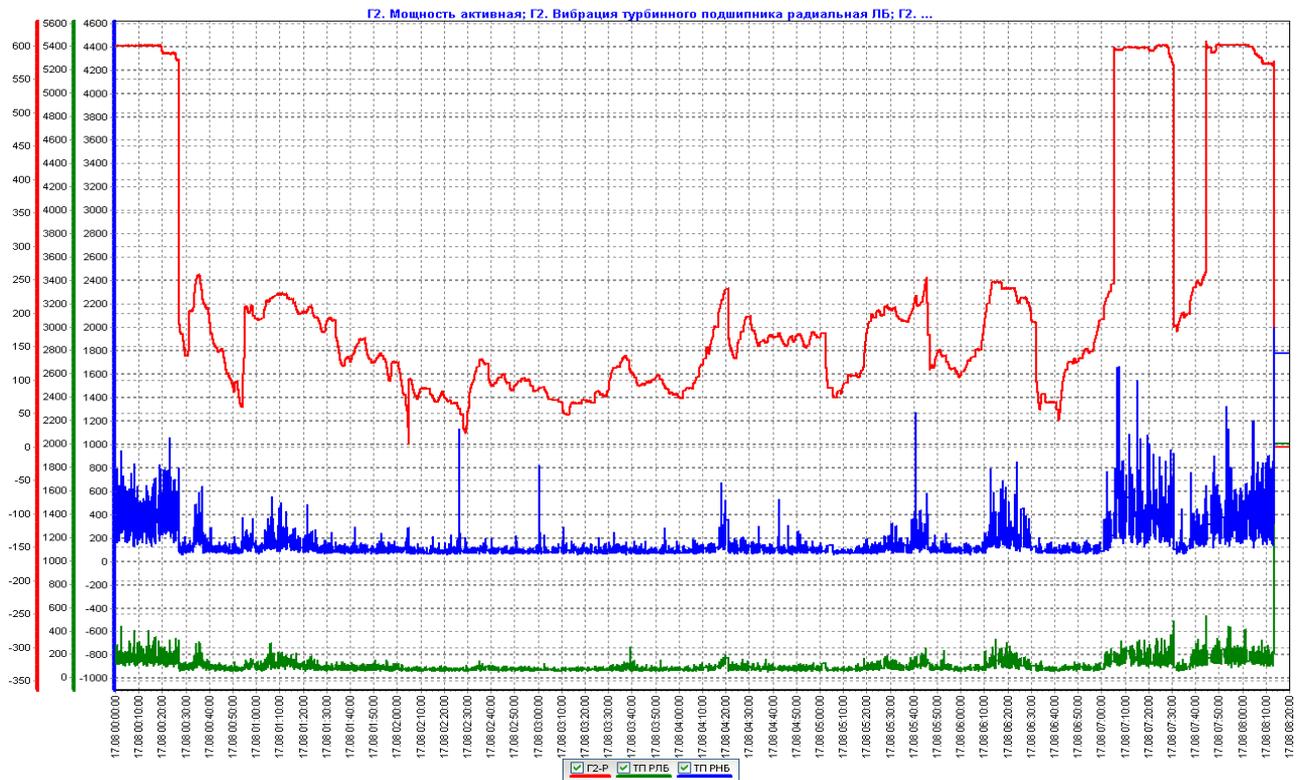
Unit 2 loading (8-hour period prior to accident)

Eight hours before the accident, there was a fire in control room at a nearby plant. And in another plant, the System Operators primarily used the automatic generation control (AGC) to raise and lower the power being generated (to maintain the frequency at 50 Hertz in the transmission system).

The System Operators selected Unit 2 as the first responding unit in AGC, the reason for this selection is not known.

With the vibration issues in Unit 2, it should have been the last responding unit. The operators should have picked a different unit. But the operators assumed that since Unit 2 had just been refurbished, it was in the best shape, and turned off the vibration alarms that were continually going off.

So, starting at midnight Unit 2 was operating at 600 MW, then dropped down in AGC mode to between 250 and 50 MW all night long, to a lower operating regime. For this type of turbine, it should not run all over this full range like this. It was then ramped up in the following morning to 600 MW, dropped back, came back up, and then dropped back down in the failure.

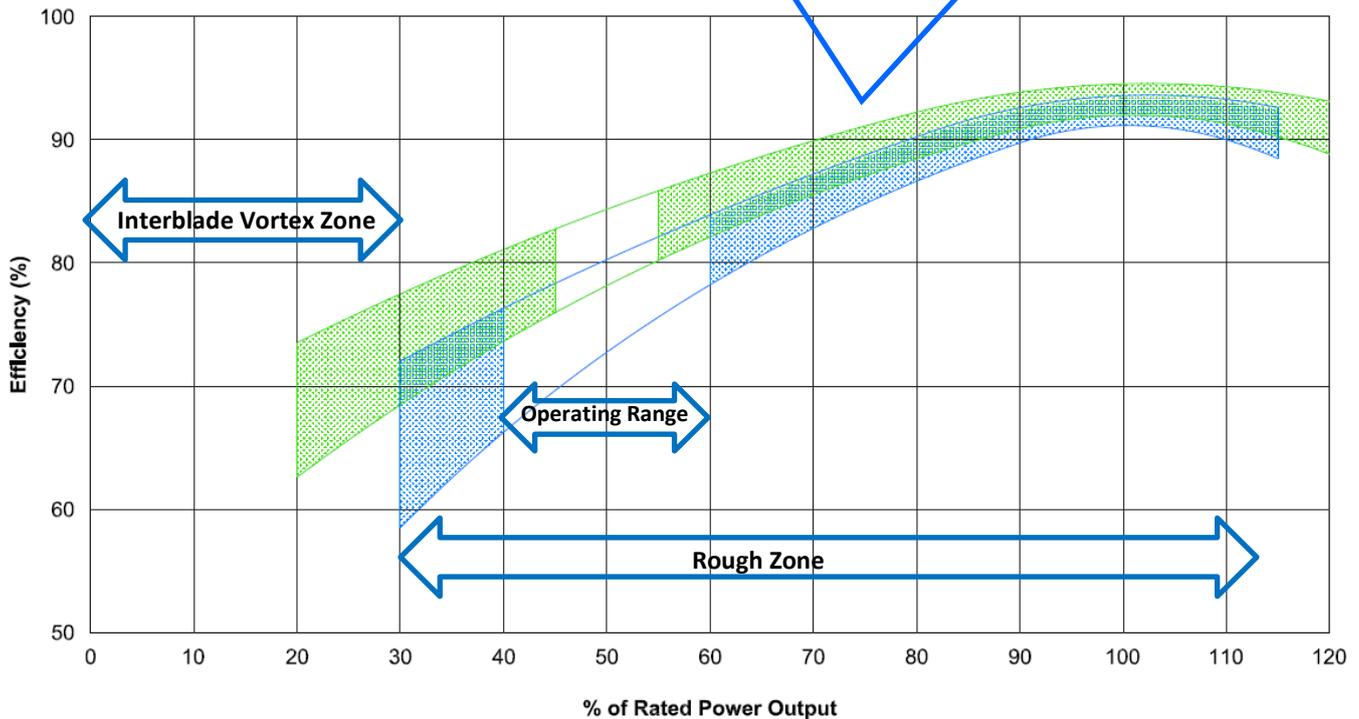
The blue shading shows the vibration on the turbine bearing and the green is the generator bearing for Unit 2. The graph shows how the different vibration levels began to climb – and yet the System Operators kept running Unit 2 and didn't trip the machine and switch to a different one.

Unit 2, during the 8 hour period prior to the accident went through the rough zone four times in a one-hour period - twice up and twice down. It was also sitting down at the low power range, at below 250 MW, which isn't as bad of a vibration regime as the rough zone, but it is a very tough place to operate because of the angles of the flow that happen.

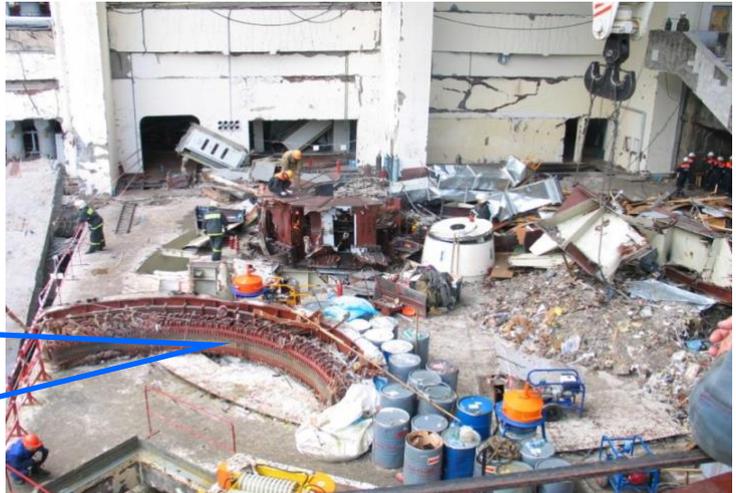
Unit 1 ended up with lots of the different parts of Unit 2 sitting on top of it, but it was not terribly damaged.

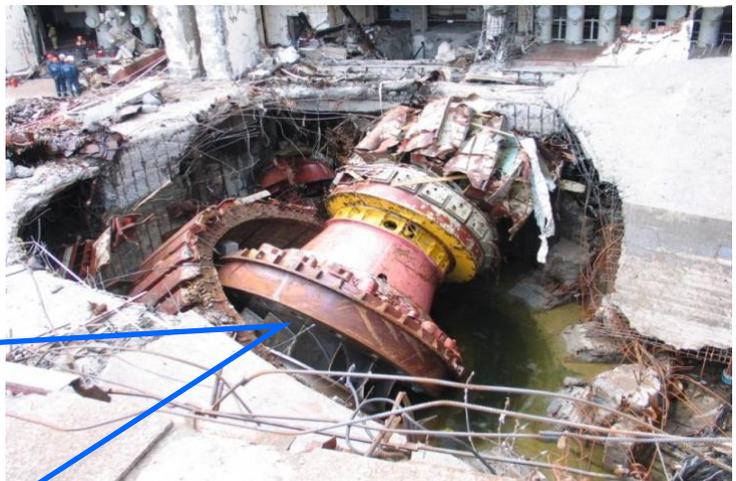
In **Unit 2** you can see the damage to the cone (that we previously saw hanging from the crane).

Also, the arms of the generators were ripped right off - in the direction of motion.

Note the rotor rim and the stator of the generator have gone (500 tons of steel and copper). All you can see is some foundation pedestals of where it used to sit.

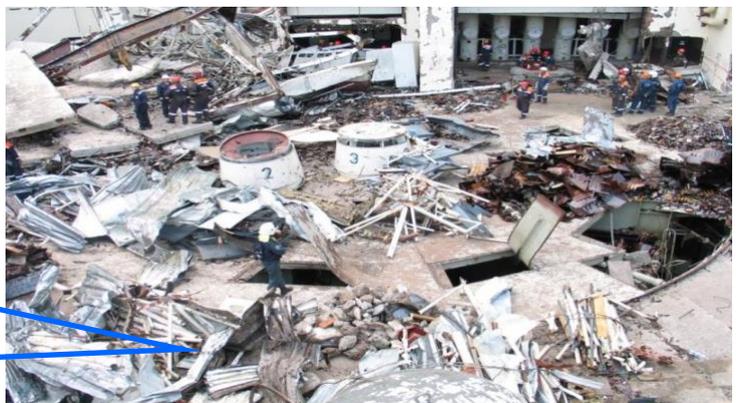
The cover of **Unit 3** was ripped off, and parts of Unit 2 and the crane landed on it.

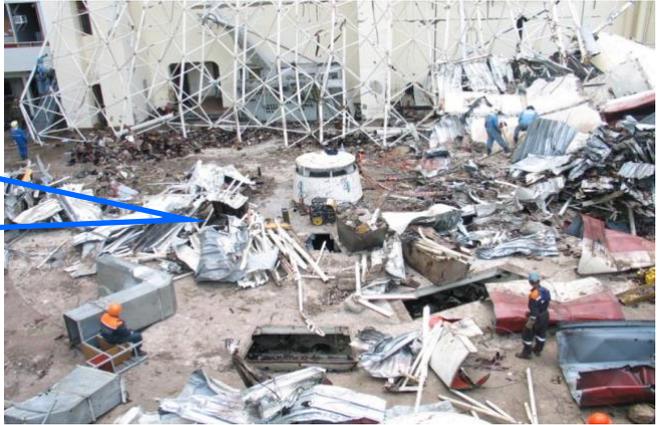
Unit 4 and 5 weren't too badly damaged.

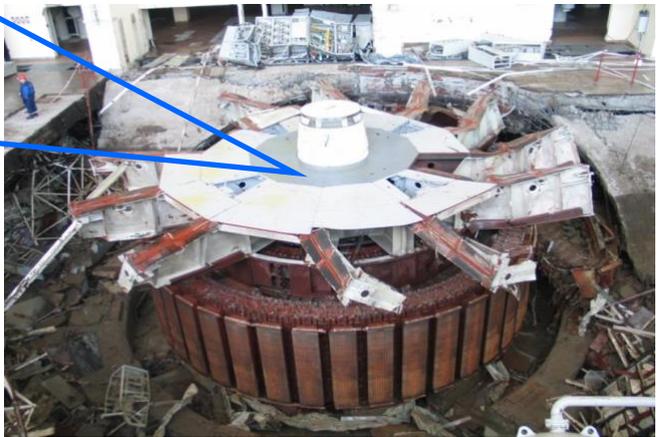
Unit 7 had a lot of damage.

The bearings and the stator were completely gone (note the arms and the torsional pattern that it came off in) with the bracket sitting on top of the stator.

The other interesting thing is that all the copper was gone from the rotor poles.

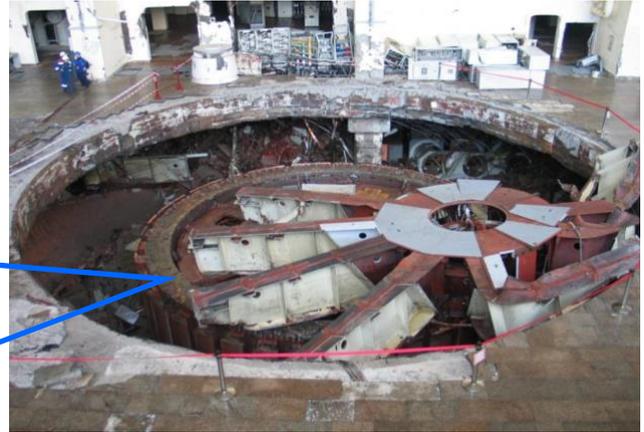
In **Unit 9** the stub shaft was completely gone, and the upper bearing bracket completely shifted off.

And again, the stator was completely gone, and the copper gone on the rotor poles.

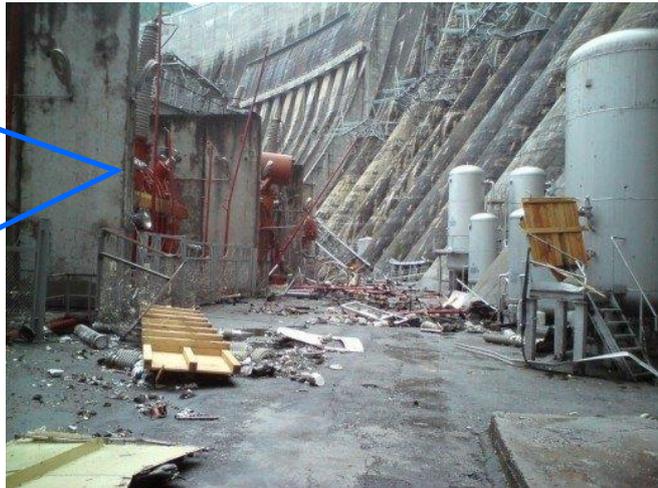
The transformer area and the area between the powerhouse and the dam.

This is where a lot of the shorting out probably occurred (when the water started to shoot out through the roof).

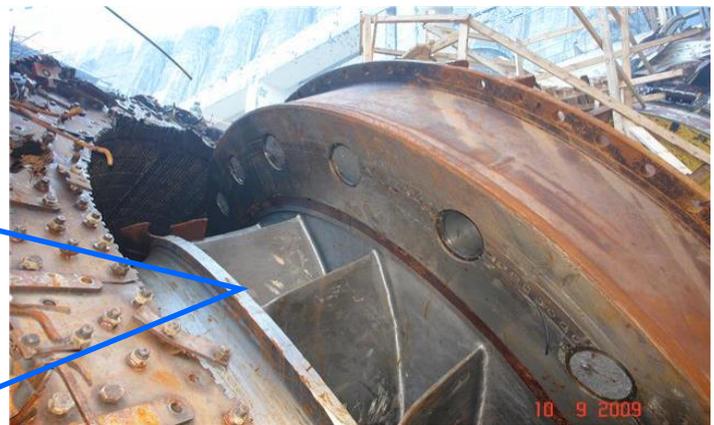
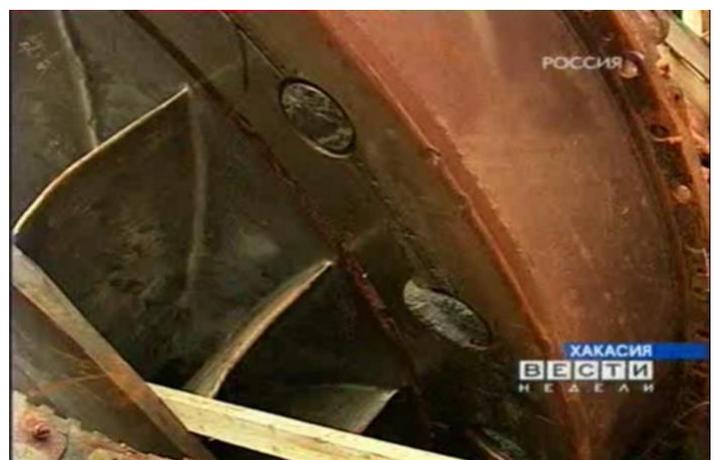
The head cover, note the damage to the wicket gate stems (which control the flow of water into the turbine). The stems of the wicket gate shafts, which were about 25 or 30 centimetres in diameter, were completely sheared off inside the upper head cover piece. Most probably as a result of the torsional failure on the wicket gates.

You can also see the head cover flange that failed. This had been bolted down to where that thrust cone connects on to the concrete section of this flange.

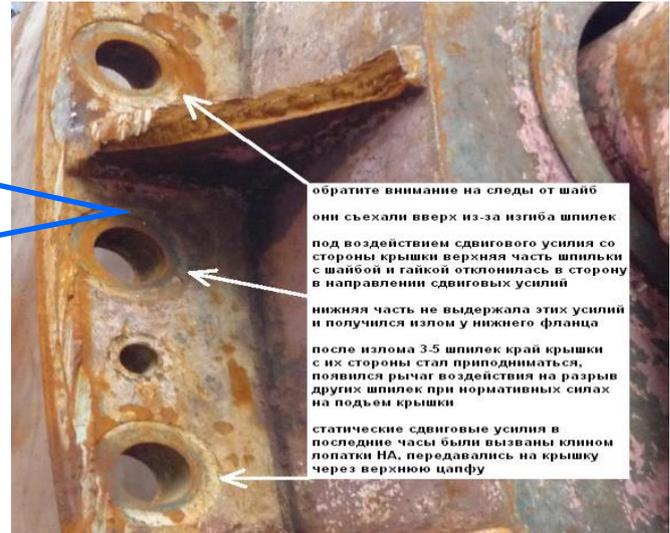
Another view of the damaged wicket gate and sheared off steel (from the other side). Note the sheared off pins.

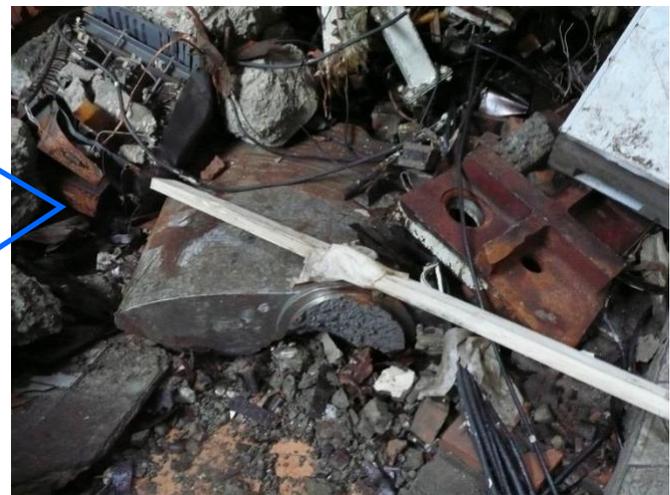
The wicket gate torn in half. This is the bottom half of the wicket gate. The top half is still in the head cover.

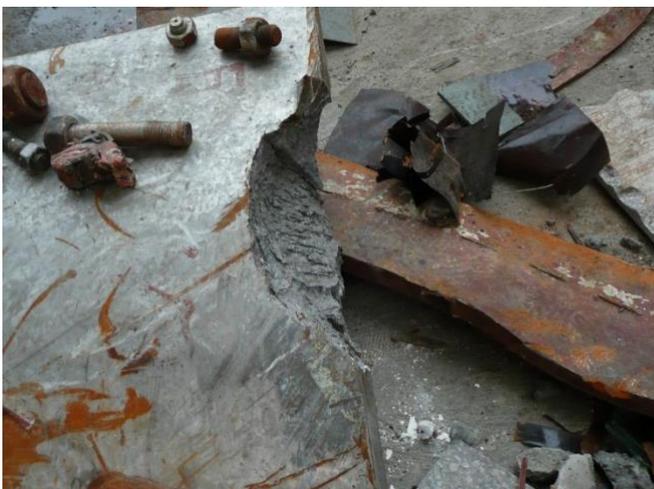
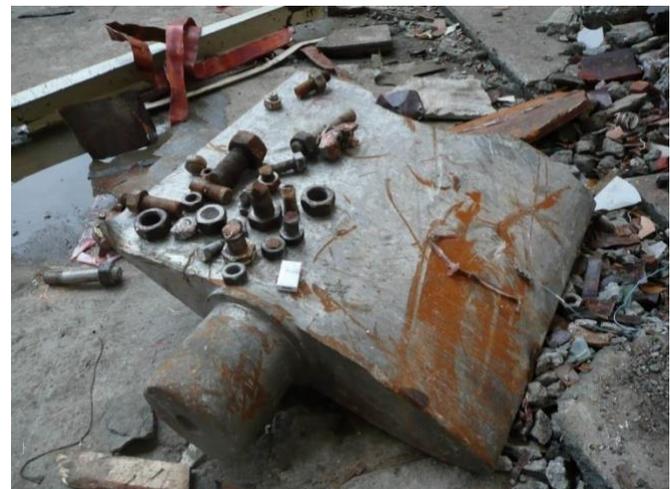
A collection of bolts - that were the main cause of the failure.

The fundamental root cause was the fatigue failure of the head cover bolts.

- Prior to the event it was reported that Unit 2 had an unusual vibration.
- Unit 2 was operating in the rough zone and the vibration levels continued to increase.
- Of the 80 head cover bolts, 41 had fatigue fracture.
- The threads on 6 of the 80 bolts were found to have no damage –there were no nuts on them.

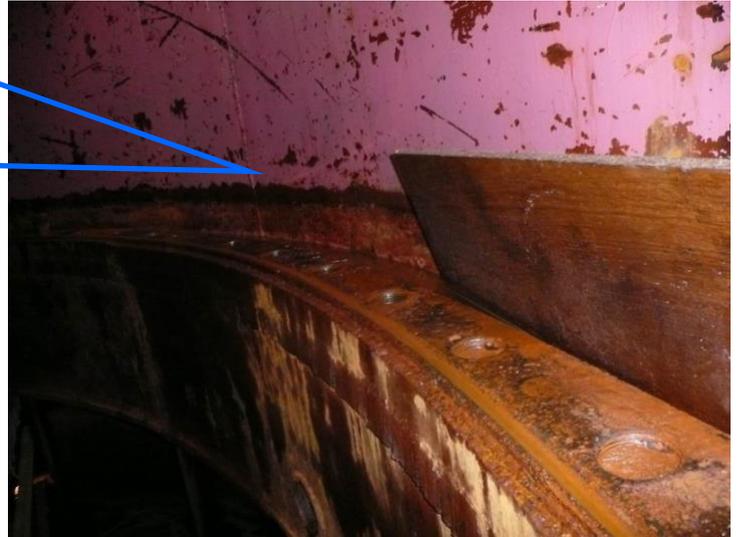
The flange embedded in the concrete.

If you look closely, you'll see the sheared bolts still in the holes.

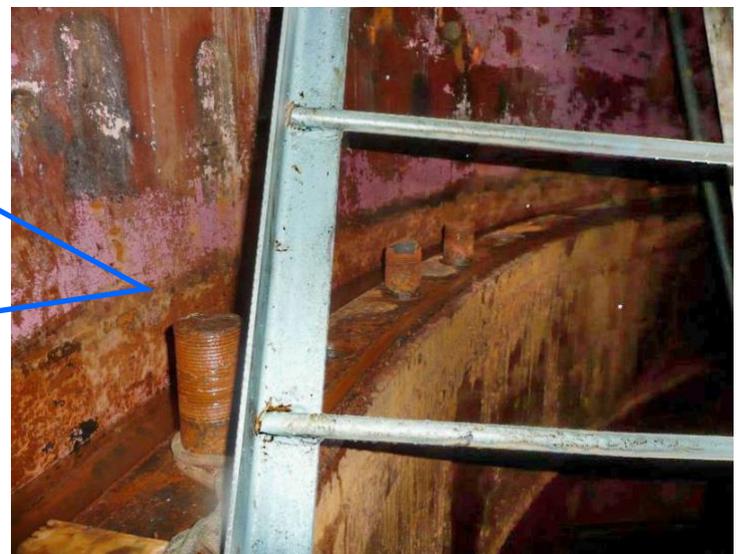
There were six studs that didn't fail and weren't even damaged, which shouldn't even be possible!

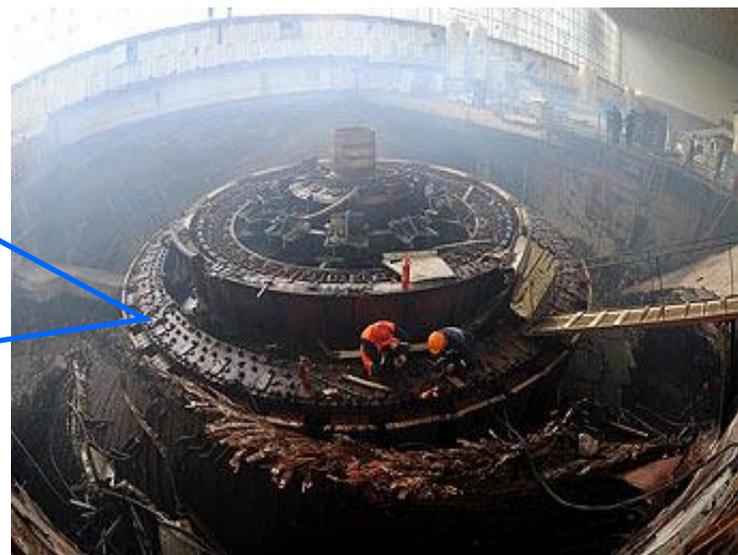
The stator core windings of Unit 7.

Because of the over-speed event and short circuiting, the copper came off the end of the rotor. The rotating parts of the rotor just ripped the stator and the foundation. The bearings twisted off and the stator just went.

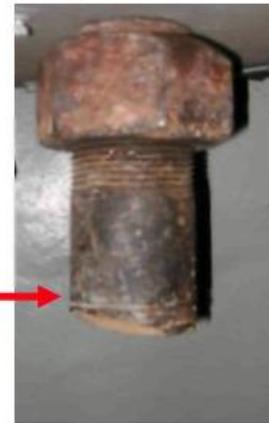
Рис.4

Example of a fatigued headcover fastening stud.

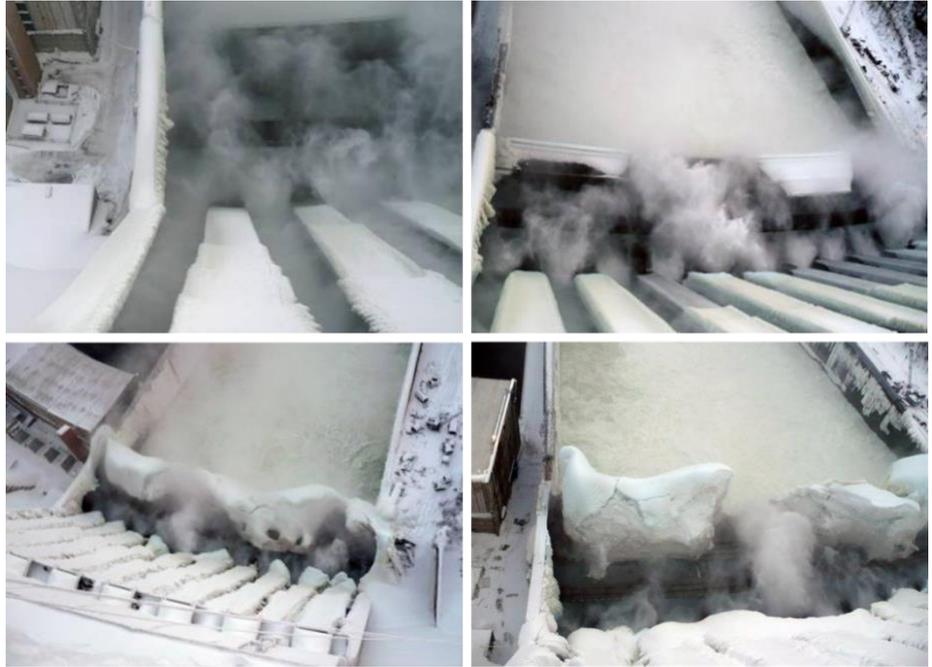
Crane trestle of Stilling Basin.
