SEISMIC ASSESSMENT AND STRENGTHENING OF THE MAJESTIC CENTRE, WELLINGTON

First published for SESOC Conference 2017

ABSTRACT:

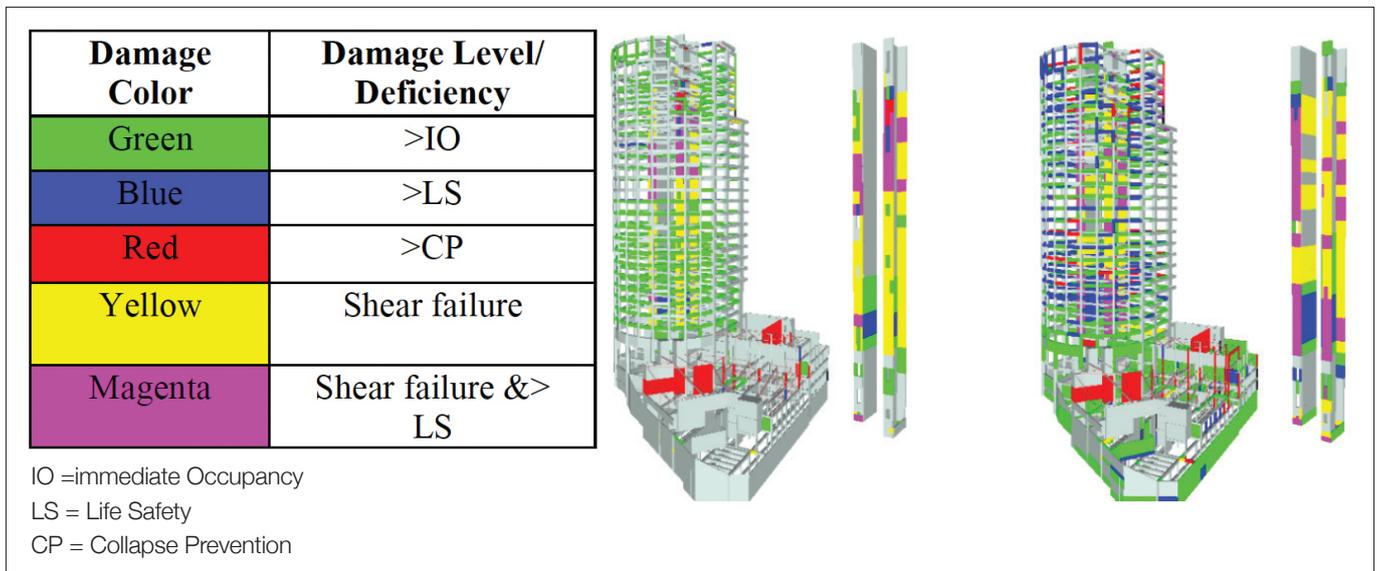
Assuming a 'nominally ductile' displacement ductility capacity, shear core moment and shear capacities were in theory approximately 65%DBE demands. However, there were doubts the computed capacities were valid due to the aforementioned detailing issues. L5 transfer beam capacities were found to be exceeded in most bays at load levels below 33% DBE.

Behaviour of the dual system and the response of such 'non-compliant' elements was deemed too complex for MRSA to be reliable. Instead a performance-based assessment utilizing non-linear time history analysis (NLTHA) was recommended.

Figure 3 – NLTHA model damage plots to ASCE 41 criteria for original building and shear cores (with strengthened transfer beams) at 100%DBE(L) and 150%DBE(R) [color key for each performance limit state provided]

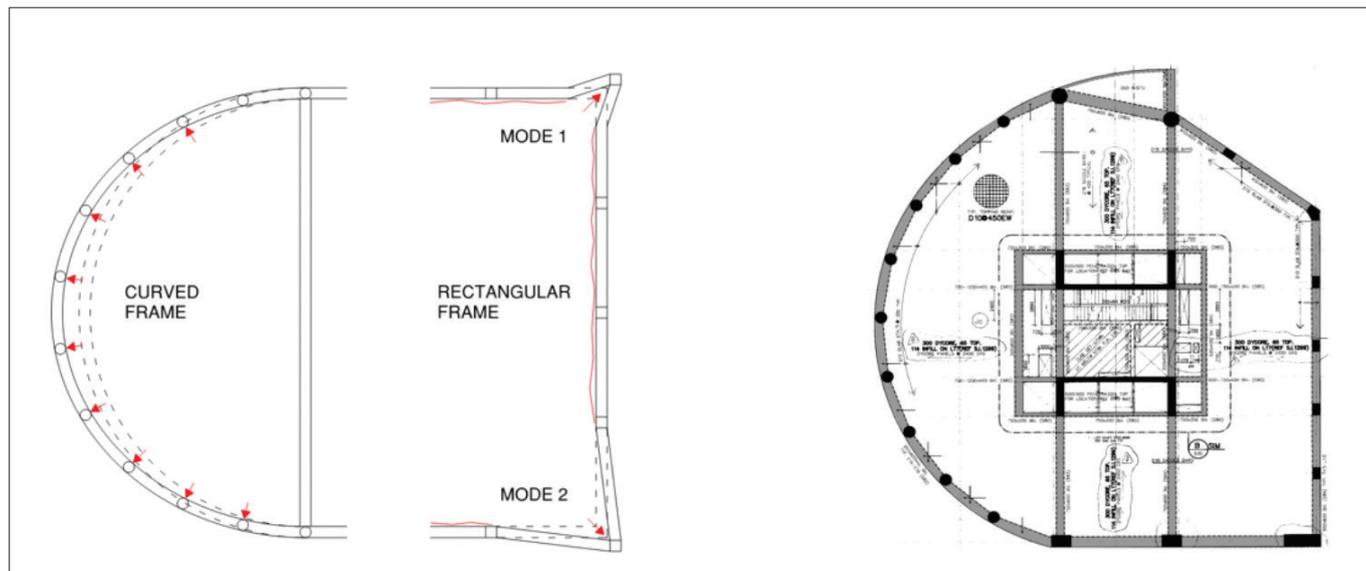
Beyond NLTHA, further analysis was required to assess the particular effects in this building arising from inelastic elongation in the perimeter framing. Frame elongation was assessed by determining the elongation expected from the potential plastic hinges (Fenwick, Bull, Gardiner 2010) and replicating these by imposing temperatures on beam elements within a three dimensional ‘line and node’ model of the structure, using the software Microstran. For a rectangular building, it is generally accepted that significant flexural yielding will cause elongation of the frame along its axis resulting in cracking along the frame-slab interface and pushing out of corner columns (Matthews 2004; Peng 2009). However, behaviour of the curved frame around the southern perimeter of the tower was expected to be different. This frame contained a large

number (20) of potential plastic hinge zones (PPHZ’s) at each level, and the ends of the curved frame were tied into the diaphragm so could not ‘push out’. Thus the direction of least resistance for elongation of the frame was radially away from the building and along its whole length, so that the curved beam could potentially completely or partially detach from the diaphragm, refer to Figure 4. A number of considerations lead on from the realization of this behaviour:

- The curved perimeter frame could detach at all levels. Load could still enter the frame at each end, where it was still attached to the floor diaphragm. The frame would continue to contribute to the overall building’s lateral system after detachment.

Figure 4 – Expected effect of frame elongation on curved frame (top left), ‘Modes 1 and 2’ effects of frame elongation on rectangular frame (top right) and typical Majestic Center tower floor plate (bottom)

- The detached frame would follow the lateral movement of the main building but slightly lagged behind resulting in a bulge in the curved frame. This would have the effect of causing large potential gaps between the perimeter frame and slab edge, which would need to be considered with regards to floor seating.

- After detaching from the floor diaphragm the frame would be inherently prone to buckling. Given the curved frame was expected to move away from the slab edge by as much as 250mm and was largely deformation driven, restraint of the columns was not deemed feasible. Instead stability of the frame was demonstrated by considering catenary restraint of columns via axial tension and compression in the curved perimeter beams.

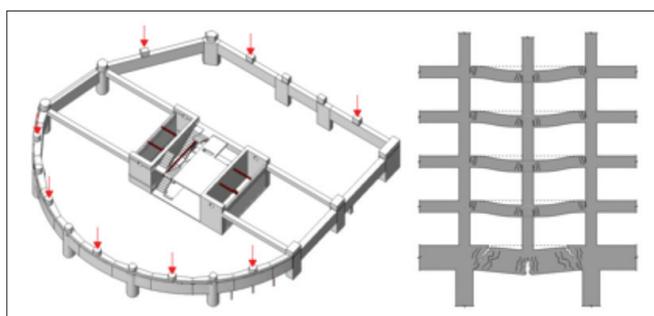
Under gravity loading, vierendeel action in the perimeter frame above transfer beam level was found to be capable of ‘hanging’ the intermediate columns, therefore reducing demands on the transfer beams. However, an important effect confirmed by NLTHA was the ‘shakedown’ of gravity loads onto the transfer beam as seismic frame action yields perimeter beams over the tower’s height, and relaxed their vierendeel stiffness. Thus gravity loads on the transfer beams were expected to approximately double during the design seismic event as shakedown occurred. A wide range of options were considered to strengthen the L5 transfer beams. The solution adopted comprised of pouring additional in-situ flanged RC beams beneath

Figure 5 – Isometric view of unstrengthened Level 5 with floor removed (L) and illustration of vierendeel action hanging transfer column (R)

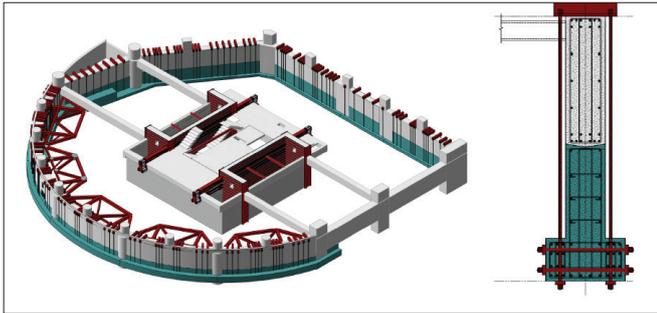
Figure 6 – Isometric view of strengthened Level 5 with floor removed (L) and typical strengthened beam section (R) (grey existing beam, blue/green new beam)

the existing transfer beams – an additional 2m depth (4m total) around the northern perimeter, and an additional 1.2m depth (3.2m total) around the southern perimeter. Transfer beam bays were typically 8m, so with these depths the strengthened transfer beam aspect ratios were approximately 2:1. Therefore a strut and tie approach was adopted for all design. Increased beam flexural strengths greatly exceeded column flexural strengths, which would have been unacceptable if not for the contribution of the central shear cores in preventing a ‘soft storey’ mechanism.

New and existing transfer beam elements were joined to form a composite section by external vertically post-tensioned ‘stressbar’ brackets placed at regular centres, since separation at the beam interface could cause a loss of aggregate interlock and thus composite behaviour. The vertical brackets also served as shear reinforcement at beam ends where necessary. Horizontal stressbars through the new beam flange were necessary to equilibrate vertical brackets, but also to resolve large horizontal forces generated where flexural reinforcing bars crank on plan.

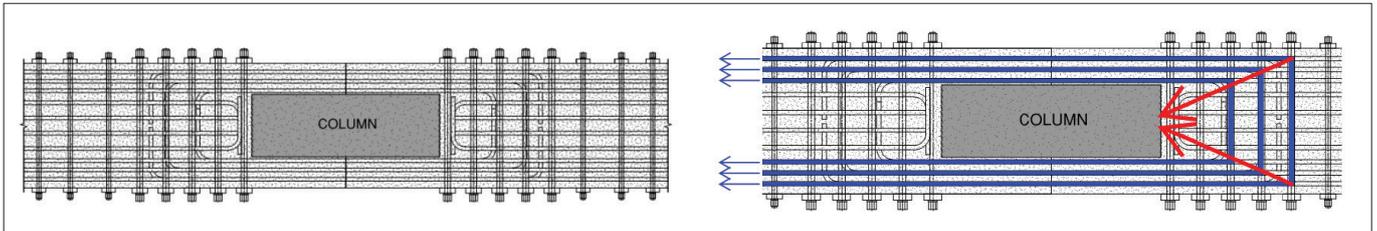
Existing columns were heavily congested with vertical and horizontal bars. The new longitudinal reinforcement in the transfer beams could not be passed through the beam-column joint. Rather, an external beam-column joint was developed. Tension from bottom longitudinal reinforcement passes either side of the column, into the adjacent bay, and then struts diagonally onto the back face of the column. Horizontal stressbars clustered at the column face were required to enable this mechanism to develop.

Figure 7 – Plan view of typical beam column joint at bottom of new beam (above), and marked-up (below) with tension (blue) and compression (red) forces to strut tension from reinforcing bars into column

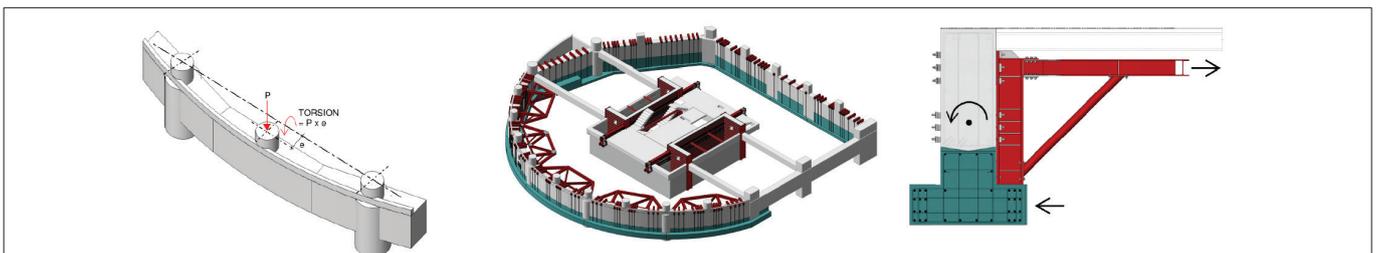
In bays around the curved southern perimeter, the axial loads from the transferred columns induced torsion in the curved transfer beams. Torsion capacity of the system was found to be insufficient to resist this torsion demand. To address this deficiency, horizontal steel trusses were placed alongside the top of the existing transfer beams. Each truss had a self-weight of approximately 2.5 tonnes. The trusses formed a moment couple with the new transfer beam bottom flange to transfer torsional demands into supporting columns.

Figure 8 – Diagram of torsion demand on one bay (top), strengthened beam with torsion truss (center), section through strengthened beam

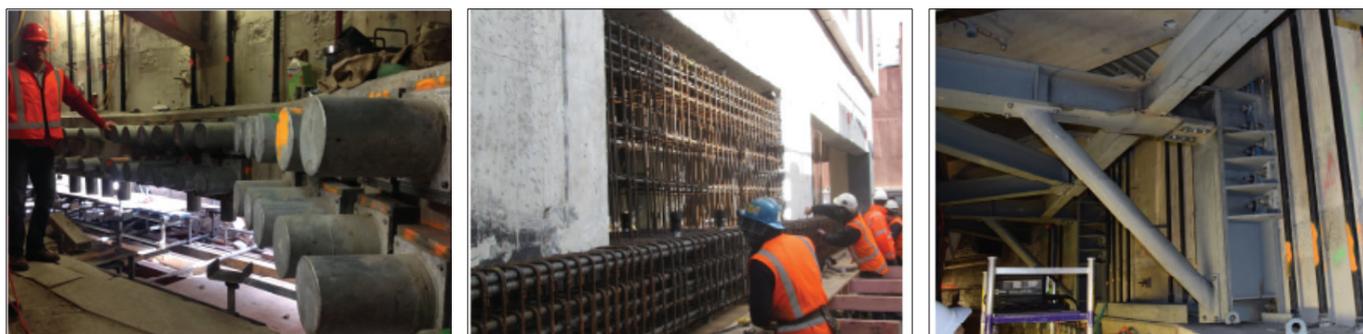
Figure 9 – (left to right); view of inner face of beam flange with horizontal PT stressbars, view of truss and rib down inner face of beam with stressbars forming vertical PT brackets, view of rebar cage for straight beams along northern face of building.

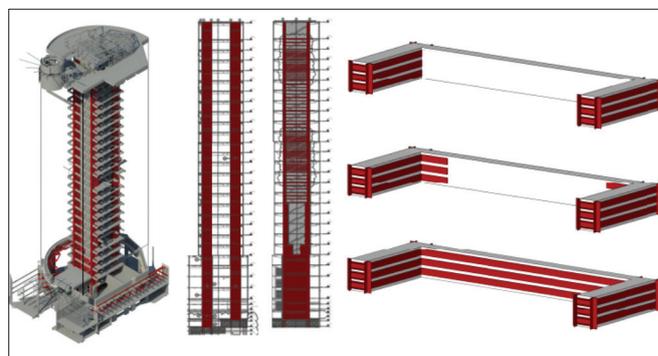
The two existing C-shaped concrete shear cores did not meet current code (NZS 3101:2006) minimum vertical reinforcing requirements, or contain sufficient shear or confining reinforcement. The only confinement reinforcement provided was a small number of stirrups across the wall width at the flange tips. Any portions of wall where flexural hinging was expected was confined with ties across the wall width at regular centers (NZS 3101:2006).

Figure 10 – Perspective view of tower with floors and perimeter frame hidden (L), elevation of strengthened flange (center left) and web walls (center right), perspective view of strengthening at various floor levels (R), (red sh)

Multiple options were considered for externally applying confining structure to the existing walls. The option selected comprised of horizontal steel bands (200mm wide, 16-25mm thick) placed at 300mm centers up both faces of the wall, with steel through-bolts (M20-M30) tying them together. Steel bands on the outer face of walls were anchored at each end to develop a portion of the bands axial strength, which also provided shear strengthening to the core walls. Scanning of reinforcement over the tower height was completed to inform the shop drawing process and to help mitigate bolt clashes with existing reinforcement.

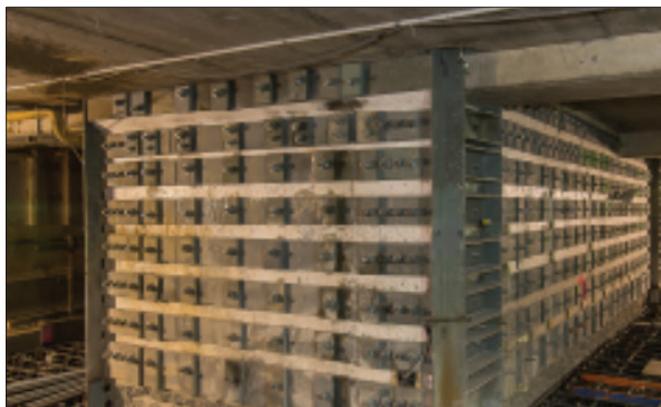
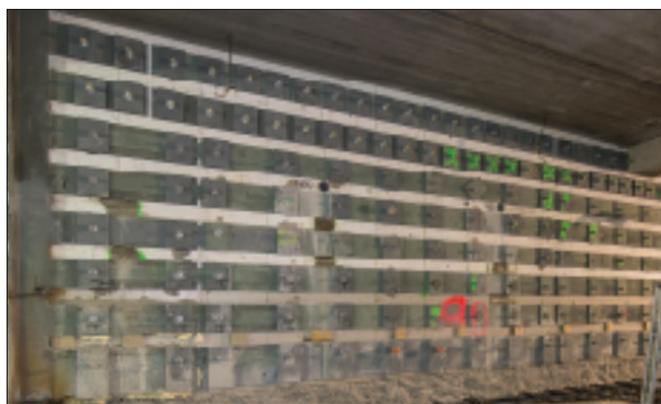
Figure 11 – Typical core strengthening (top) and flange strengthening (bottom)

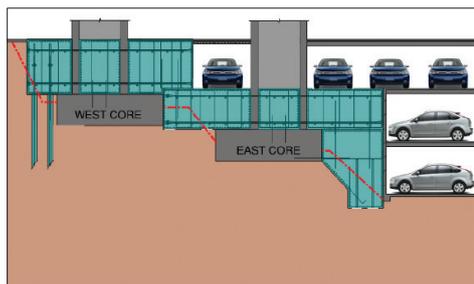
For the tower shear core pad foundations, bearing capacity was concluded to be less than the design demands due to a steeply cut slope adjacent. Owing to the steeply inclined disturbed zones in the rock mass, the eastern side of the foundations was assessed to be much stiffer than the western side. The resulting rotation of the pads was unacceptable for stability of the tower above, so an increase in the plan area of the foundation pads was required to reduce differential deformations.

Aside from bearing capacity and stiffness considerations, the existing pad foundation had a series of geometric and detailing issues that could limit their performance; Thickness of the pads was not sufficient to prevent shear failure at 100%DBE loading; and Flexural reinforcement was not sufficient to sustain bending induced by 100%DBE loading.

Figure 12 – Section through shear core foundations (existing dark grey, new construction light green, original ground profile shown by dashed red line).

The solution adopted maintained the existing foundation pads and their service gravity stress state. A new all-encompassing stepped foundation (one storey deep, ~1000m³ volume) was placed over the top of both existing pads. The new pad wrapped over the front of the existing pads preventing bearing failure of the steep ground profile. The new pad was post-tensioned onto the

scabbled face of both shear cores to ensure seismic loads were shared across the composite foundation as a whole, rather than just the existing pads. Along the western edge of the new pad, 38-300mm diameter piles were placed to overcome the particularly flexible founding material in this area.

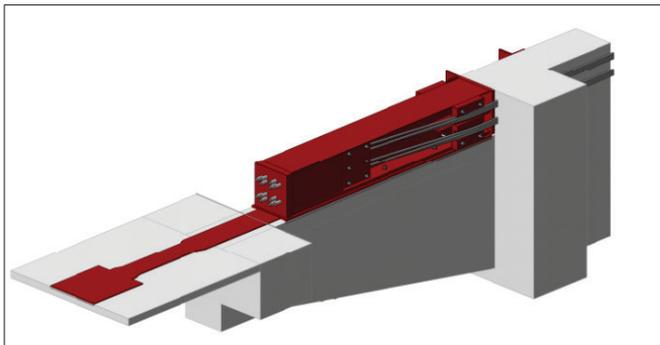
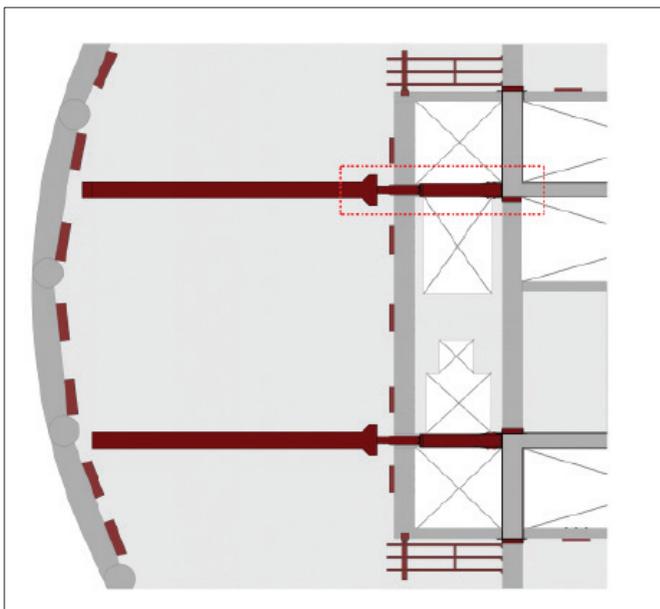
Floor inertia demands alone exceeded the capacity of the existing connection, but given the tower had a dual lateral system, the connection was also subject to far

larger transfer forces arising from the disparity between the response of shear cores and moment frames. Therefore, early in the design process it was clear significant tie elements ('core ties') would be required to improve connectivity. Determining the demands upon these tie elements, and finding a tie design that could be installed across the existing floor plate proved to be the most significant challenge in the whole project.

Figure 15 – Typical arrangement where floor tie plate reaches the shear core and transitions to post-tensioned strands (top), partial tower floor plan with two core ties indicated (bottom)

Each core tie comprised a large steel tie plate (500-1000mm wide, 16-25mm thick, and 7-9m long) extending from the perimeter frame to the shear cores. The tie plate was bolted to the top side of the in-situ slab that spanned between hollowcore units, which happened to align with each web wall. Bolts collected and transferred diaphragm compression struts into tension in the plates. Bolts were placed at approximately 250mm centres in each direction over the plate's length, although bolts over the end 2m were capable of developing the full tie demand. The plate was sized to limit elongation to 2-3mm, thus preventing bolts shearing off. Prior to reaching the web wall, the tie plate transitioned to a stocky steel beam, which sat in the narrow space between a lift shaft and service riser. The beam itself was post-tensioned onto the end of the web wall with 16-15.4mm strands that extended across each face of the web wall to a mirrored arrangement opposite. Along their path, strands had to deviate around lift gear via large machined steel deviator plates and through holes cored in flange walls, floor beams, and stairs as shown in figure 15.

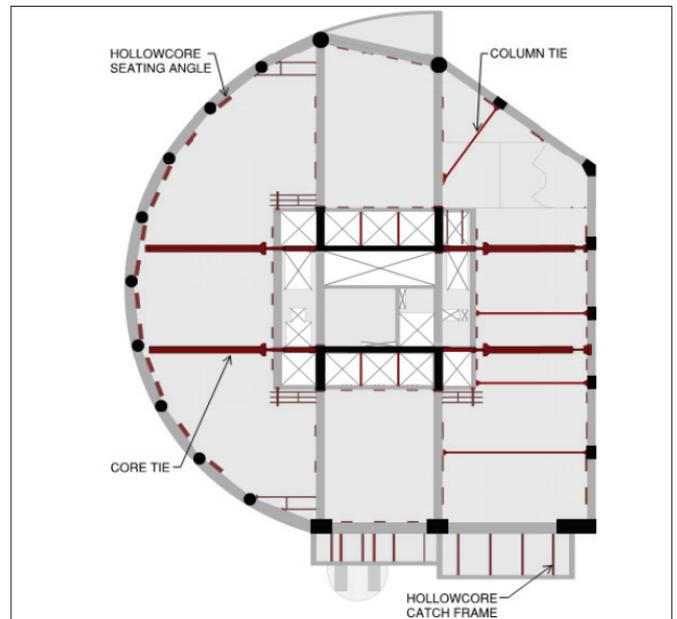
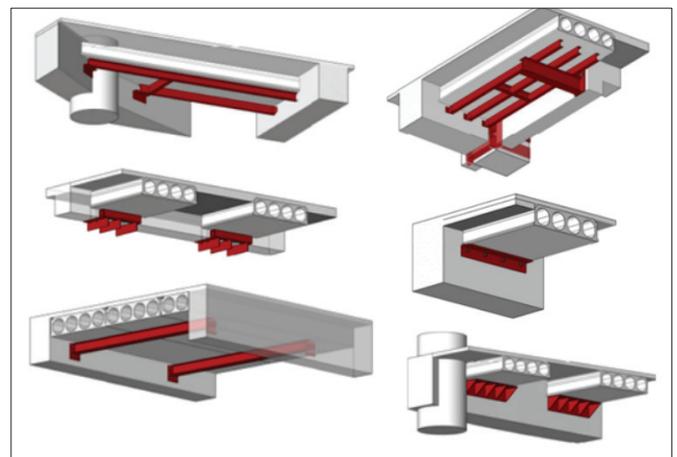
A number of items at each floor required supplementary support or restraint as shown in figure 16. These issues are common to RC buildings of this vintage and therefore are only briefly described below.

Figure 16 – Plan view of typical ‘on-floor’ works (top), selection of hollowcore restraint brackets (bottom)

- Hollowfloor unit seating, an increase in the seating of hollowcore floor units was required and was generally achieved by bolting steel angles to the face of supporting beams.
- Hollowcore Floor Unit Catch Frames, hollowcore situated adjacent to perimeter frame beams are prone to web splitting from torsion induced as the frame displaces laterally (Fenwick, Bull, Gardiner 2010). Steel

catch frames spanning between perimeter concrete beams were installed to prevent the risk of units collapsing onto the occupied space below.
