CAVE CREEK - 1995 PLATFORM COLLAPSE LESSONS TO BE LEARNT

February 2021

This document summarises the webinar developed and led by Gordon Hughes (FEngNZ), a structural engineer, for Engineering New Zealand in 2021.

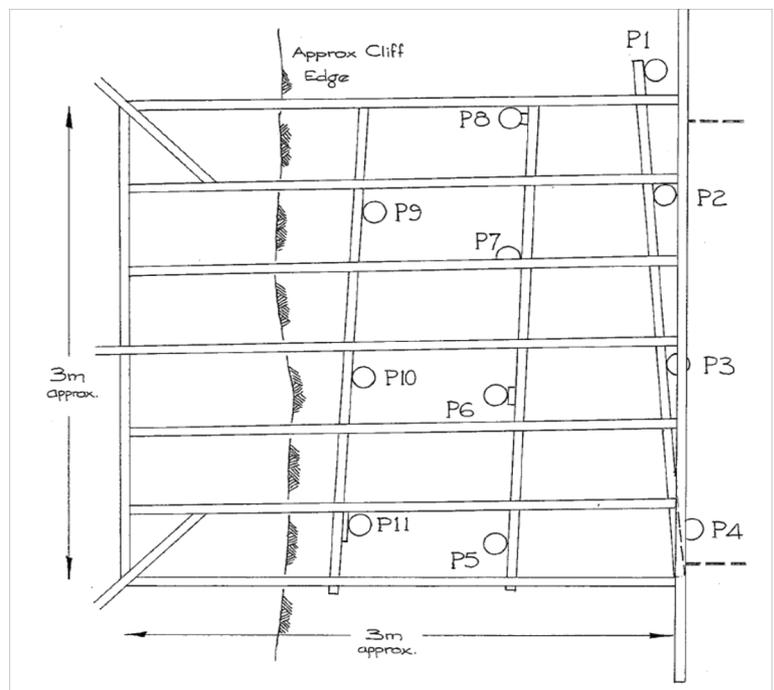
The platform foundation consisted of three rows of wooden fence posts, each between 110 and 140 millimetres in diameter, driven vertically into the ground as piles. They extended between 200 and 400 millimetres above ground level and were within an acceptable height tolerance of approximately 20 millimetres of each other. The rear row contained four piles, as did the centre row but these rows were not parallel to each other), and the front row contained three piles approximately parallel to but offset from those in the centre row.

Layout plan Note: The deck was cantilevered out over a 30 m ravine to provide the best viewing of Cave Creek. (Australian Journal of Structural Engineering, Vol. 15,) No. 1, 2014: 111-120

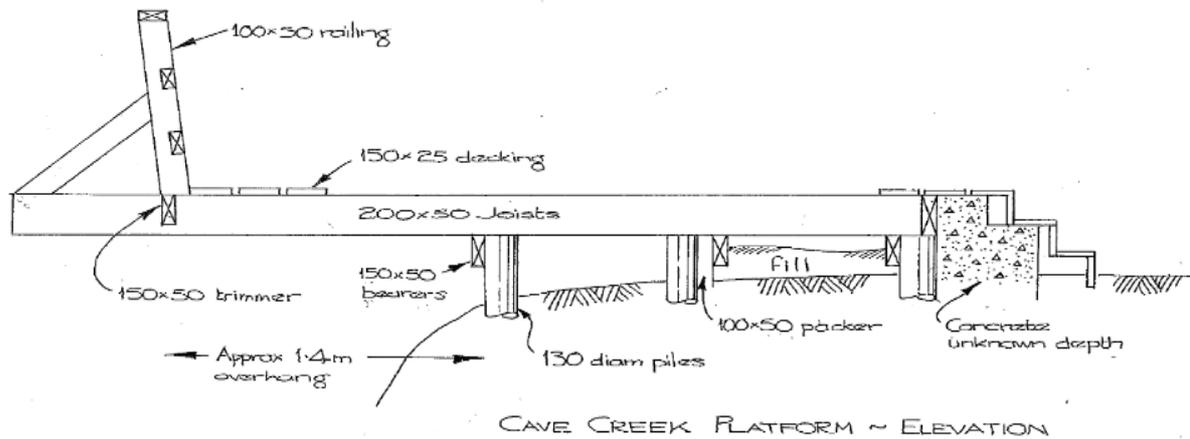
To the front of each row of piles had been nailed a 150 x 50-millimetre timber bearer fastened at each pile by two 100 x 4-millimetre galvanised flat-head nails. Because three of the piles were slightly misaligned in their row (i.e. those designated P11, P8 and P6 on the plans) 100 x 50-millimetre wooden packers had been used to fill the space.

Onto and at right angles to the bearers, seven 200 x 50-millimetre timber joists had been attached to the bearers by use of two 100-millimetre skew nails, and with 200 x 50-millimetre timber trimmers fixed to each end of the joists.

Cross-section plan. (Australian Journal of Structural Engineering, Vol. 15,) No. 1, 2014: 111-120

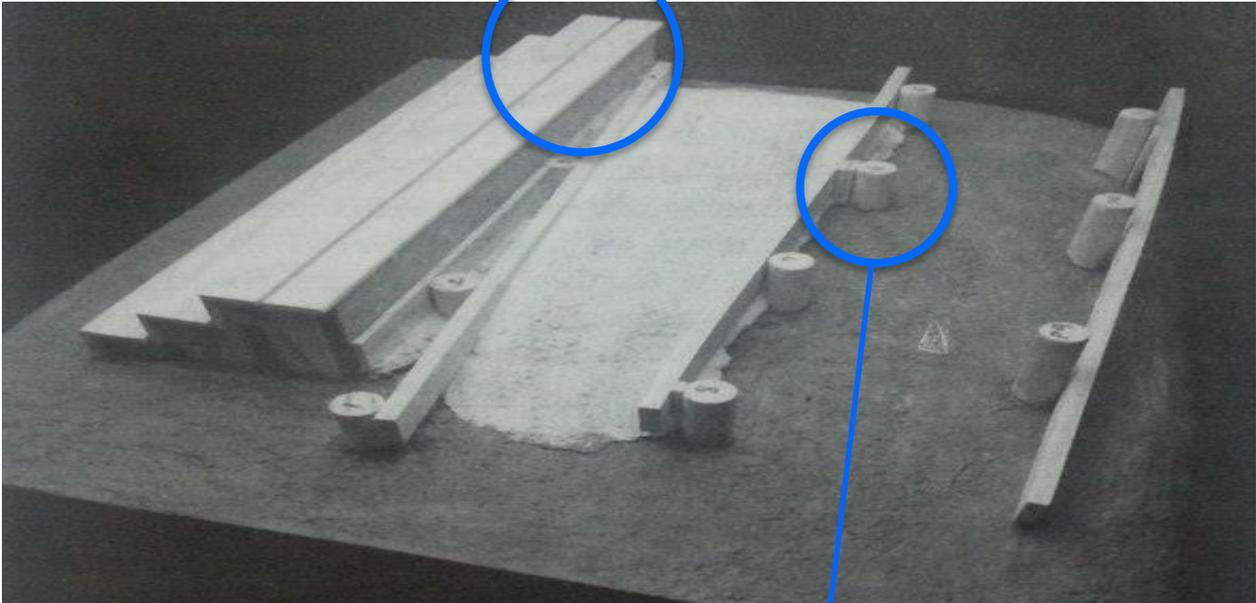
The Commission of Inquiry found that the standard of workmanship was adequate for the deck fastening but was substandard in the following areas:

- Piles were not properly set out and aligned.
- Packers were used for bearer spacing to misaligned piles.
- A nail only dented a pile on bearer joist 2 and did not significantly penetrate the pile.
- Some joist to bearer connections had one nail and others had nails that missed the bearer.
- Either no plan was used, or the plan was not followed.
- Normal construction practice regarding bearer pile connections was not followed.

In addition, although piles were placed and cut off at the required level, only three piles were placed in the first line, and there was some inaccuracy in pile placement.

The model of the deck that was created as part of the Inquiry.

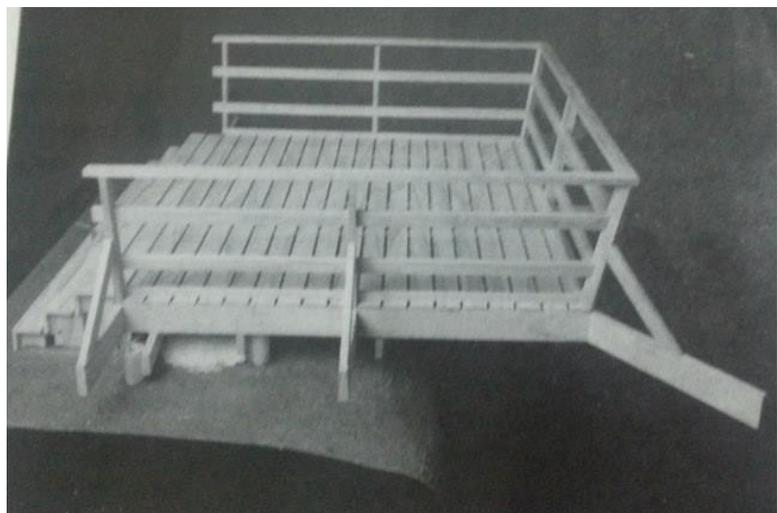
Bearers were placed alongside the piles and fixed to the piles with 100 mm nails. In some cases, timber packers were used.

The timber joists were nailed to the bearers with skew nails and the timber decking was nailed to the joists.

Timber hand railing was provided.

Concrete steps were later added but were not robustly connected to the platform.

The model of the deck that was created as part of the Inquiry.
