AUSTRALASIAN ENGINEERING HERITAGE CONFERENCE PAPERS 2022

THE TALE OF TWO BRIDGES: HOW UNDERSTANDING HERITAGE SIGNIFICANCE CAN GUIDE THE TREATMENT OF OUR COUNTRY'S UNIQUE STRUCTURES

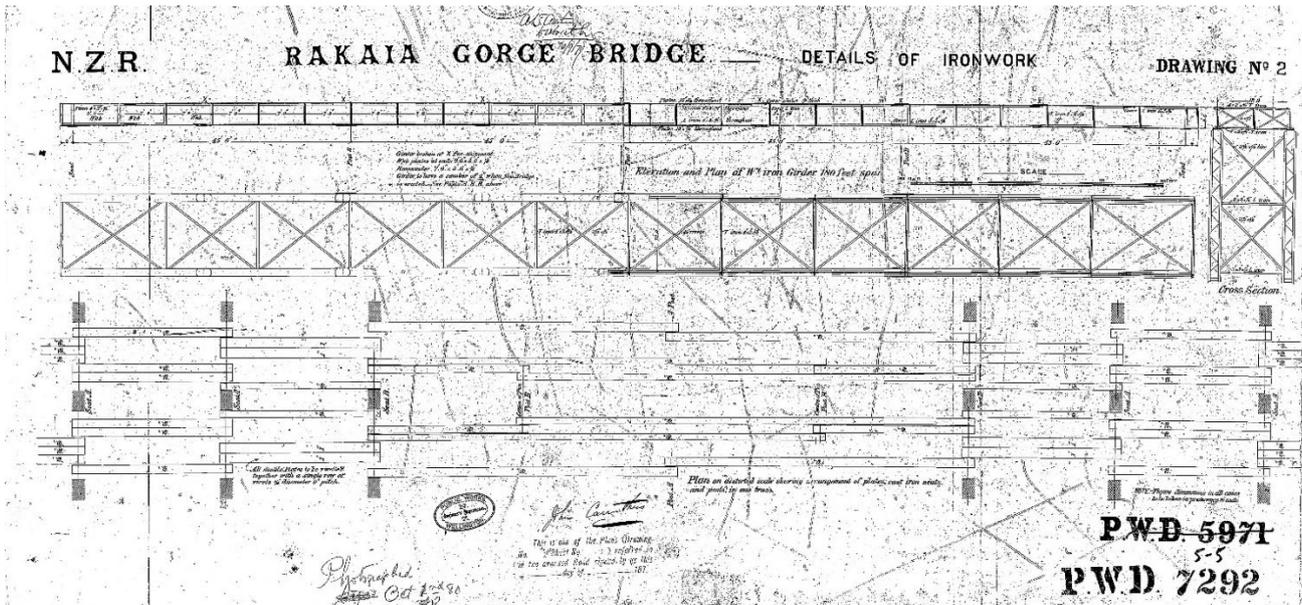
[Figure 3] Original drawings for the Rakaia Gorge No. 1 Bridge showing some of the ironwork details. Source: Archives New Zealand PWD 7292

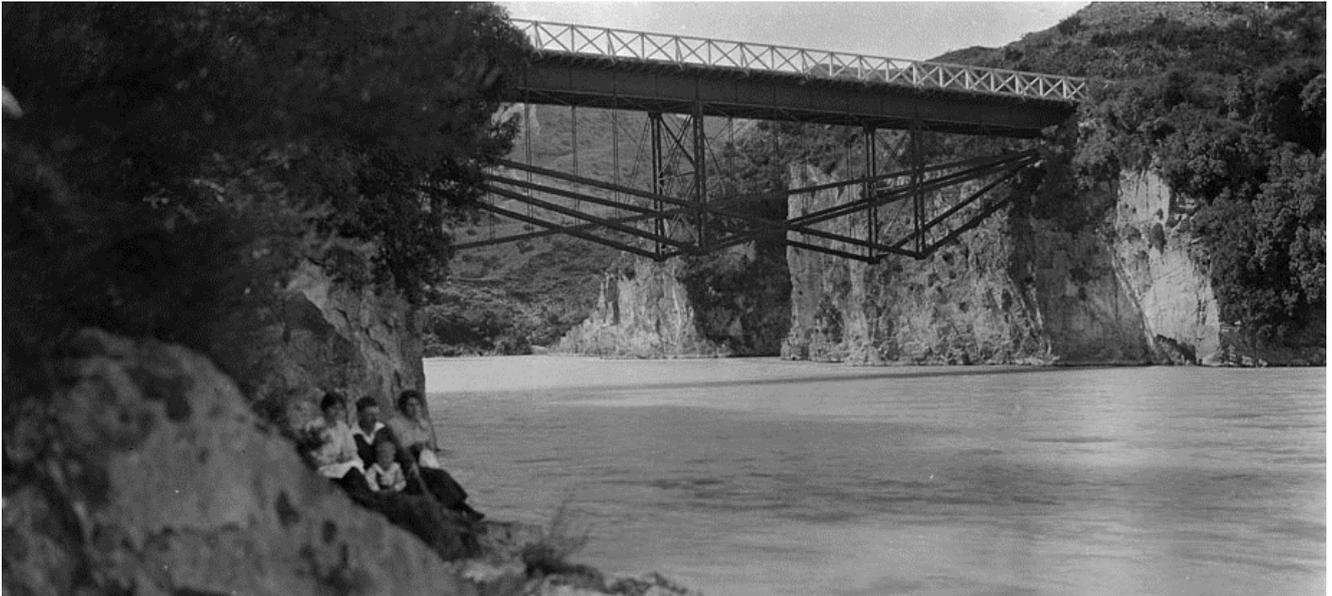
[Figure 4] Drawings for the Rakaia Gorge No. 1 Bridge showing some of the additional wind bracing details, 1889. Source: Archives New Zealand PWD 16498

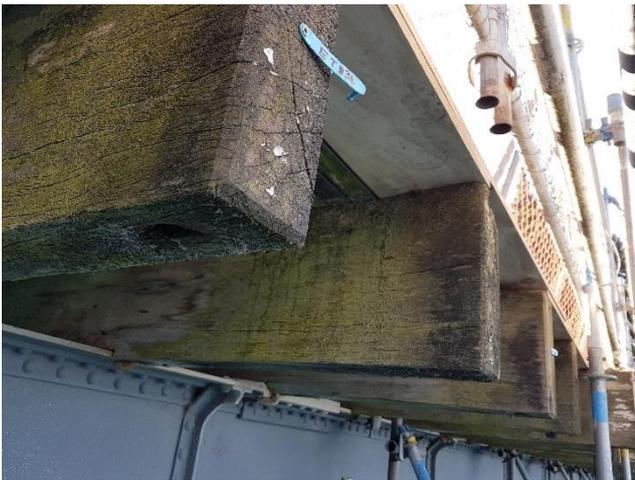
Left: [Figure 8] The original hardwood transoms, showing signs of decay and microbiological growth.

The original hardwood transoms were a highly visual element of the bridge when viewed from the beach below and from the approaches on either side. Along with the deck planks, the transoms were identified as being significantly decayed (Figure 8). The engineers' original proposal to replace the timbers with new steel transoms at wider spacings was considered to be necessary to reduce the overall weight of the deck and thereby improve the resilience of the bridge. To maintain the aesthetic of the original design, timber salvaged from the original transoms was spliced to the ends (Figure 11). Where there were no steel transoms to splice to (due to the wider spacing), dummy transom ends were attached to retain the historic appearance of the bridge (Figure 10). The new steel transoms were dated to record the introduction of new fabric.

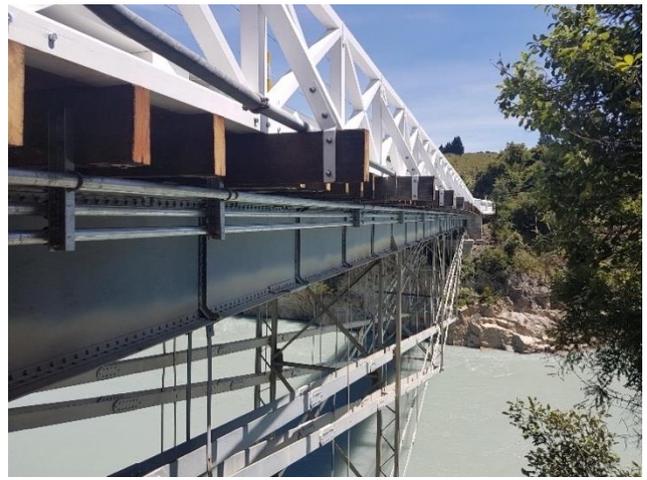
Right: [Figure 9] The new spliced transoms.

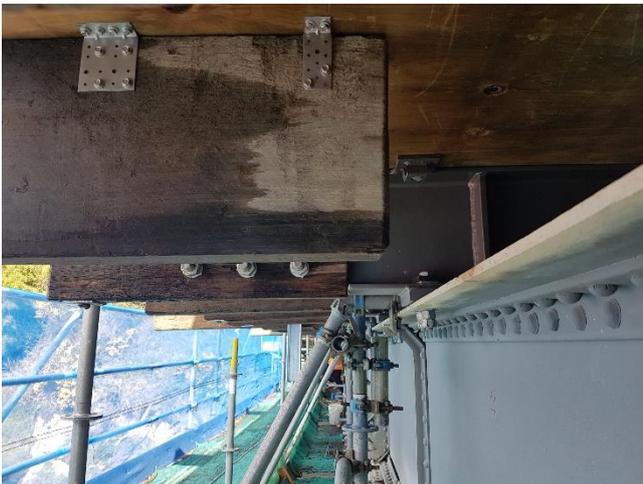
Left: [Figure 10] Transoms without steel substructure attached to the deck to retain the aesthetic features of the bridge.

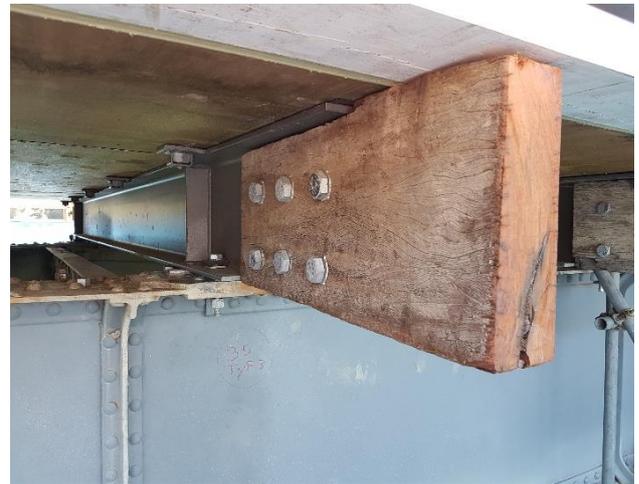
Right: [Figure 11] The new spliced transoms – steel with hardwood ends.

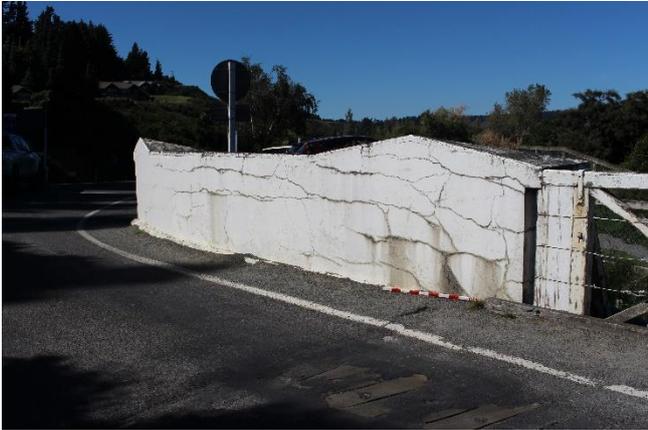
Left: [Figure 12] The damaged parapets prior to repair.

The mass concrete parapets at each end of the bridge were in poor condition with widespread cracking, moss growing out of the cracks, flaking paint and areas of graffiti carved into the rendered finish (Figure 12). The engineers' proposed solution was to inject a high strength mortar; however, this would likely cause future problems as the repairs would perform very differently to the original low-strength concrete. Samples were taken from the parapets to confirm their composition and compressive strength, and this was used as the basis for the selection of specialised repair products. The parapets were then completely

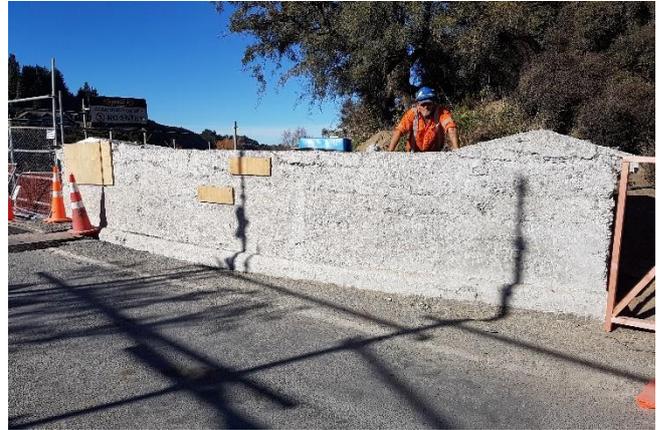
Right: [Figure 13] Re-plastering of the parapets.

stripped of paint and render, repaired, re-rendered and re-painted white. Areas of graffiti deemed to be of heritage value were retained as part of the refurbishment and the new render was placed around and plastered to match (Figure 13). In addition to the conservation related benefits, the restoration and painting improved the visibility of the parapets and hence improved the safety of the road user.

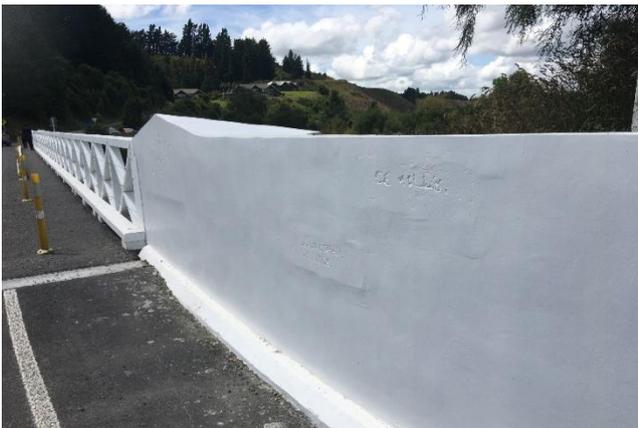
Left: [Figure 14] The repaired parapets, repainted white to improve visibility.

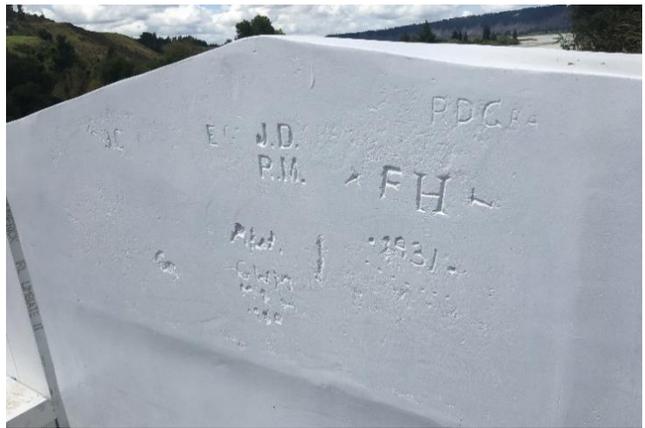
Right: [Figure 15] The repaired parapets, with retained historic graffiti.

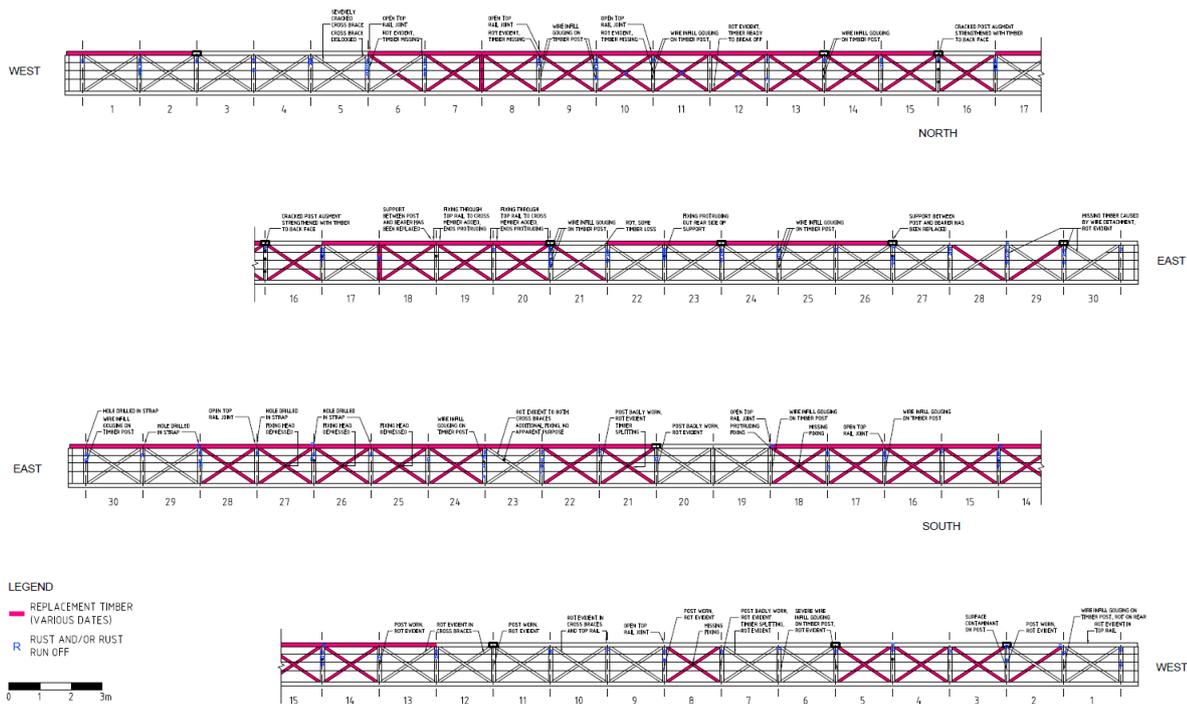
[Figure 16] Rakaia Gorge No.1 Bridge timber balustrade assessment, prepared by WSP (C. Stevens) 2016

As part of the Conservation Management Plan, an analysis of the existing balustrades was undertaken to determine how many original members remained in situ, and exactly where these were located. This revealed that a significant number of the timber members within the balustrade had been replaced sporadically over time; and replacement timbers were of varying ages and condition (Figure 16). Joints between original and replacement timbers were often poor, and some members were dislodged. Rot and organic growth were widespread (Figure 17). A similar extent of replacement and decay was evident in the iron straps and fixings; and the fencing wire fixed to the balustrade was gouging the timber. Carved graffiti was widespread; however, some of this dated as far back as the 1930s. Rather than replacing the balustrades with new metal barriers as had been proposed, the balustrades were taken apart in numbered sections and reconstructed using as many of the historic components as their condition permitted. Where this was not possible, new hardwood was used, with joints detailed to match the original as closely as possible (Figure 18). The new material was date stamped to indicate the introduction of modern fabric (Figure 25 – Figure 26). The historic straps and fixings were cleaned, repainted and reinstated; and new straps and fixings were made to match where required.

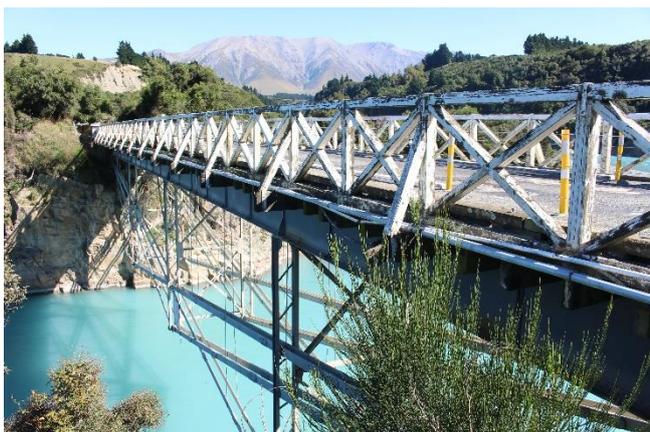
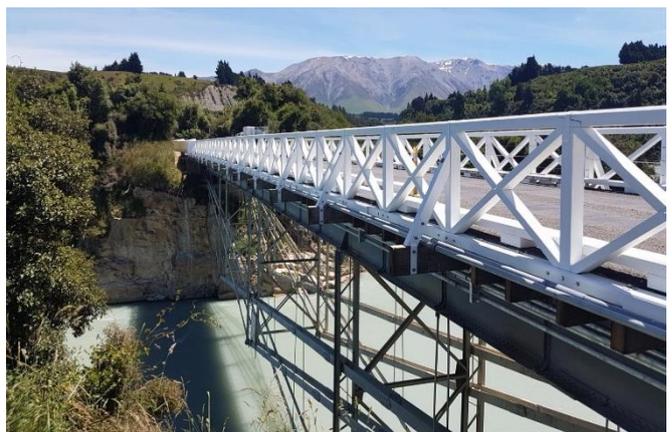
Left: [Figure 17] The damaged balustrade prior to repair.
 Right: [Figure 18] The repaired balustrade.

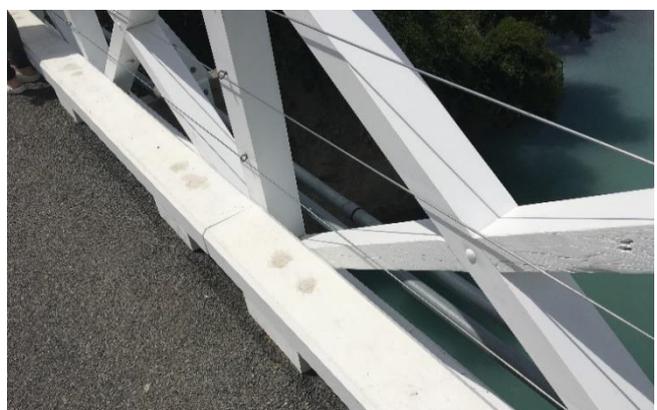
Left: [Figure 19] The damaged balustrade and timber kerbing prior to repair.
 Right: [Figure 20] The repaired balustrade, with timber kerbing.

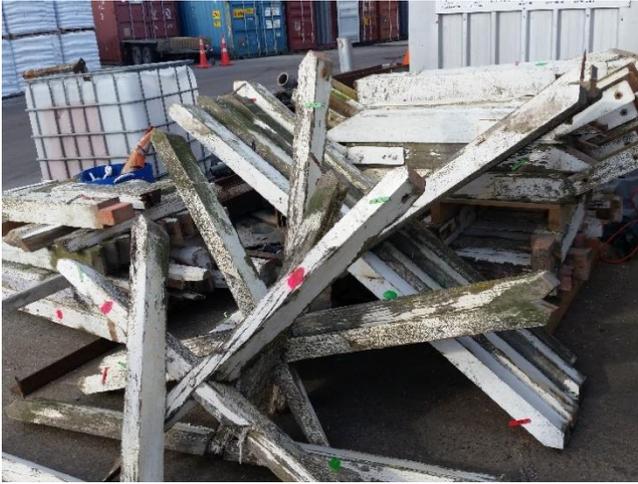
Left: [Figure 21] Removal of the historic balustrades.

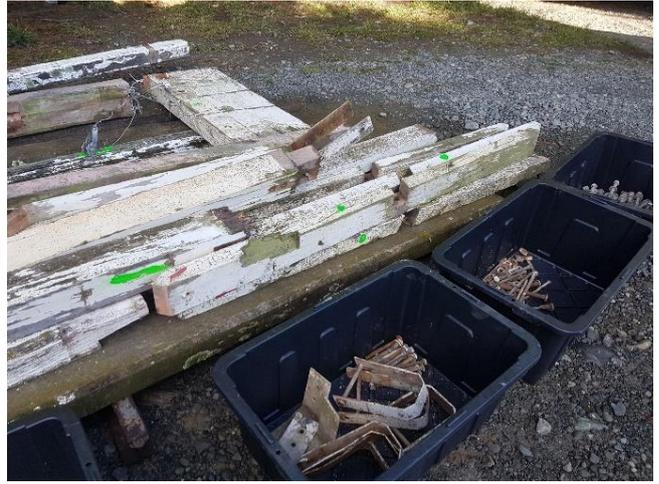
Right: [Figure 22] The balustrade was deconstructed using conservation best practice - each member individually numbered, and its condition assessed for reuse.

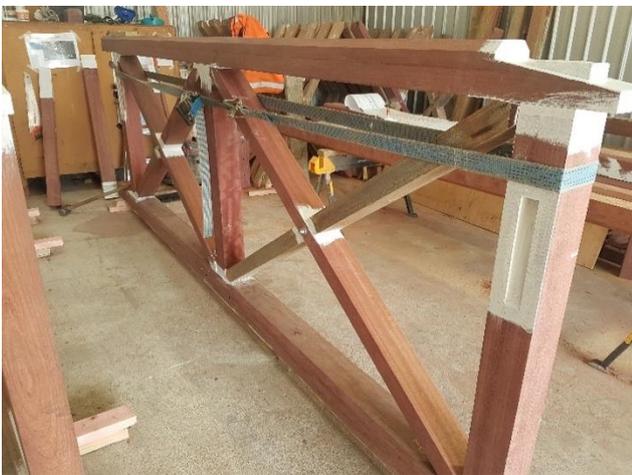
Left: [Figure 23] Reconstruction of balustrades, incorporating historic fabric where possible.

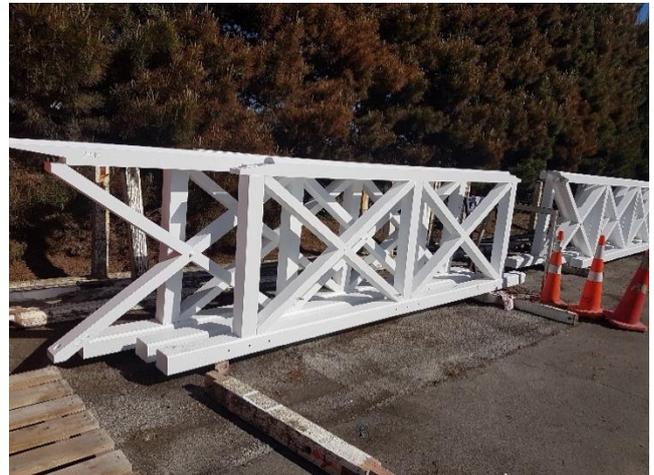
Right: [Figure 24] Reinstatement of balustrades on site.

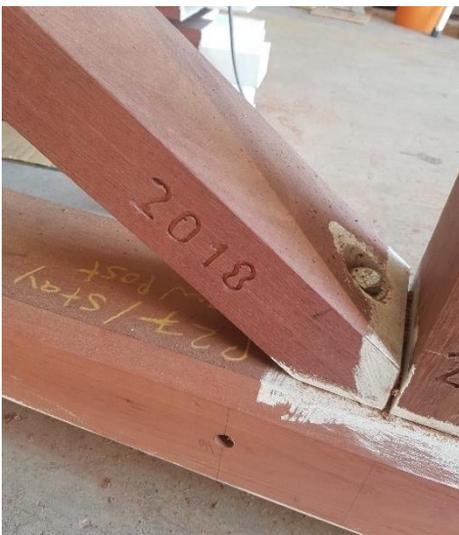
Left: [Figure 25] Date stamping of the new balustrade.

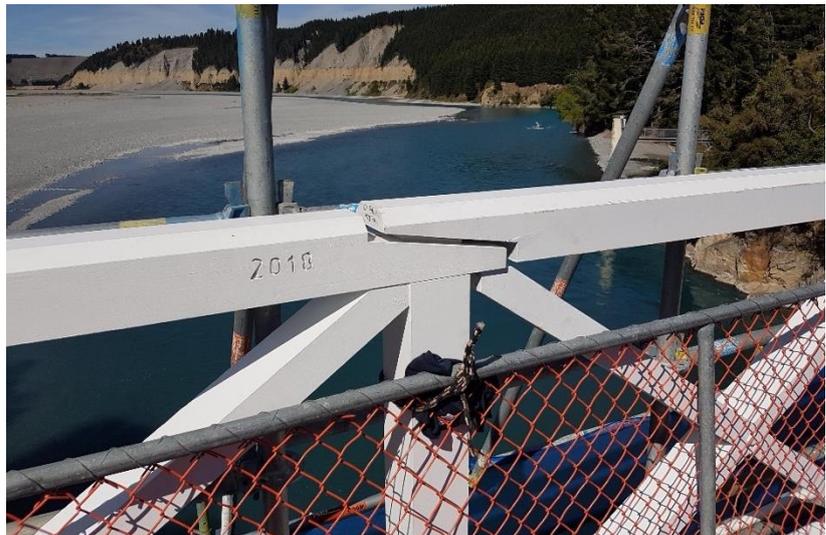
Right: [Figure 26] Installation of the new balustrade with interlocking design.

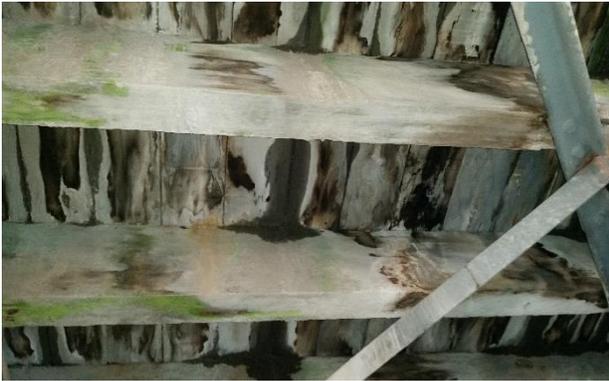
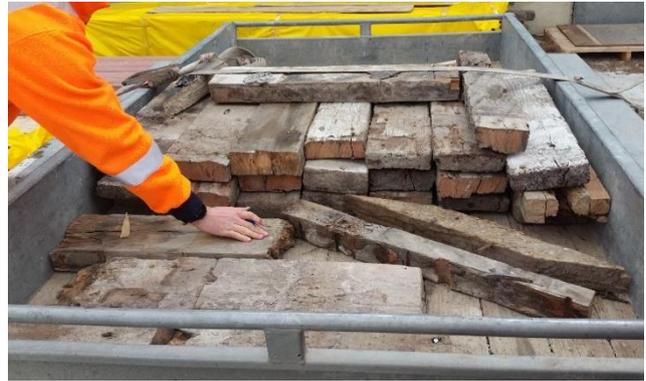
Left: [Figure 27] The original longitudinal decking, viewed from underneath the bridge, showing water damage.
Right: [Figure 28] Some of the original decayed decking members being removed.

The original longitudinal timber decking which remained underneath a modern layer of timber and seal was removed due to advanced decay identified in the Special Inspections, and replaced with NiuDeck. This significantly reduced the weight of the deck, reducing stress on the superstructure below, and resolved water drainage issues which were negatively impacting the structure. The deck system sits longitudinally between the transoms but is not visible, and therefore had minimal aesthetic impact. Salvaged timber decking was donated to an adjacent landowner for construction of signage and furniture along a walking track from which the bridge is visible.

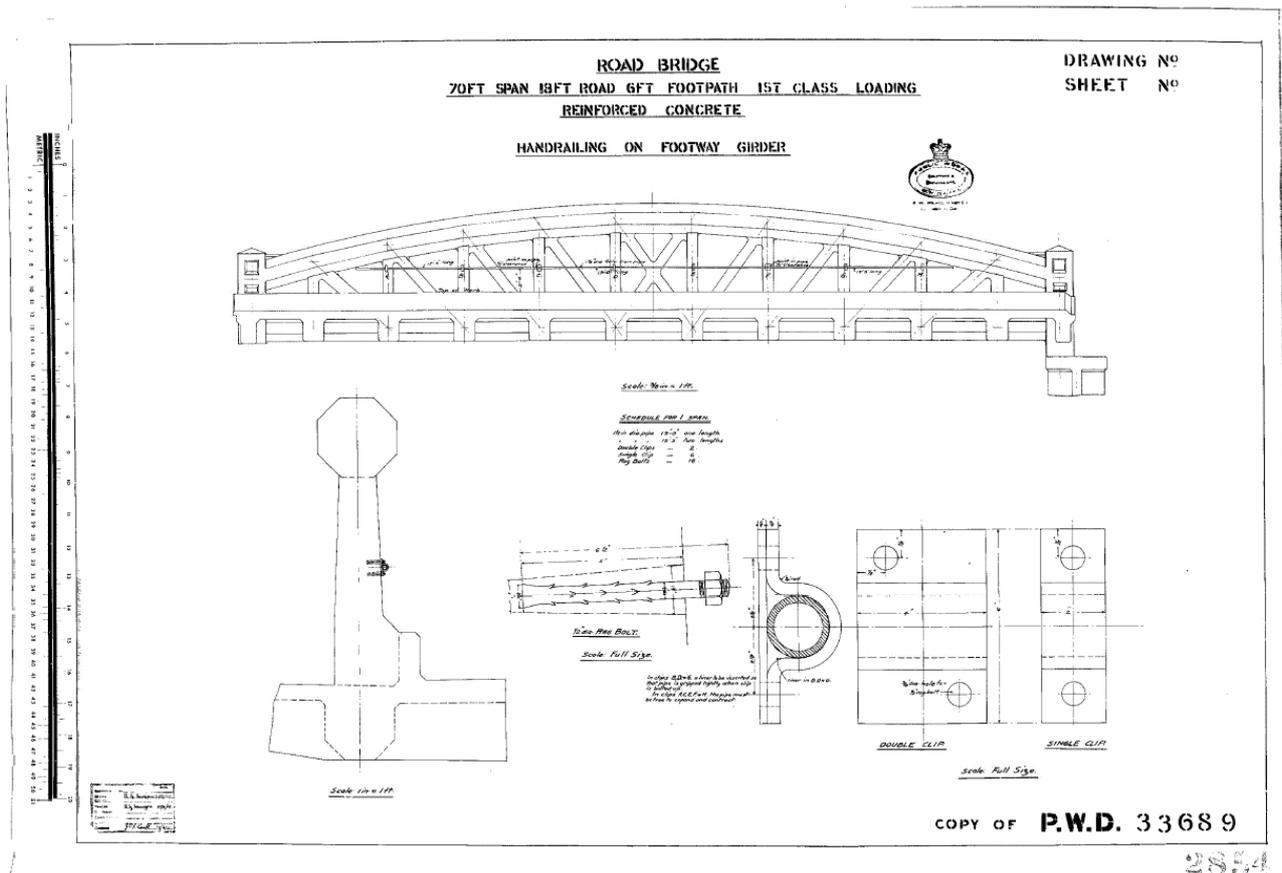
[Figure 33] Original drawings for the Opawa Bridge showing the bowstring arch truss. Source: Archives New Zealand PWD 33689

The structure comprises eight reinforced concrete bowstring arch trusses either side, with a central deck of 5.5m for road traffic and a cantilevered pedestrian walkway on the eastern side. The bowstring arch trusses are an adaptation of the Pratt truss [6], with crossed members in the centre and the top chord forming a true arc. Loads on the bridge deck are carried up the hangers to the top chord of each truss; and the trusses are tied at the base with a bottom chord that prevents them from spreading. Generally, each span is simply supported, fixed to the reinforced concrete piers at one end, and resting on steel bearings fixed to the concrete piers at the other. This created slip joints between the spans, allowing the bridge to move under live loads and during earthquakes, and accommodate thermal variations [7]. Like the Rakaia Gorge No.1 Bridge, the Opawa Bridge is a striking example of engineering that was highly innovative at the time it was conceived.

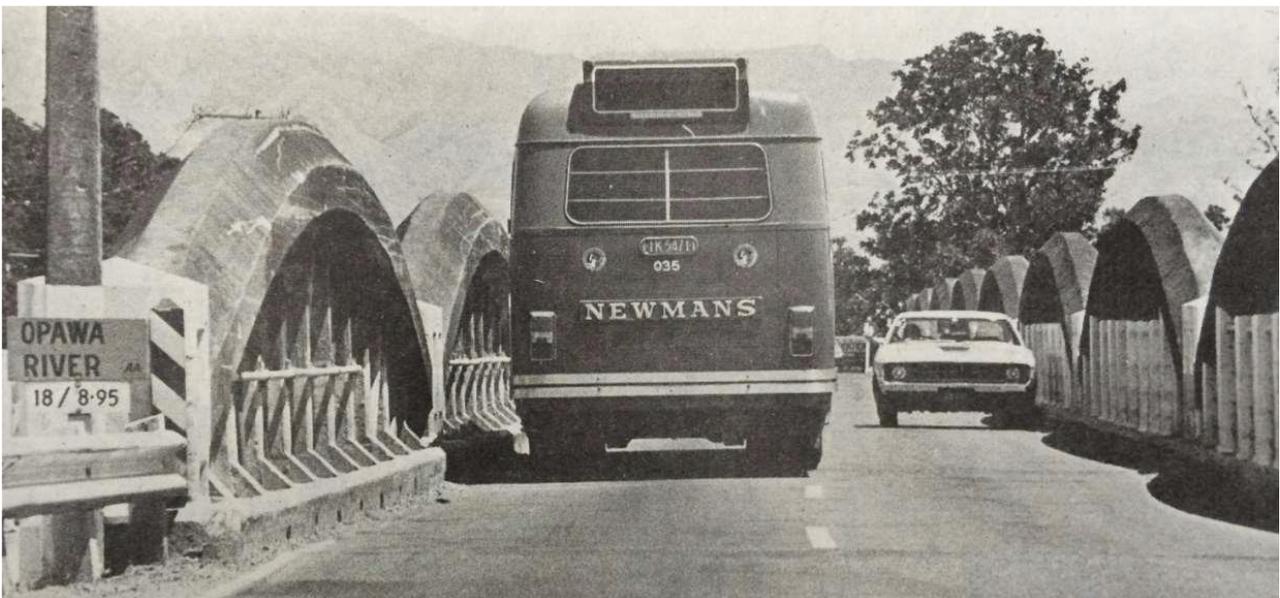
[Figure 39] Opawa Bridge from the north, c.1980s., published in the Marlborough Express at the time a second bridge was proposed. Source: Trilford, D. (2015) Archaeological Assessment for the Ōpawa Bridge Upgrade. Unpublished

Once constructed, the Opawa Bridge became a critical feature of the country's primary road, later designated as State Highway 1. The rapid increase in traffic volumes, and the ever-expanding size of vehicles mean that, by the late 20th century, the narrowness of the bridge deck was becoming problematic (Figure 39). During the 1980s, the Ministry of Works and Development (formerly the PWD) planned to convert the Opawa Bridge into a single-lane bridge by constructing an additional bridge downstream; but these plans were never advanced [8]. In the meantime, the bridge was inevitably being damaged by vehicles hugging the left hand side of the traffic lane to avoid oncoming vehicles (Figure 40).

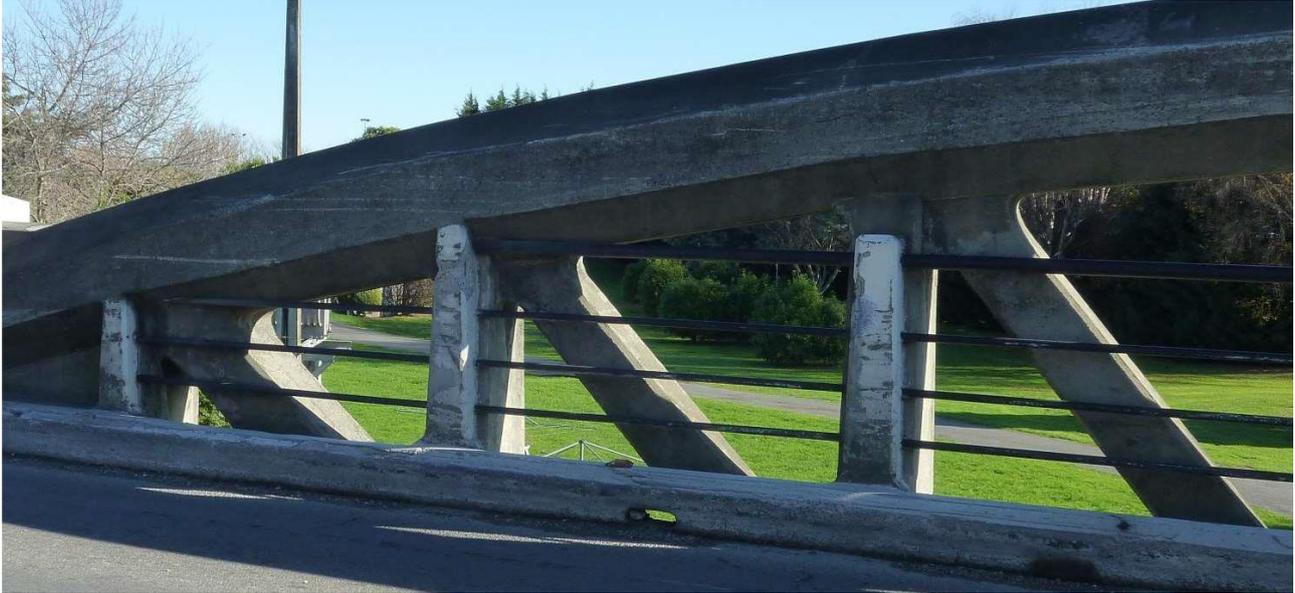
[Figure 40] Mechanical damage to the Opawa Bridge resulting from vehicle scraping and impact.

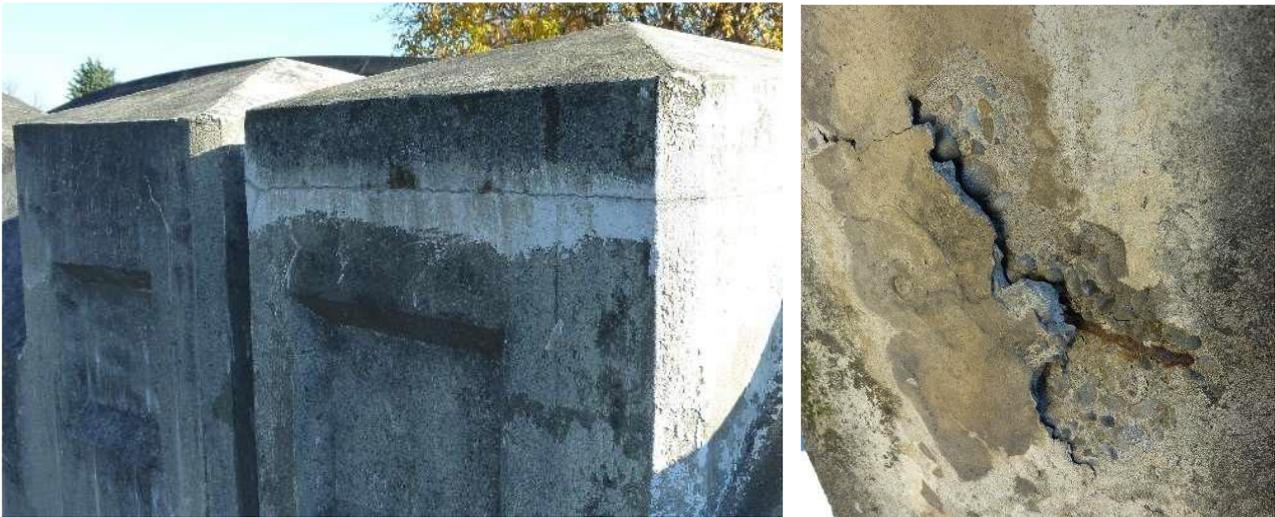
Left: [Figure 41] Typical example of cracking on the Opawa Bridge prior to restoration works.

Right: [Figure 42] Spalling concrete on the Opawa Bridge prior to restoration works.

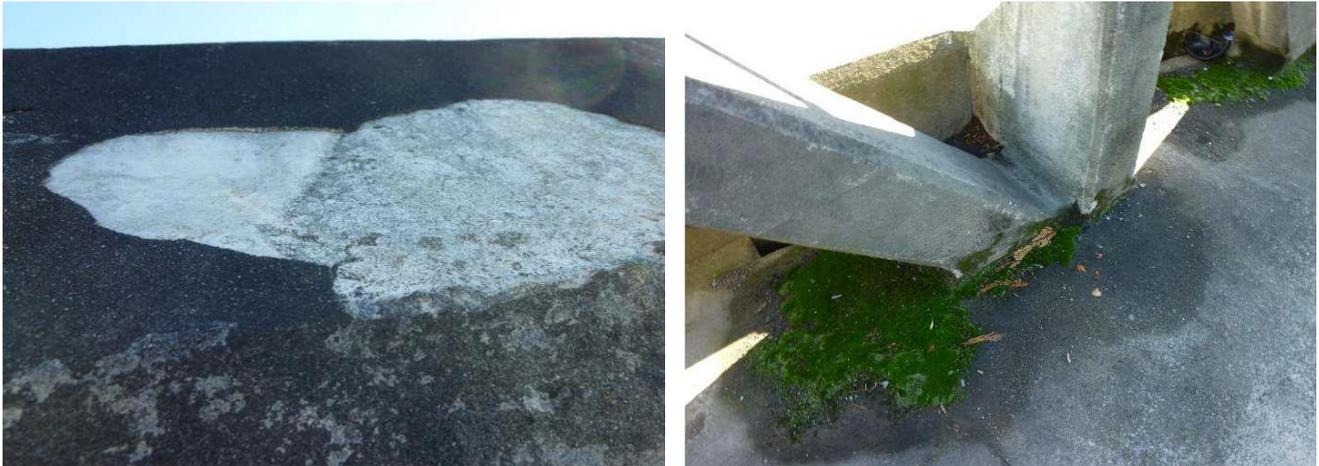
Left: [Figure 43] Delamination of surface render on Opawa Bridge prior to restoration.

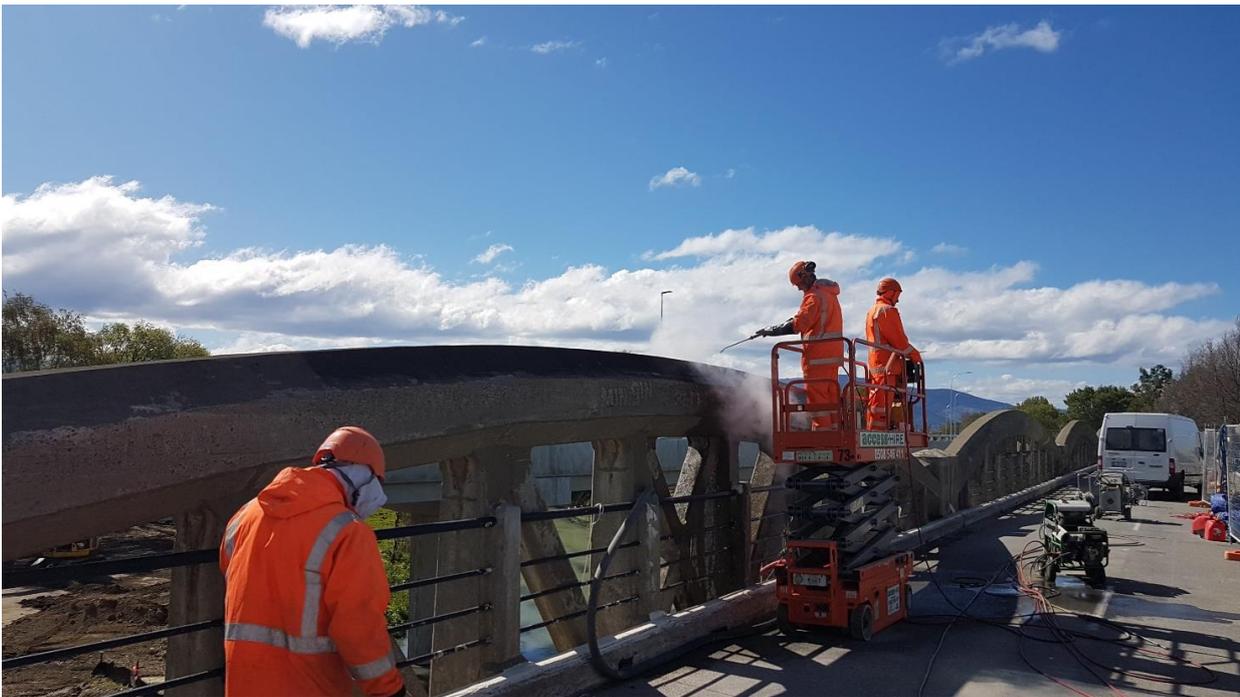
[Figure 45] Cleaning the Opawa Bridge with the Thermatech system.

First, the bridge was cleaned using a super-heated water (steam) cleaning system, ThermaTech. This system was chosen because it reaches deeper into porous substrates than other water-based or chemical methods, but is relatively gentle and does not abrade the material surface or force too much moisture into the fabric. Specialist operators from Auckland were brought to Blenheim for the project, and additional equipment was imported from the UK to cope with the scale of the work (Figure 45 and Figure 47). The use of mobile work platforms ensured that all parts of the bridge, above and below deck, were accessed for cleaning.

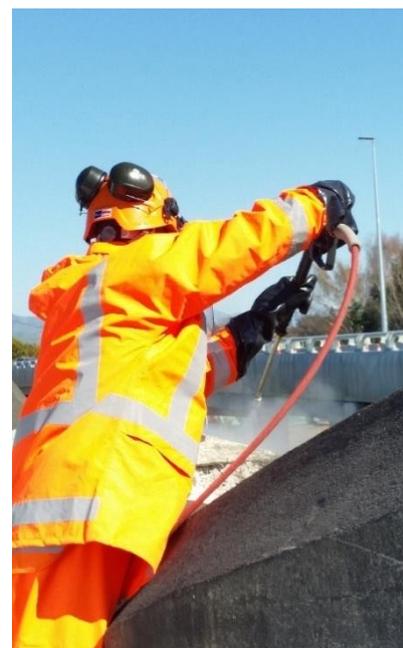
Right: [Figure 47] Cleaning the Opawa Bridge with the Thermatech system.

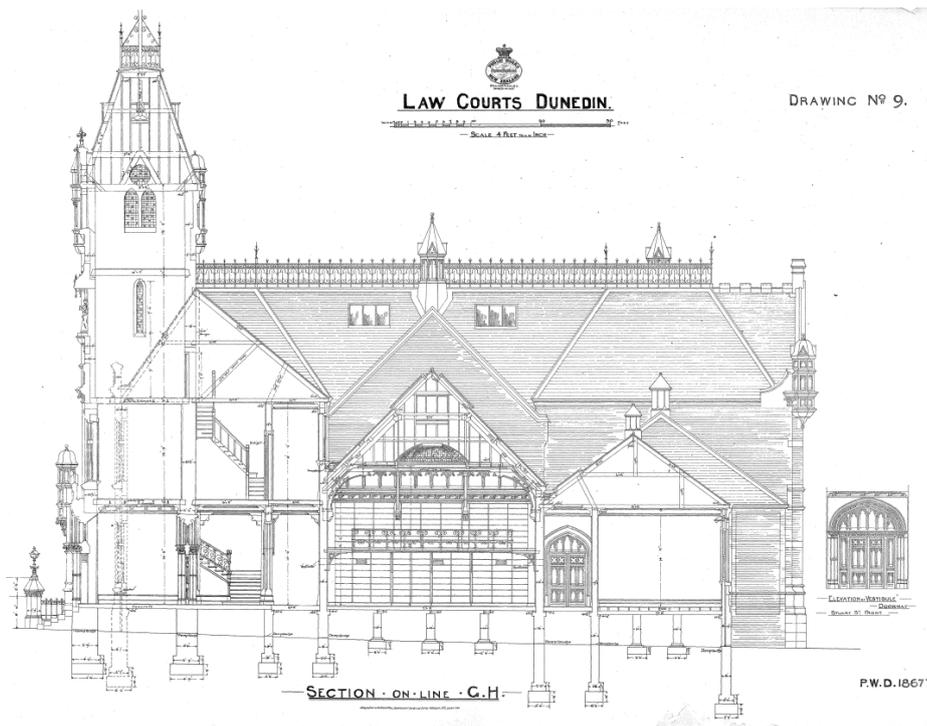
[Figure 4] Original drawing showing cross section.

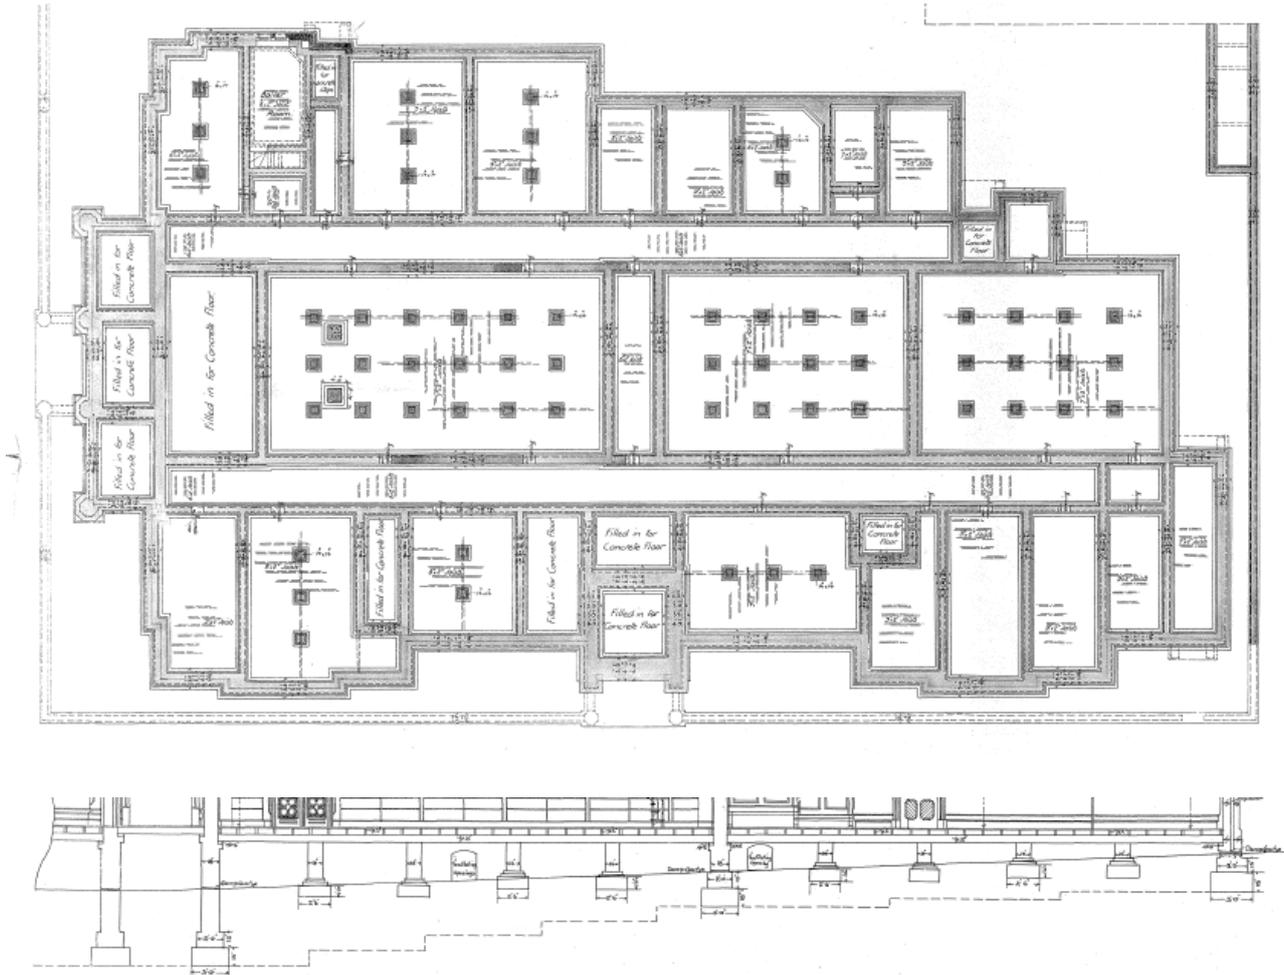
[Figure 5] Original drawings showing plan and cross section views of the existing foundations.

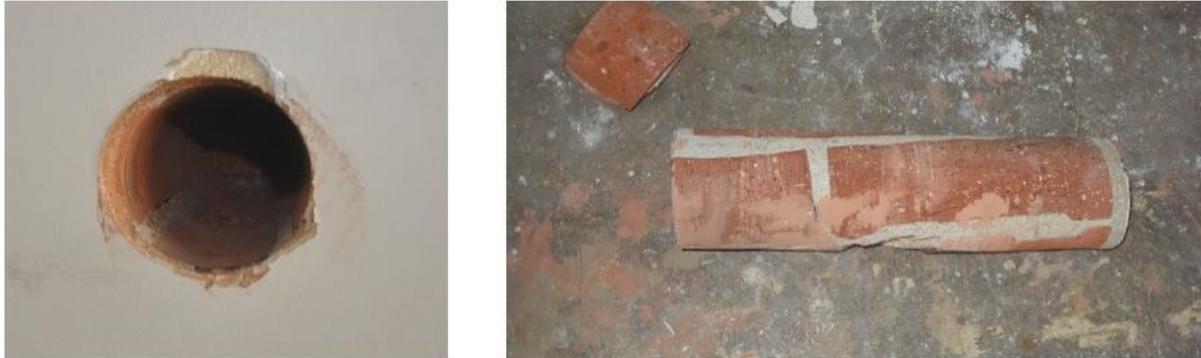
[Figure 7] Photos of existing URM interior wall core samples, illustrating their solid construction with no internal cavity.

The URM walls in-plane were assessed using the “Assessment and Improvement of Unreinforced Masonry Buildings for Earthquake Resistance” by the University of Auckland, dated December 2011.

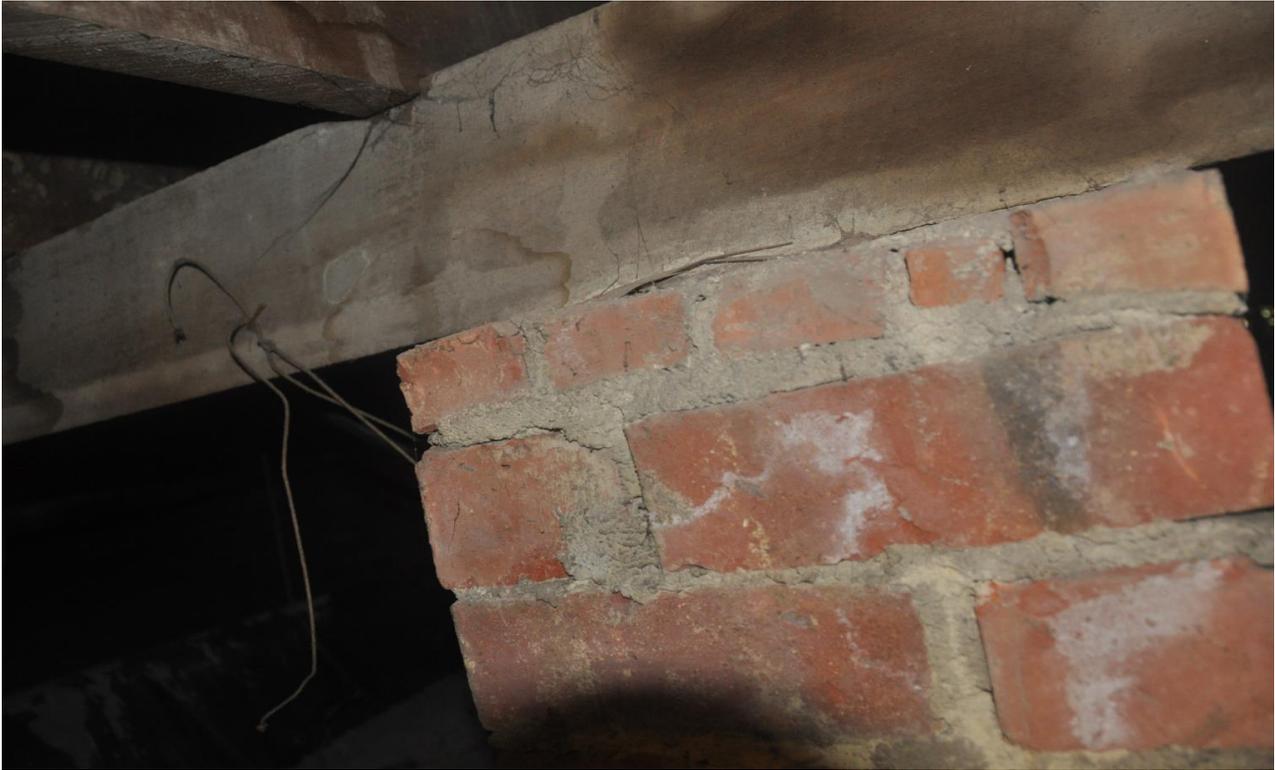
[Figure 8] Photo of existing timber bearer on URM supporting pier. No tie or direct fixing is evident.

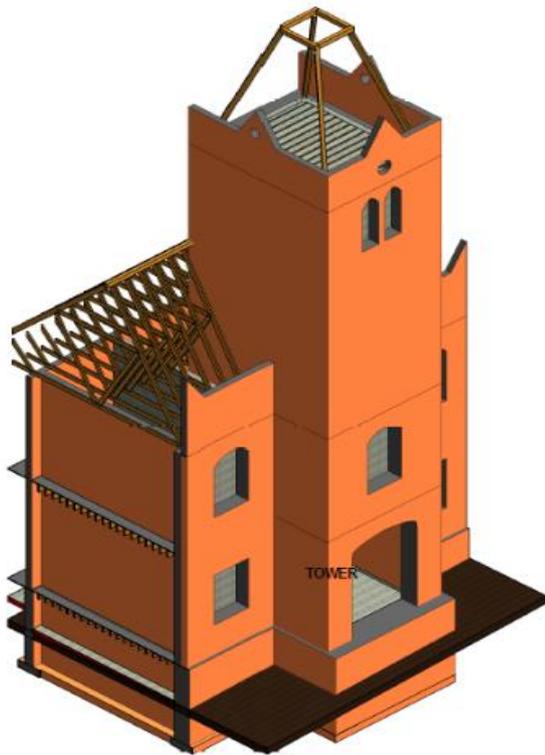
[Figure 9] 3D REVIT and photo illustration of tower structure.

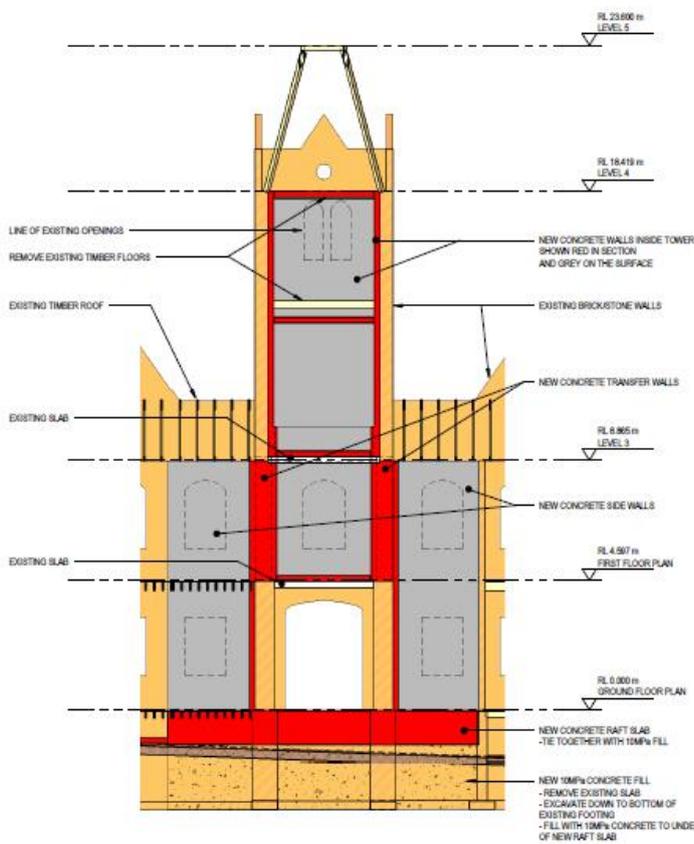
[Figure 10] Reinforced concrete internal skin strengthening of tower, with photos of the existing seismic steel bracing to be replaced.

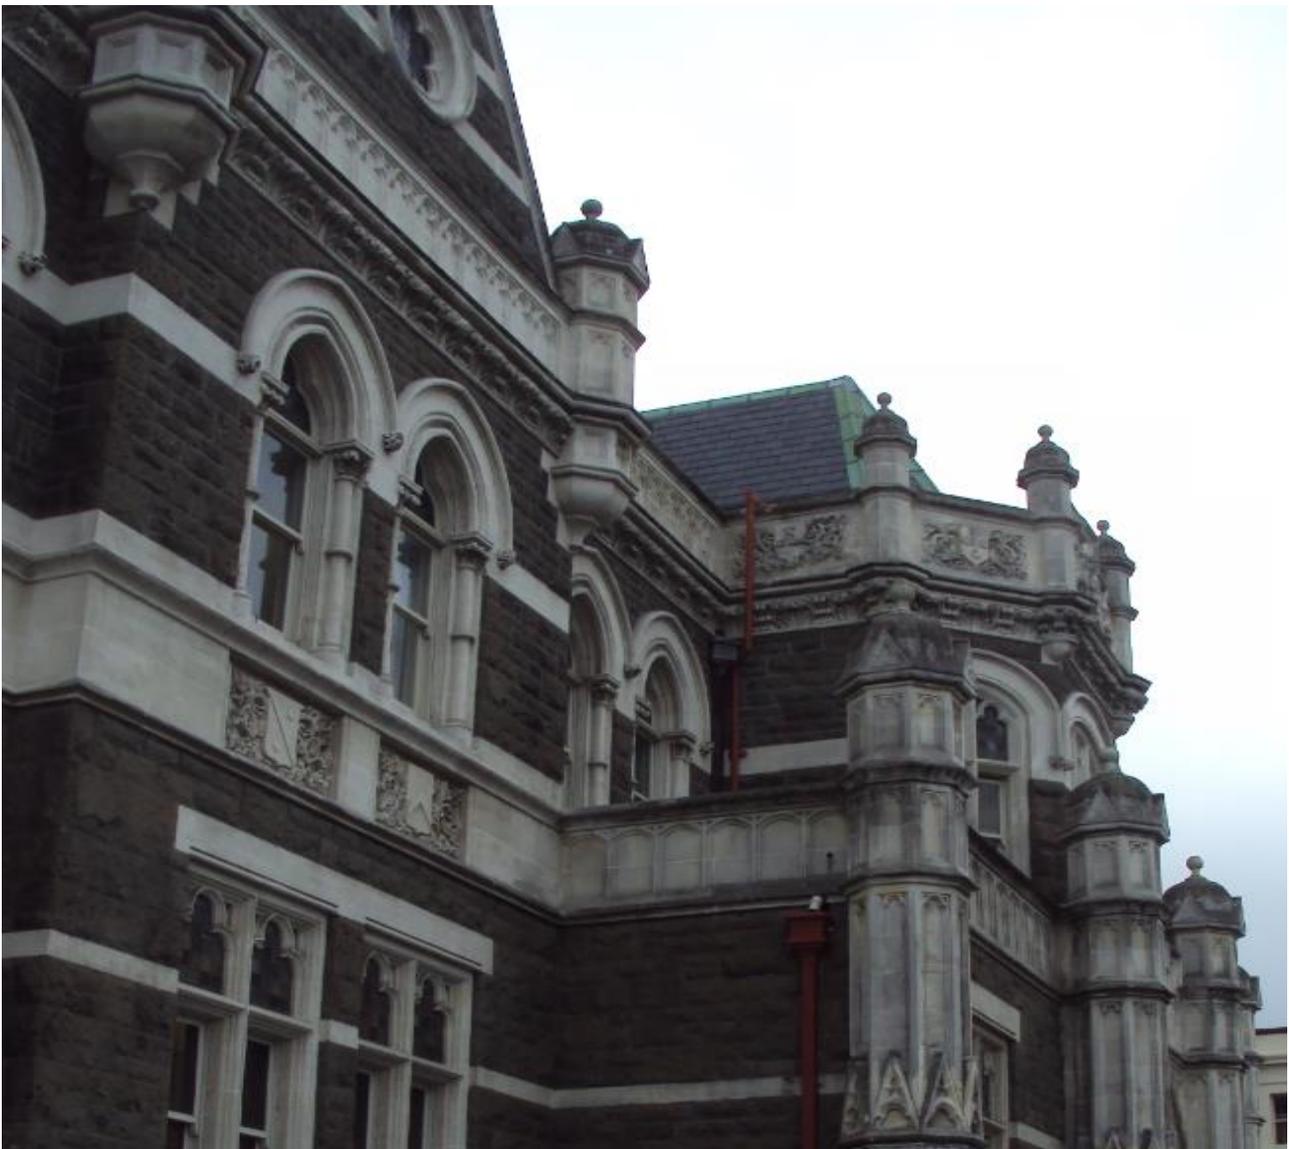
[Figure 11] Photo showing typical URM and Oamaru stone parapets and ornaments which required additional seismic restraint.

All ornamentation assessment and ornamentation strengthening has been designed for 100% seismic loads.

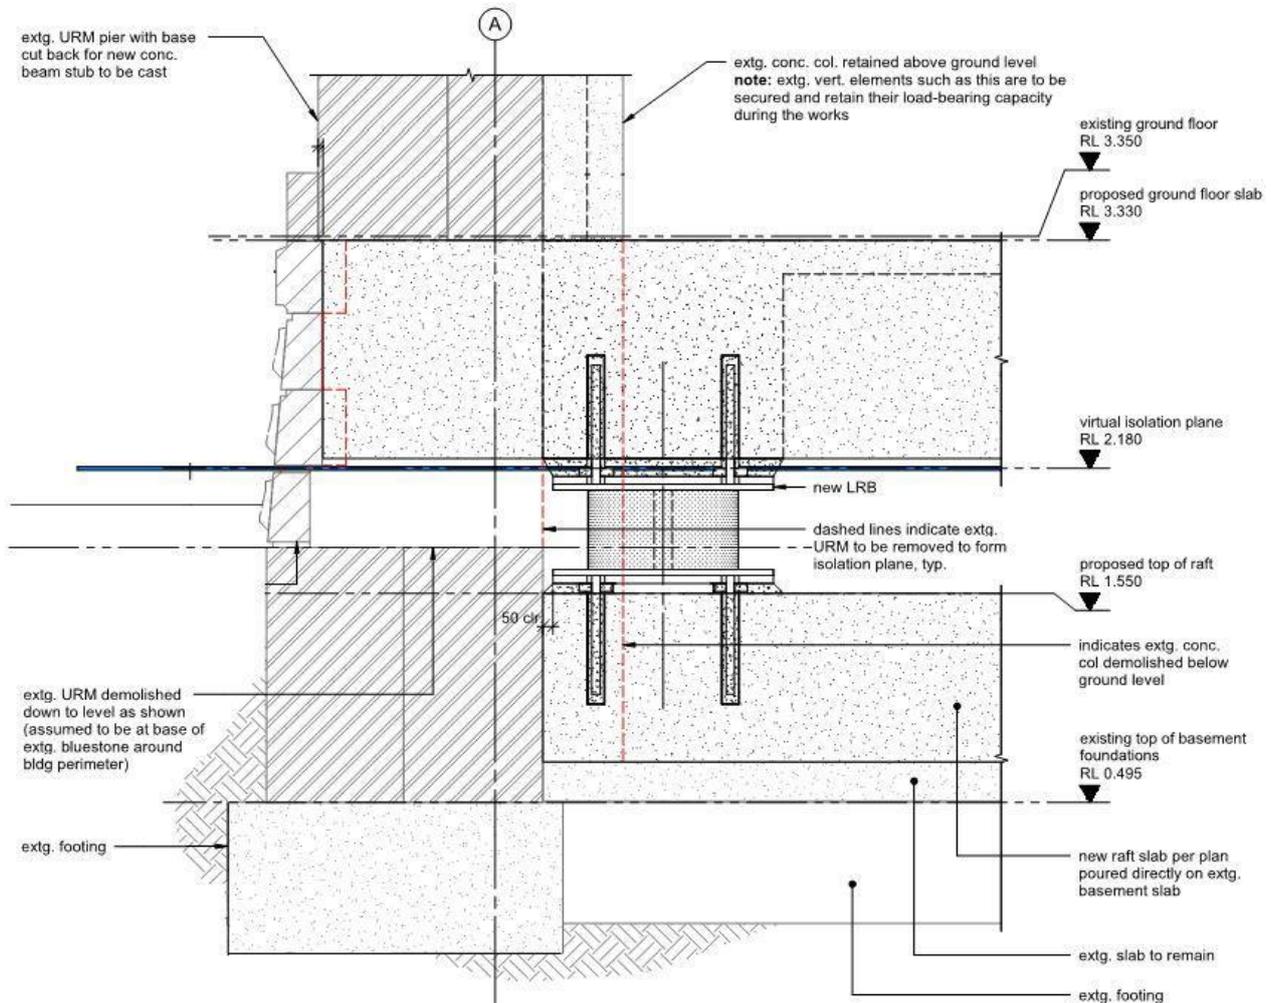
[Figure 5] Proposed foundation strengthening cross section
