AUSTRALASIAN ENGINEERING HERITAGE CONFERENCE PAPERS 2022

THE TALE OF TWO BRIDGES: HOW UNDERSTANDING HERITAGE SIGNIFICANCE CAN GUIDE THE TREATMENT OF OUR COUNTRY'S UNIQUE STRUCTURES

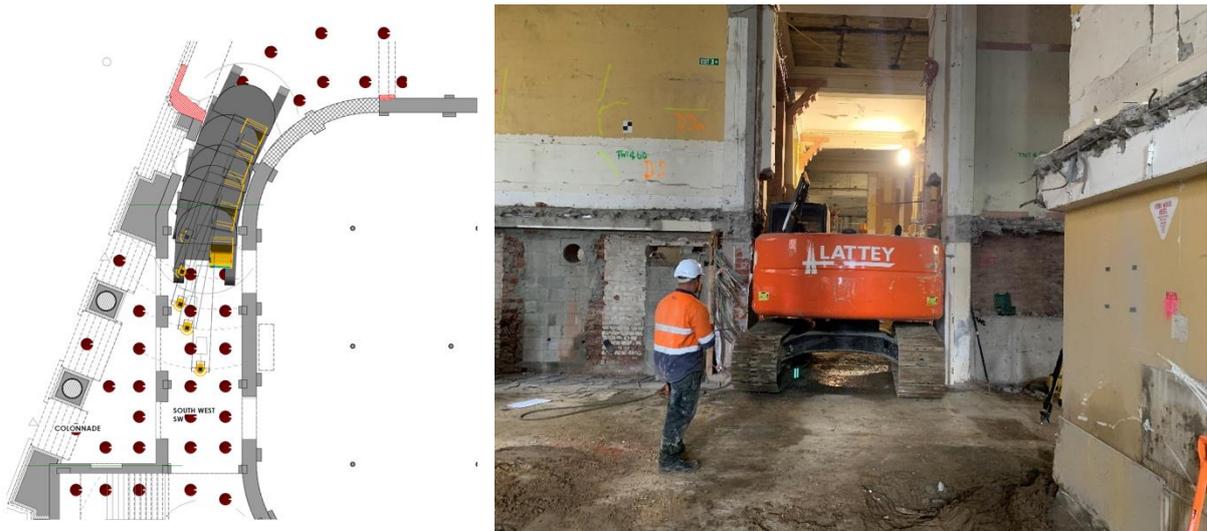
[Figure 7] Modelled route of machinery and reality. There is about 50mm clearance either side of the digger

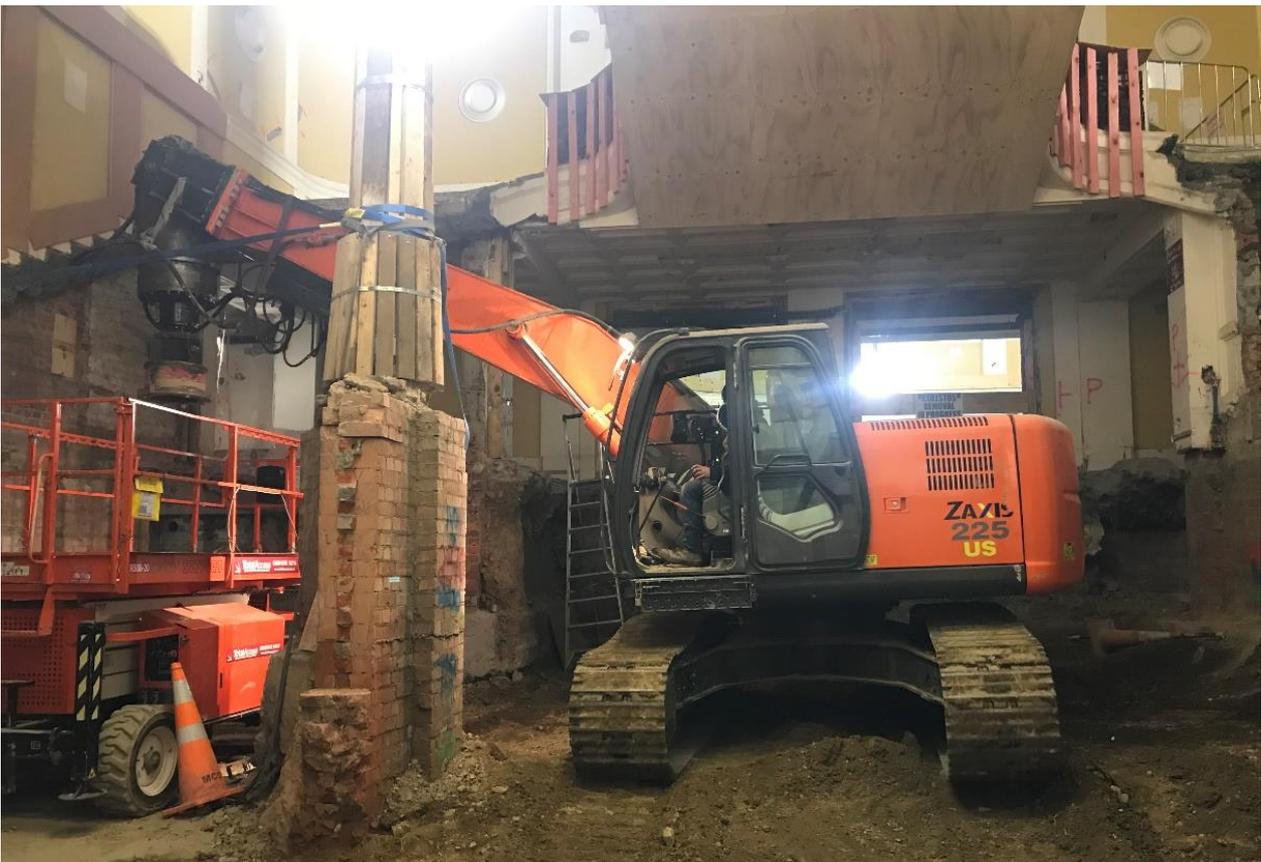
[Figure 9] Main staircase during construction

During the BIM process, other heritage items were identified as impacting on the construction and needed to be removed. The grand stairs at the Main Foyer were originally not noted as demolition scope. The foundation design required installation of several deep steel screw piles beneath the stairs. The piling equipment could not operate in the limited head room available or access the spaces opposite to install piles as intended by the design. The detailed sequence developed with the aid of modelling showed that either the stairs needed to be demolished and replaced, or the foundation design needed to be amended. Following a review by the consultants, it was deemed too difficult to re-design the foundations and hence the main stairs were demolished and will later be replaced in replica.

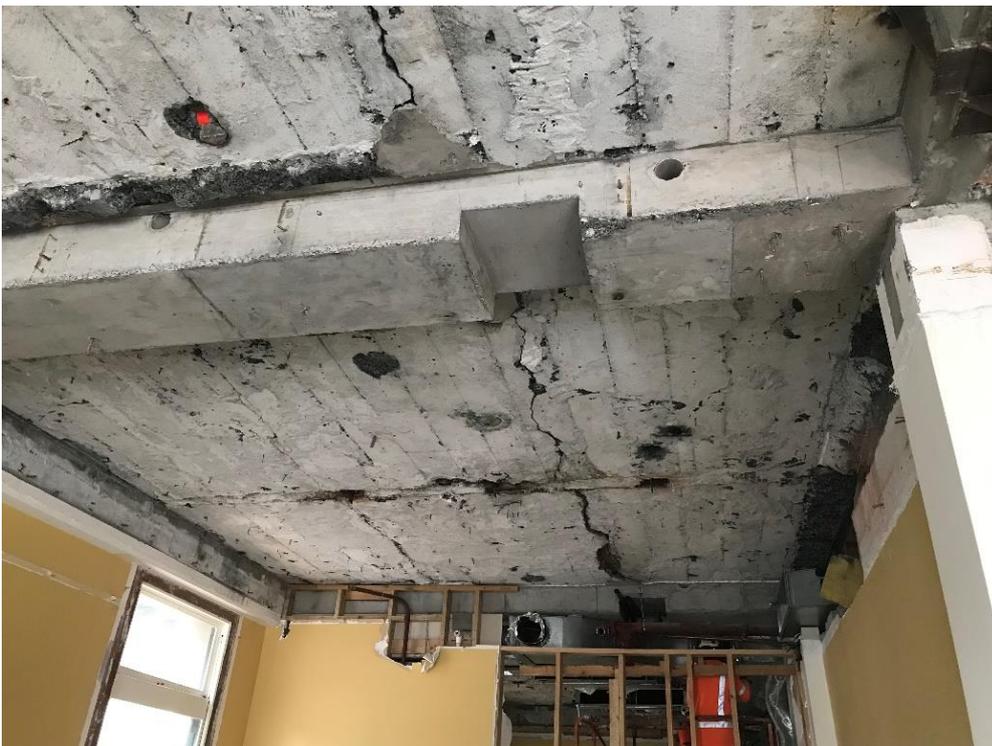
[Figure 10] Cracks uncovered in concrete Breeze Floor prior to remediation

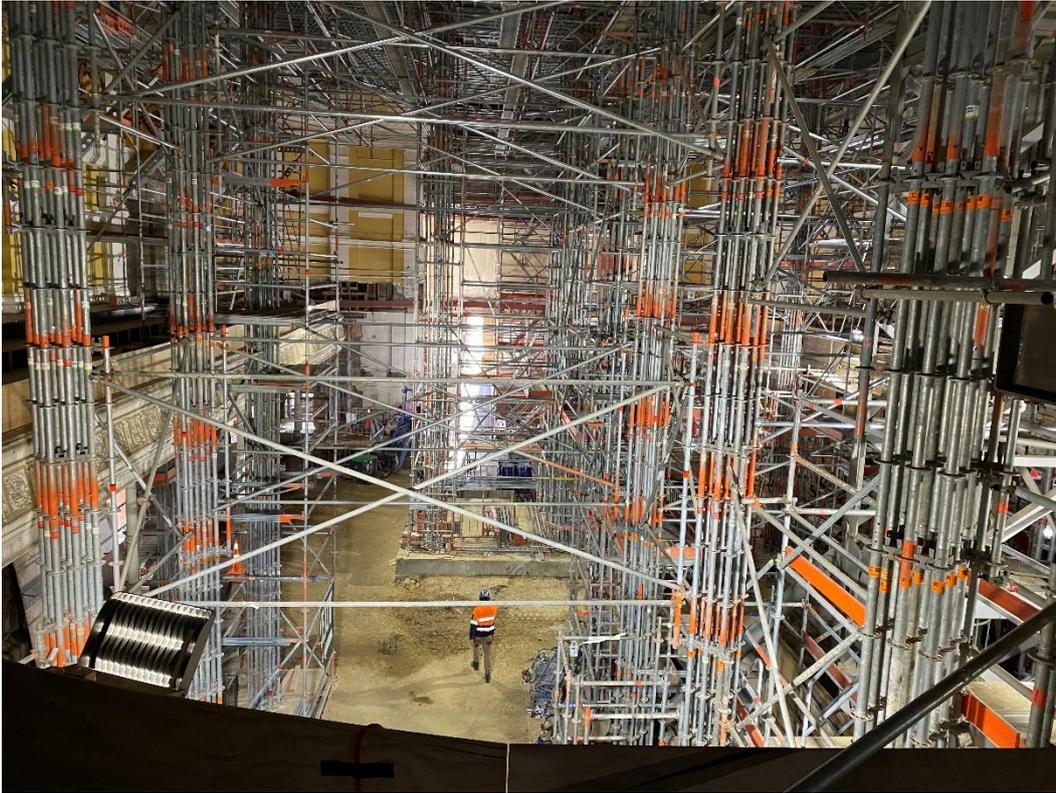
[Figure 11] Truss propping through the auditorium

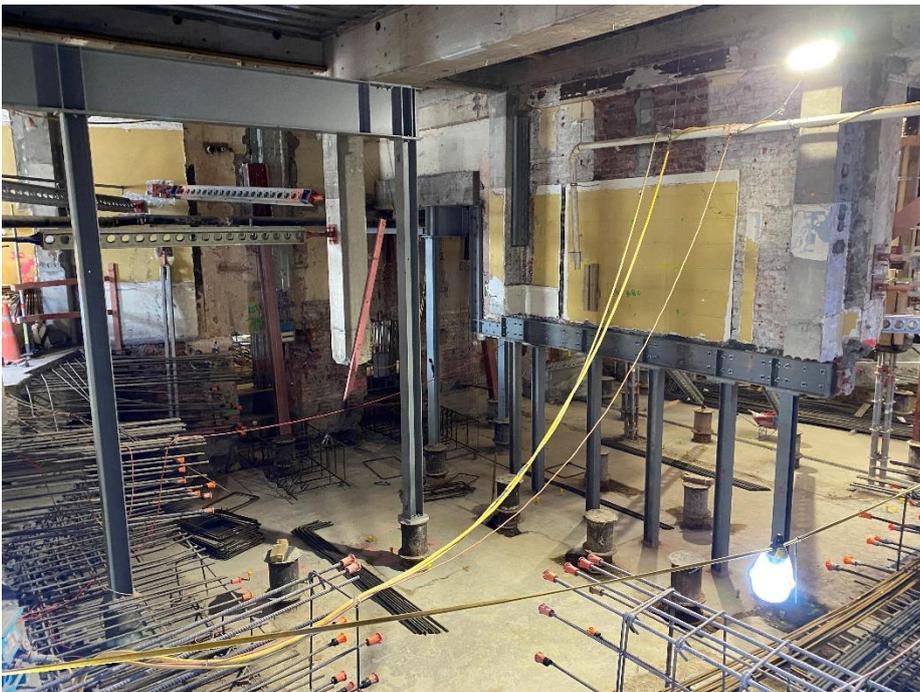
[Figure 12] Regular surveying for temporary propping supporting existing URM walls and concrete columns prior to forming raft slab

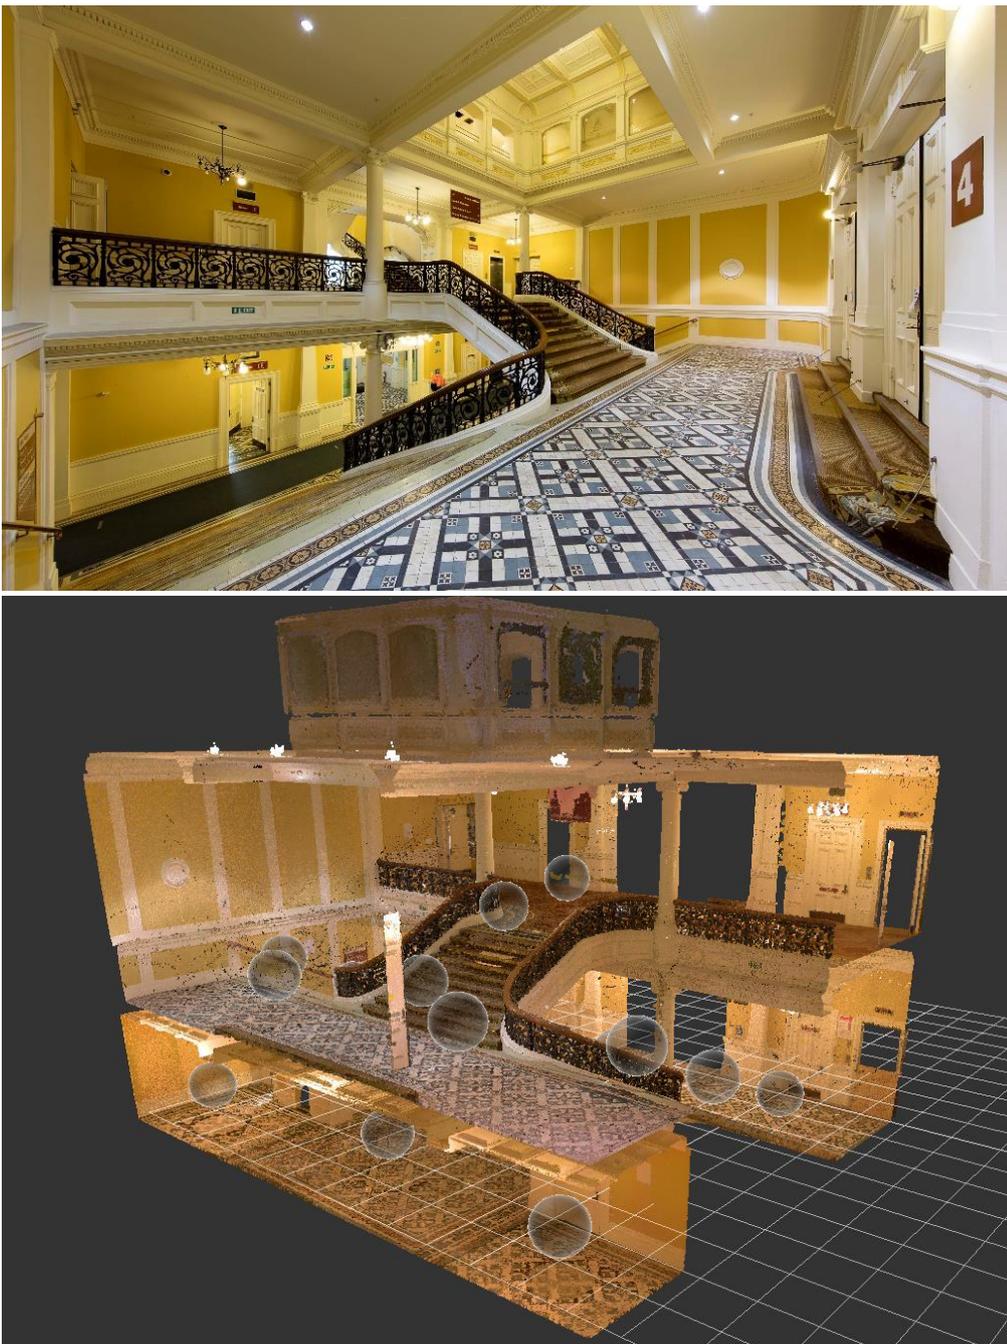
[Figure 13] Photograph and point cloud data of the main stair before demolition. This digital data will be used to make the moulds for rebuilding the stair. Ref also figs 8 and 9

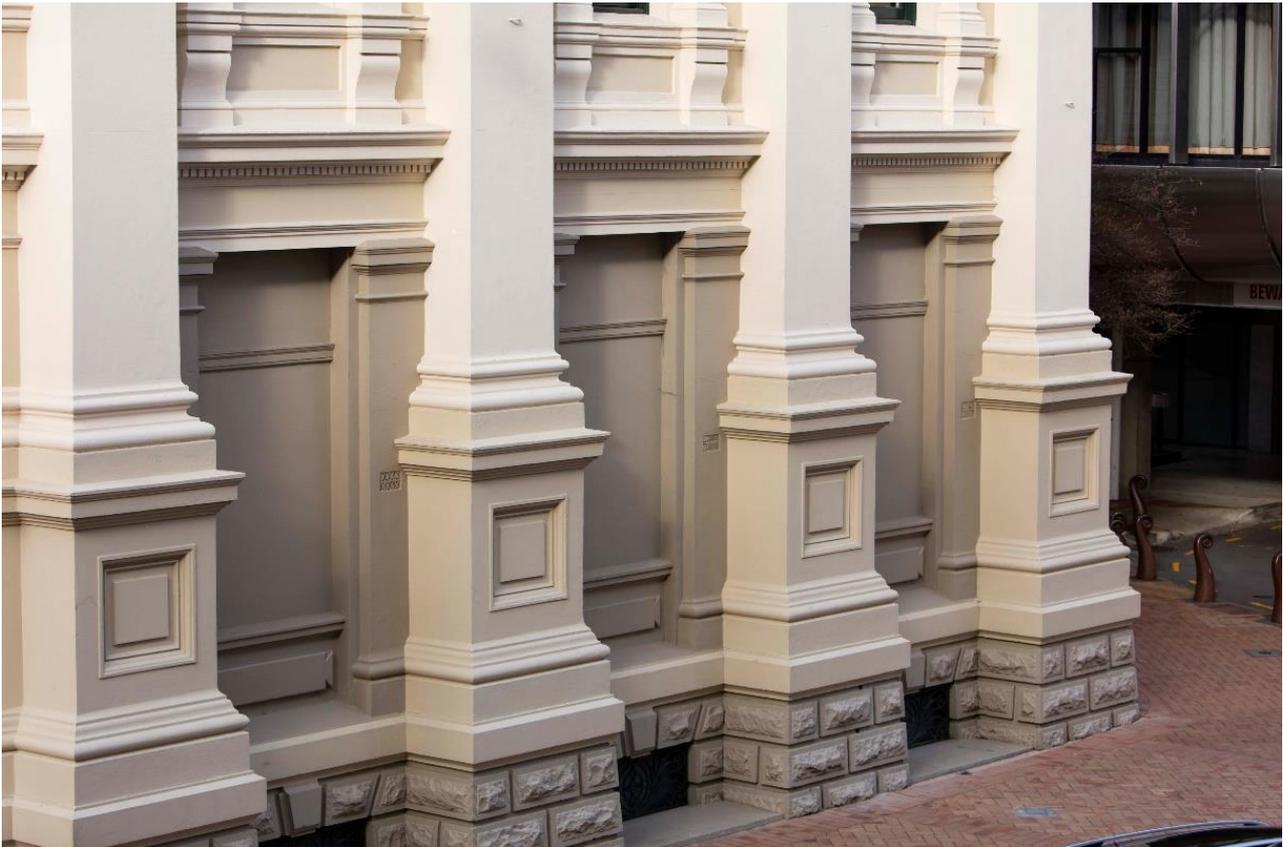
[Figure 14] Exterior of building showing bluestone plinth at base

The bluestone on the external face of the building is an integral part of the building's heritage fabric. The bluestone was required to be removed to allow for construction of the new ground floor beams. Detailed investigatory works were complete to determine a suitable methodology to protect the bluestone during removal and re-instatement.

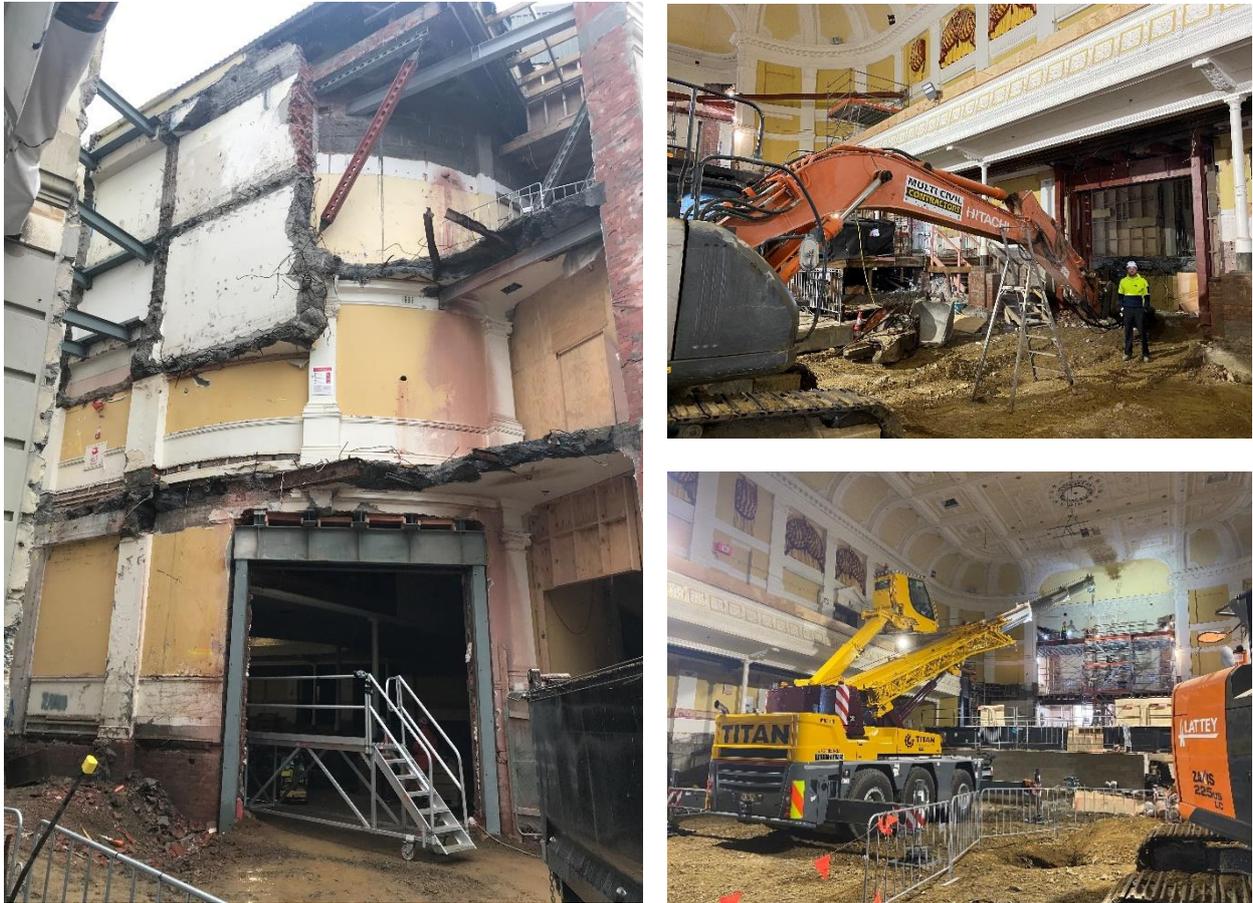
[Figure 15] Openings in URM wall for access and equipment needed inside

One of the first major challenges for construction was creating access for machinery into all areas where demolition or major structural works are occurring. There were no existing openings large enough at the start of construction, so an access way was created through the existing URM wall from Wakefield Street. This opening provided the main access into the site during the construction works and will be filled with reinforced concrete at the end of construction.

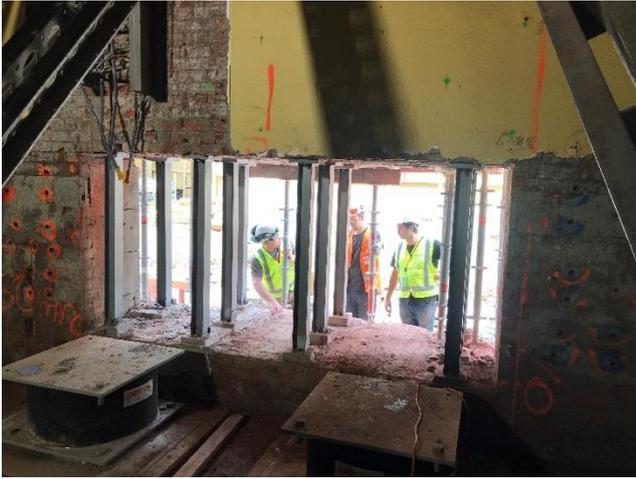
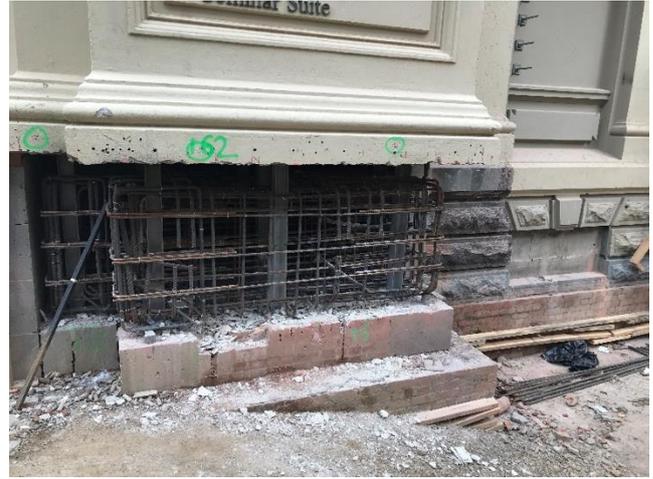
[Figure 16] Temporary works UC props, later cast in with permanent works ground beams

Further BIM modelling was used to ensure that the temporary works props did not interfere with placement of the base isolators. The temporary props were also placed to minimise the impact on the reinforcement within the permanent works ground beams.

Similar temporary works propping was completed inside the Town Hall where existing structure was being re-founded onto new ground beams.

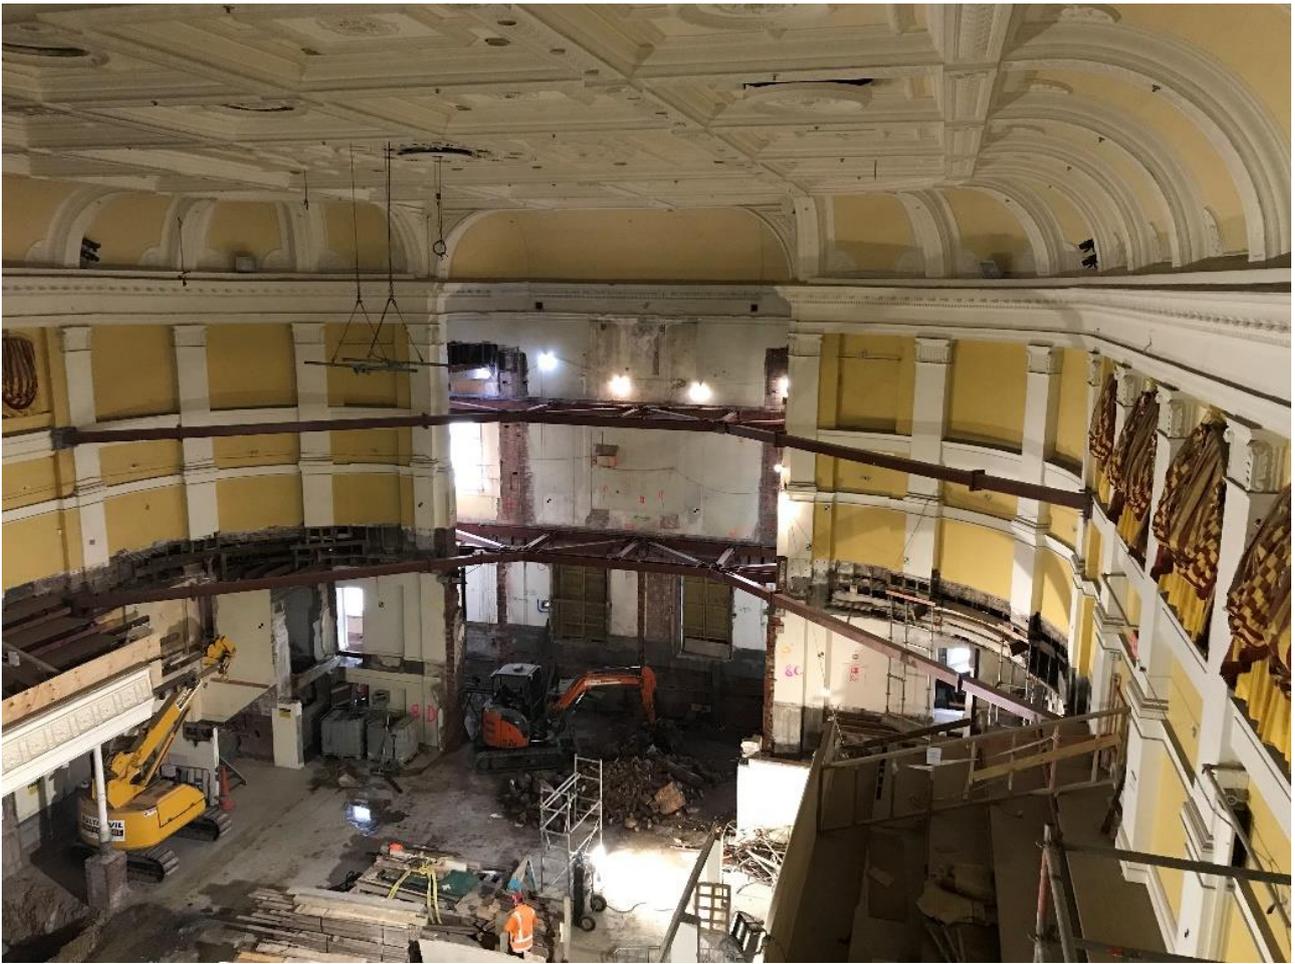
[Figure 17] temporary lateral stability to North Wall

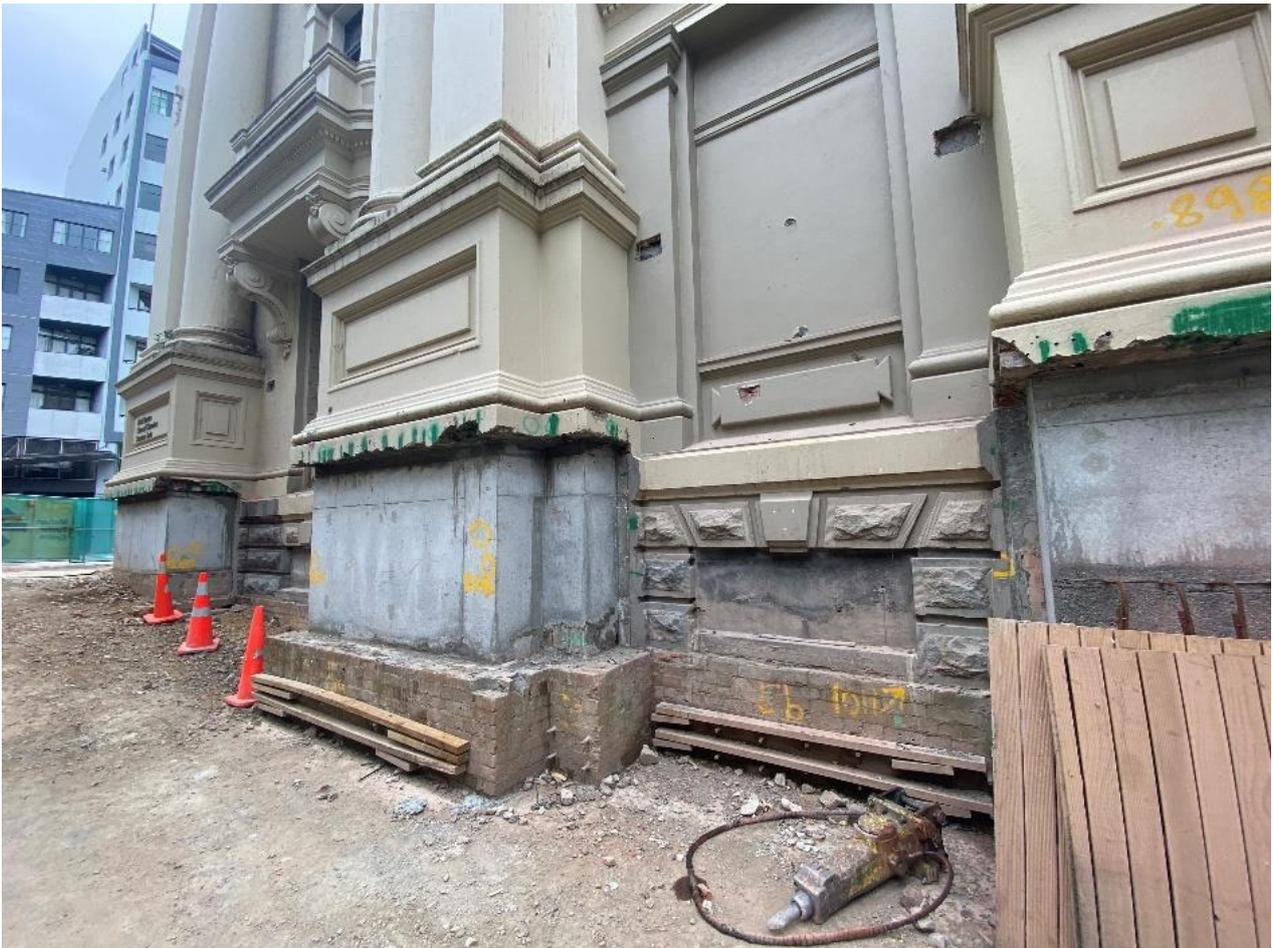
[Figure 18] shear capacity of the exterior walls was managed within the concrete works

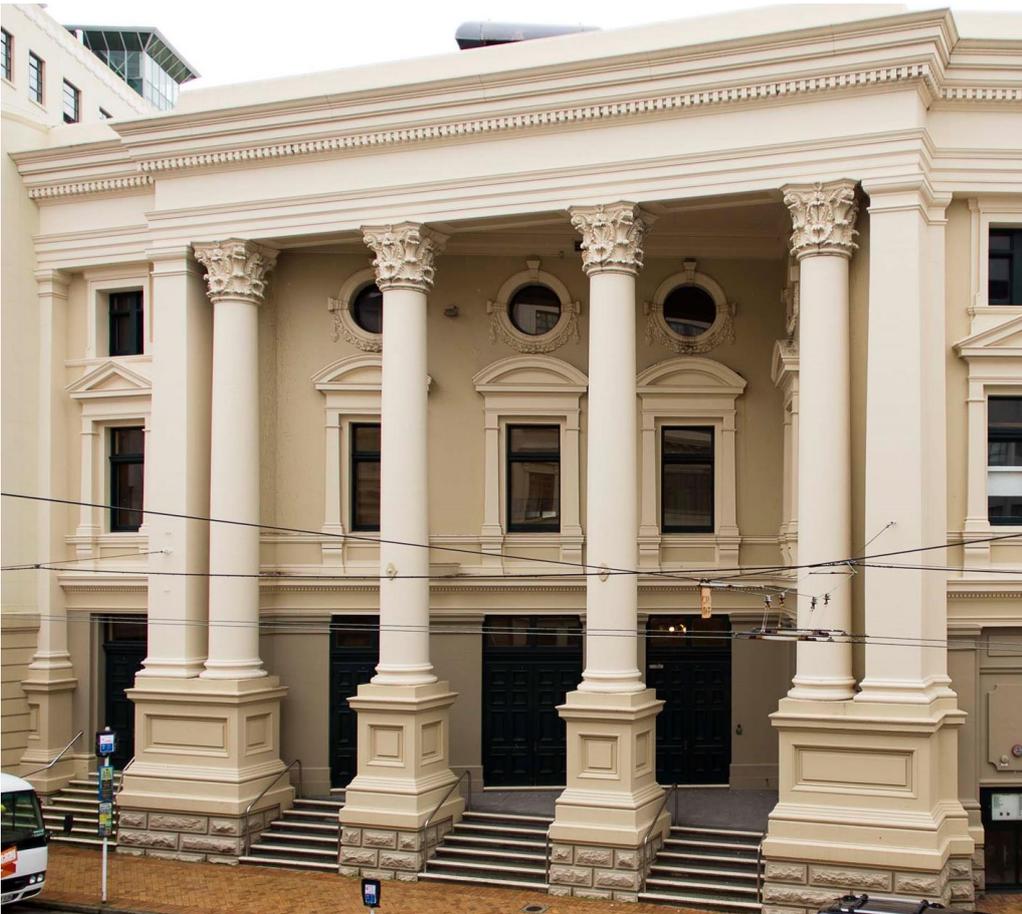
[Figure 19] Colonnade along Wakefield Street prior to construction

The proposed strengthening works created some significant challenges for the Contractor, as we needed to disconnect the base of the columns to construct the new foundations but there was no obvious solution to support the weight of the 12m high columns while this work was underway.

After exploring a number of solutions, it was decided to utilise a temporary steel truss to support the URM columns. The steel truss was supported by six UC columns which were founded on top of the new screw piles. This solution enabled the new foundation works to proceed whilst maintaining the strict settlement deflection limits set by the Structural Engineer.

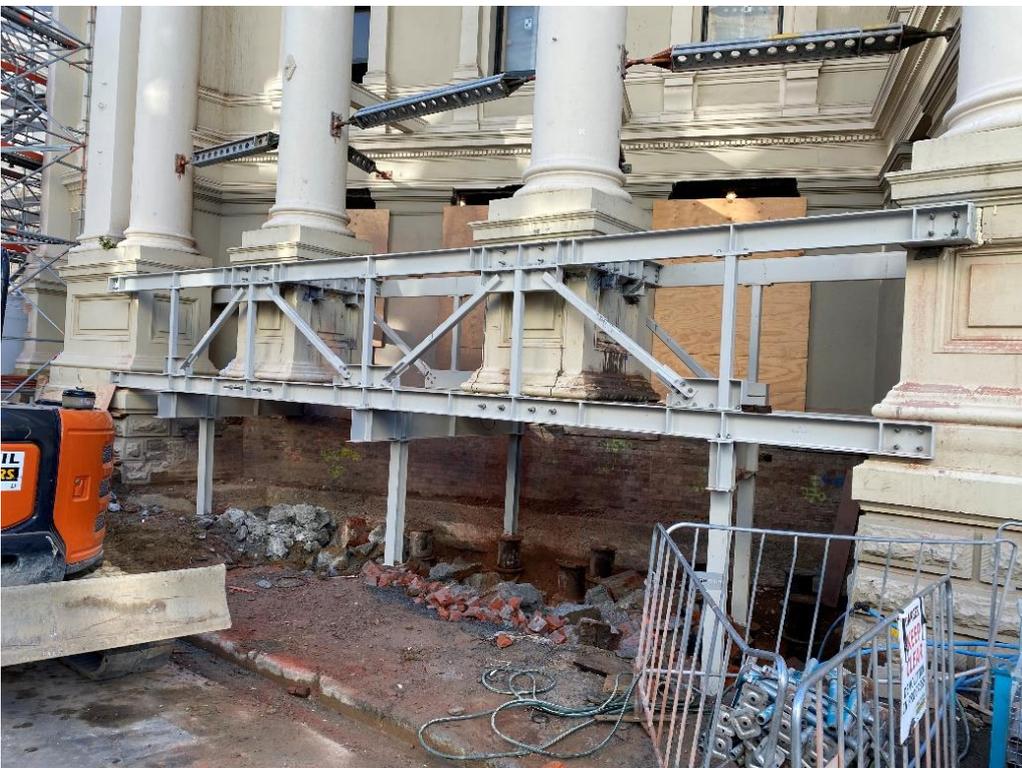
[Figure 20] Colonnade temporary truss in place after demolition of the column foundations

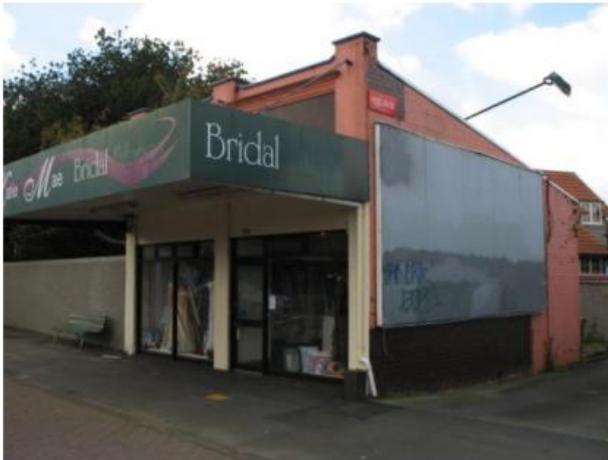
Typology A building – one storey isolated.

[Figure 2] Eligible buildings. Reproduced from Ingham and Russell (2010) with permission.

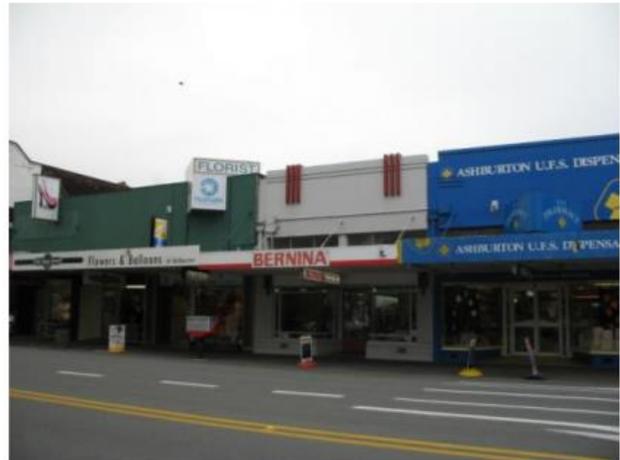
Typology B building – one storey row.

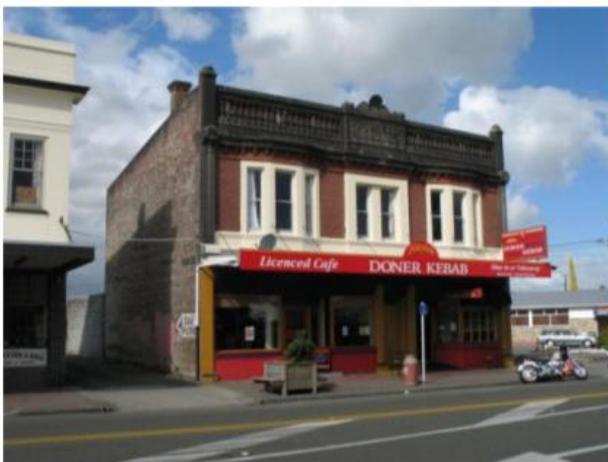
Typology C building – two storey isolated.

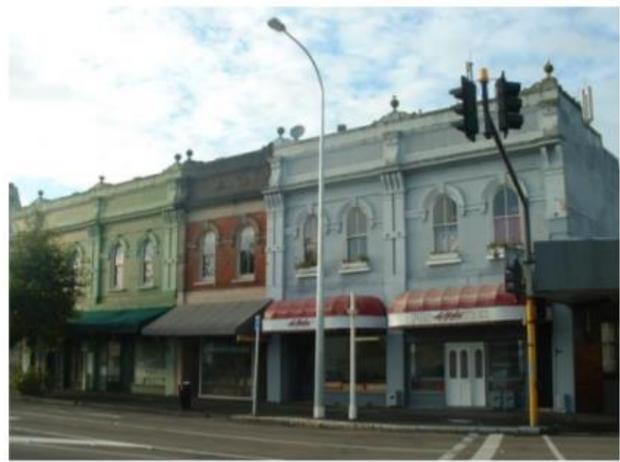
Typology D building – two storey row.

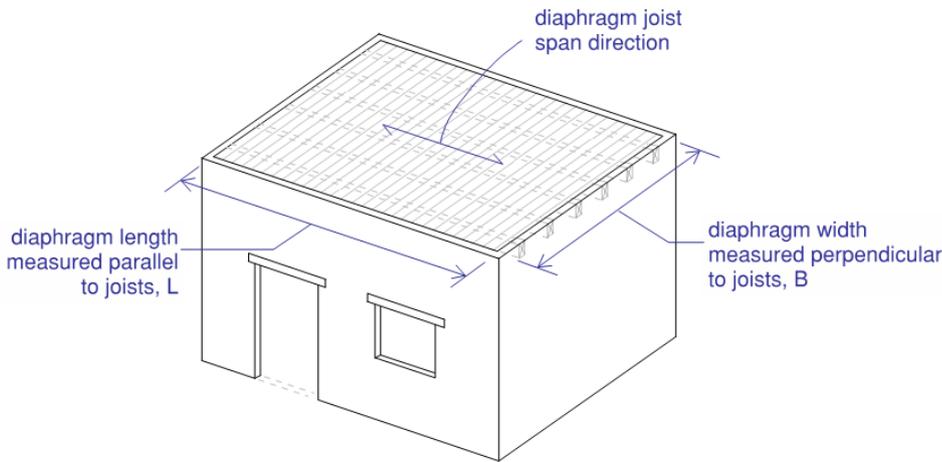
[Figure 3] Isometric sketch of a simple URM building showing how diaphragm length and width are measured.

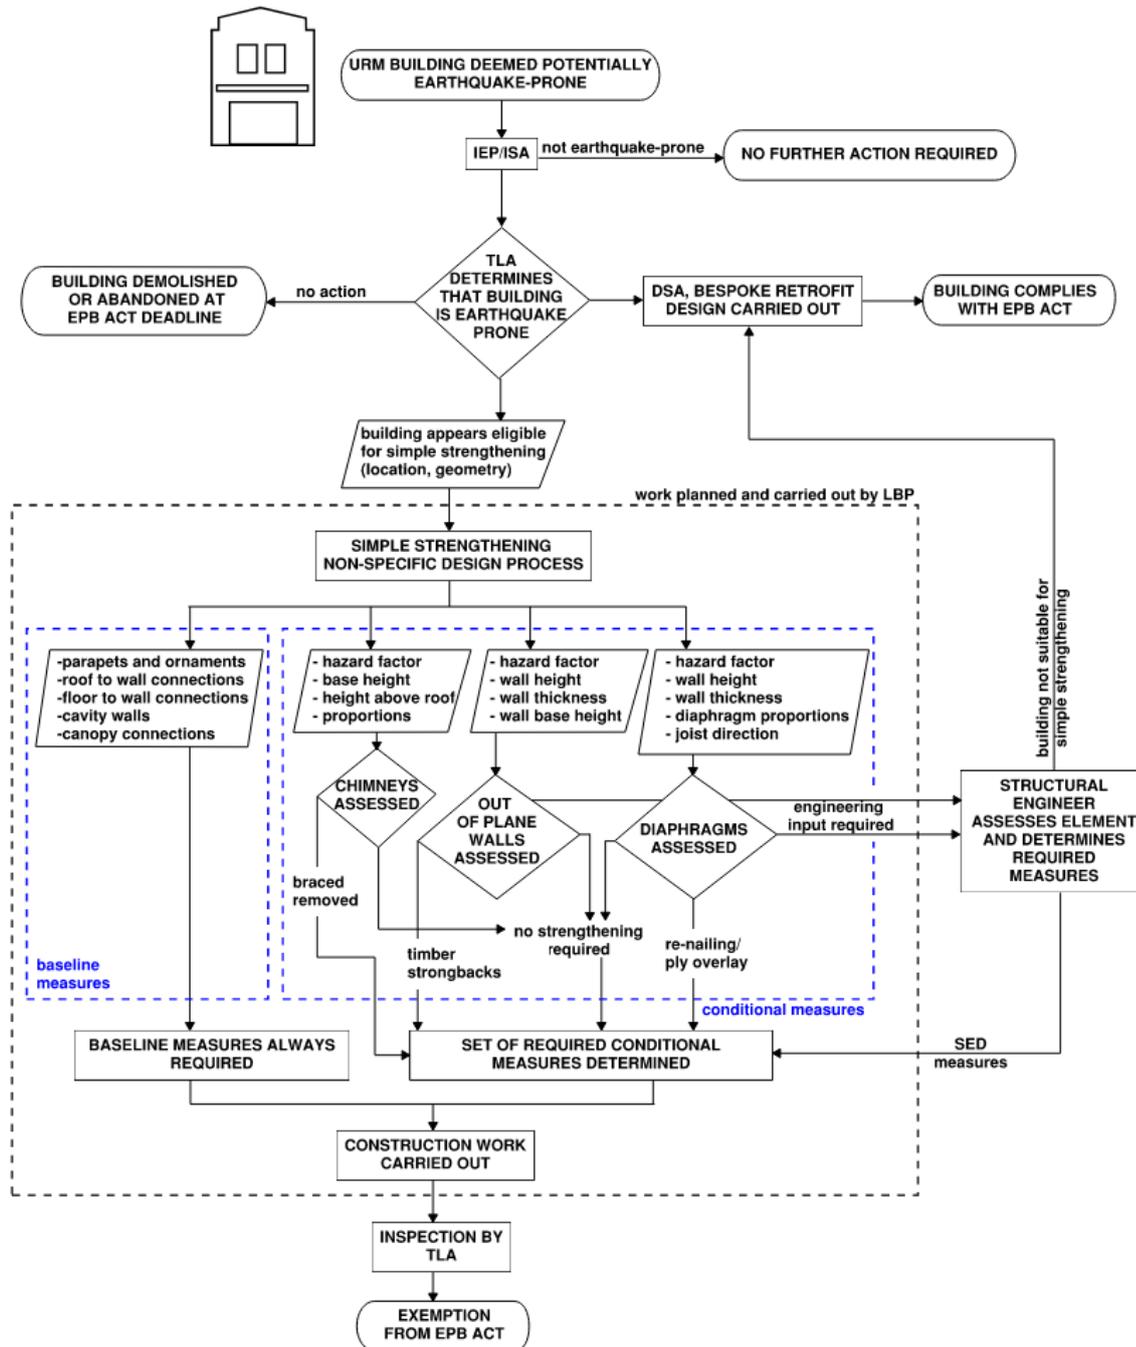
[Figure 4] Simple strengthening process flow diagram.

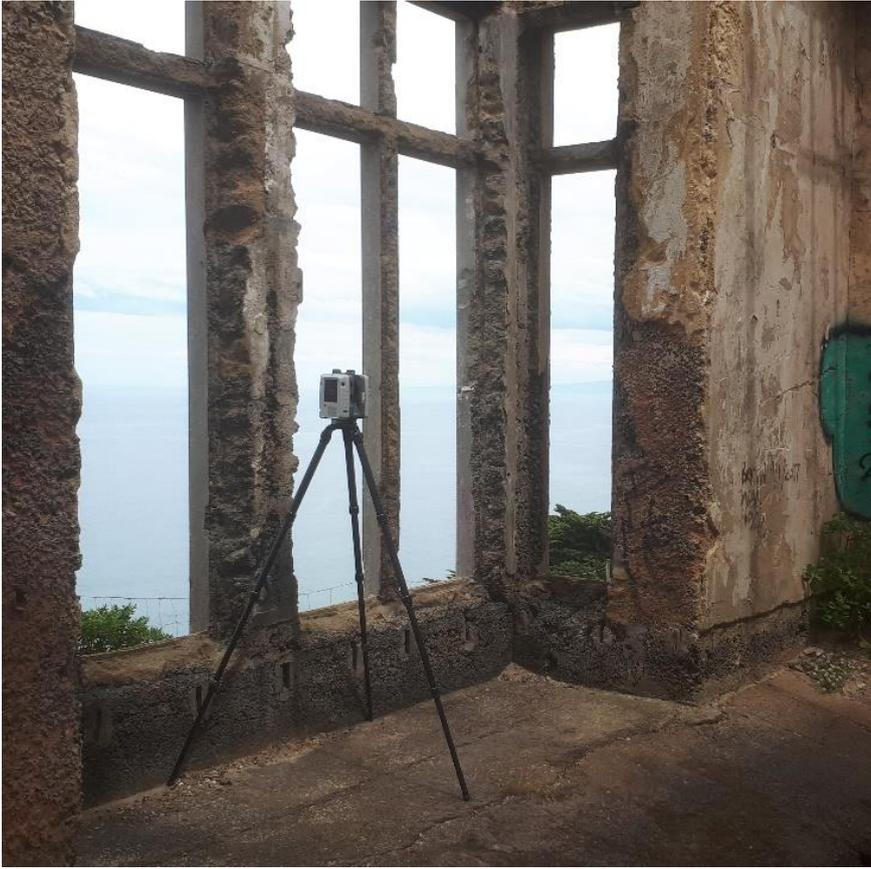
[Figure 1] A Leica RTC360 Laser Scanner capturing a heritage building

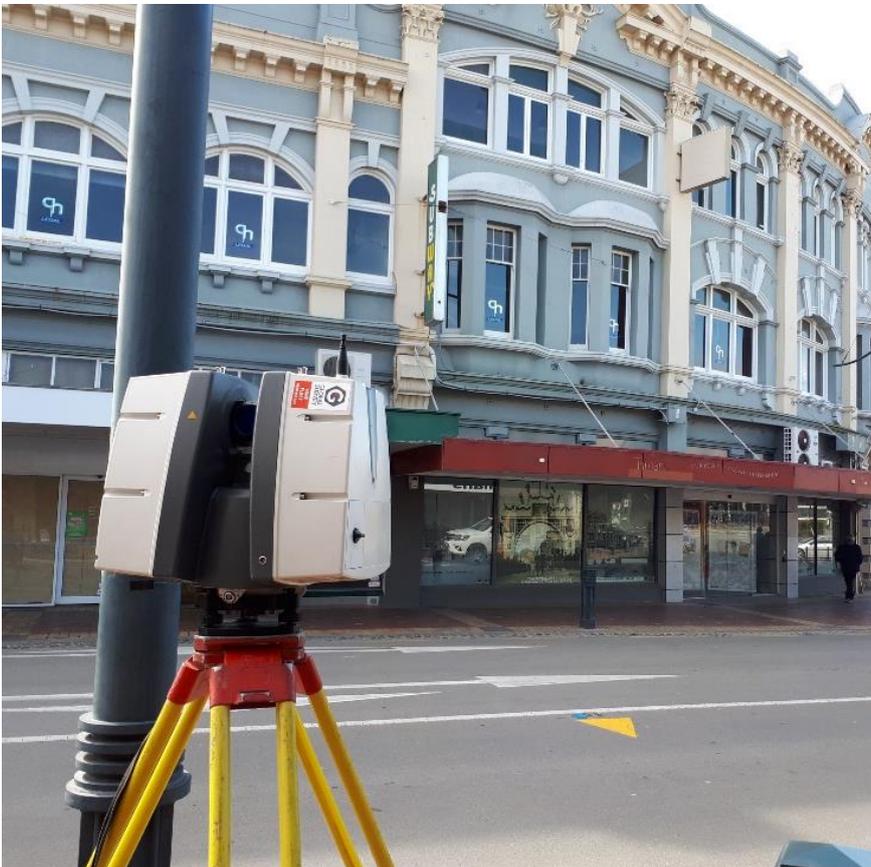
[Figure 2] A survey-grade Leica P40 Laser Scanning capturing a historic building facade

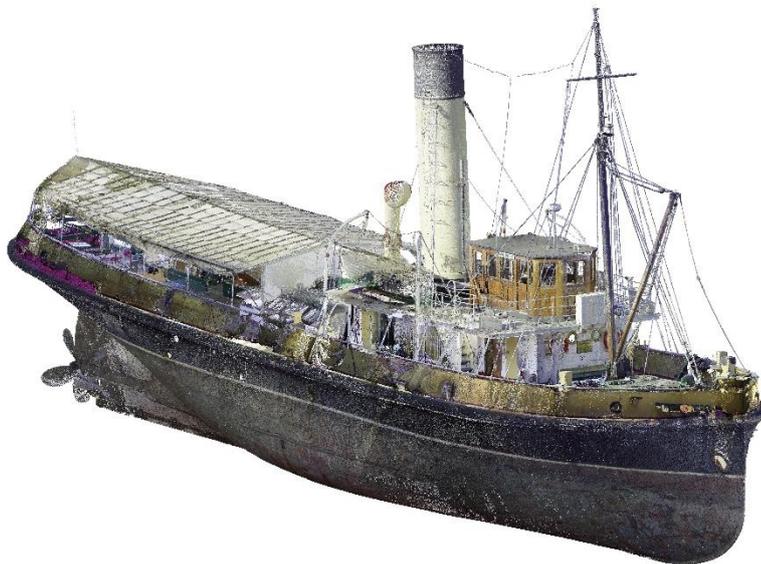
[Figure 4] Final unified point cloud of the Tug Lyttelton as scanned by the Leica RTC360

The environment, which was very constrained thanks to the enclosed dry dock outside and the small, closed spaces inside, lent itself to “cloud-to-cloud” registration (a technique that requires a significant percentage of overlapping scan data) both in terms of efficiency and accuracy. Targets were only used for difficult transitions between spaces such as hatches into chambers where it was difficult to capture overlapping clouds.

The Leica RTC360 scanner was selected as the tool for the job as it’s speed (360° scan in as little as 26s and panoramic imagery in 60s) gave us the luxury to capture more than enough overlapping data to create a comprehensive and robust registered point cloud while the instruments’ ability to capture HDR imagery provides an evenly coloured point cloud. The RTC360 captures very low-noise data (sub-millimetre range noise) which provides crisp, high-quality scans that are rich in detail. In this case we captured almost 1 billion points over 120 scans.

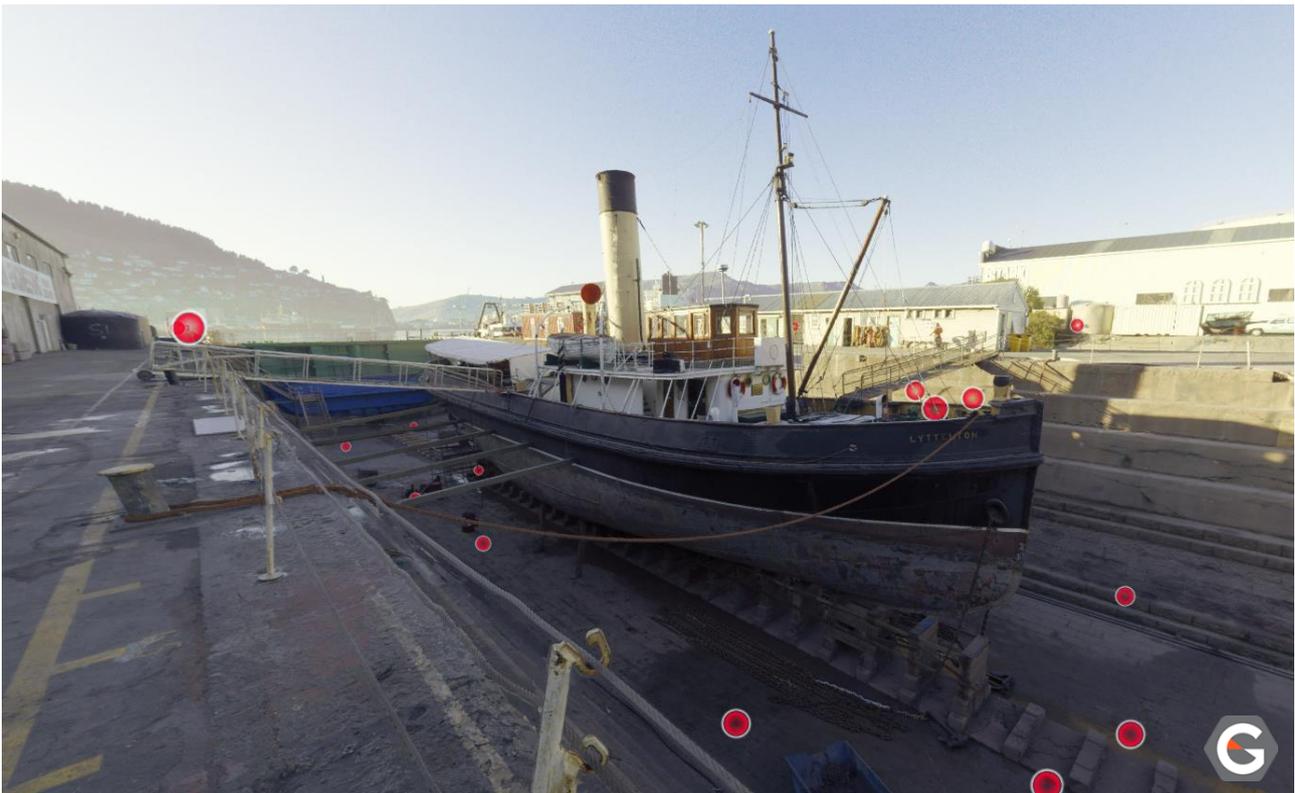
[Figure 5] An example of the 5K HDR panoramic images captured by the RTC360. The red spheres show a sub-selection of the setup locations used to capture the point cloud and panoramic imagery.

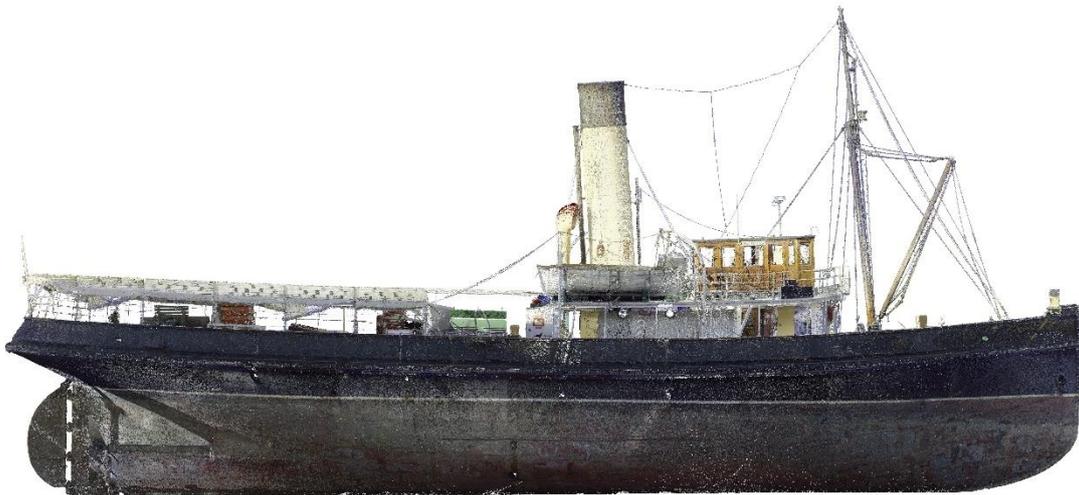
[Figure 6] An orthographic image of the unified point cloud

- A highly detailed, cleaned, coloured point cloud
- Orthoimages of the point cloud from different perspectives
- A lightweight complex mesh of the outer hull
- A reverse engineered CAD-model of the outer hull, which could be used to construct a scale model of the tug

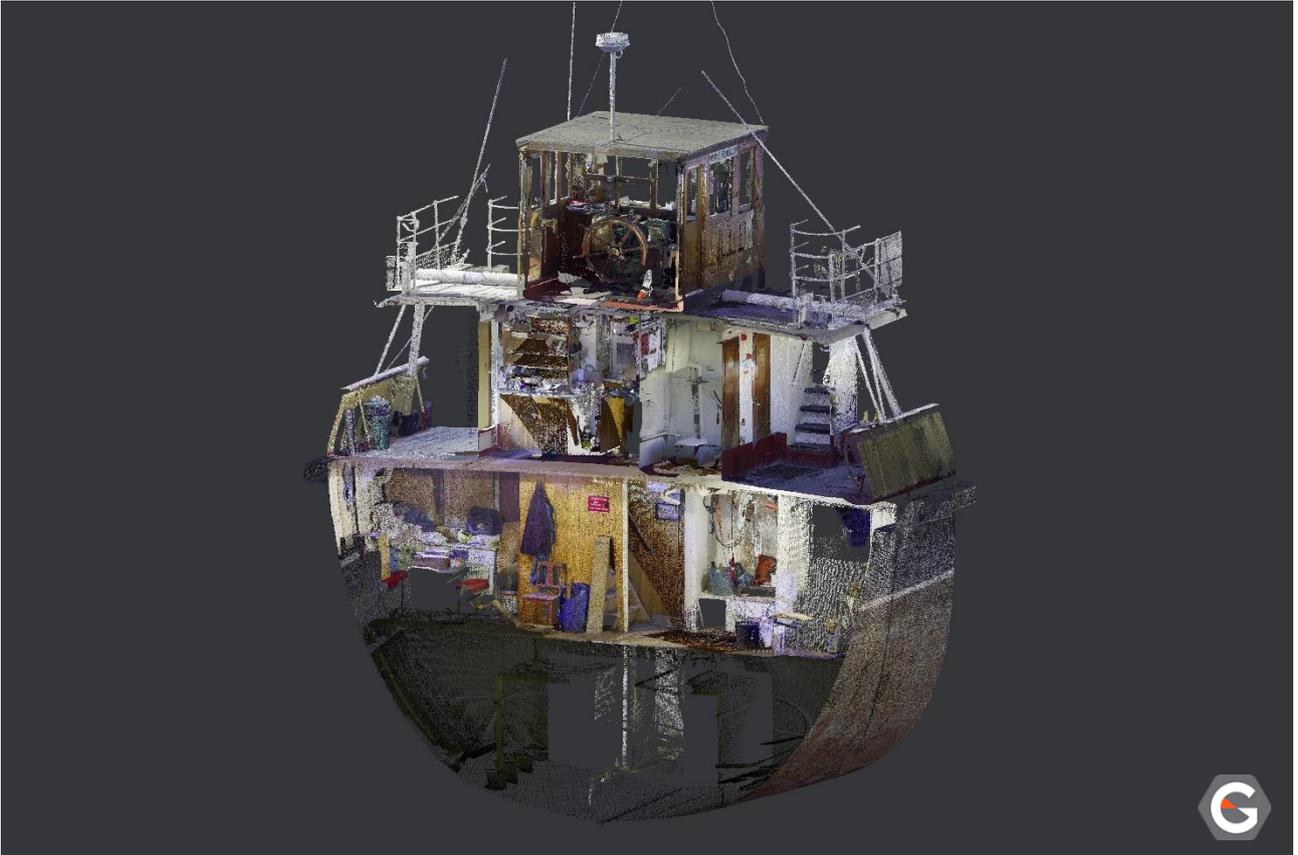
[Figure 8] A slice of the point cloud showing the interior spaces captured

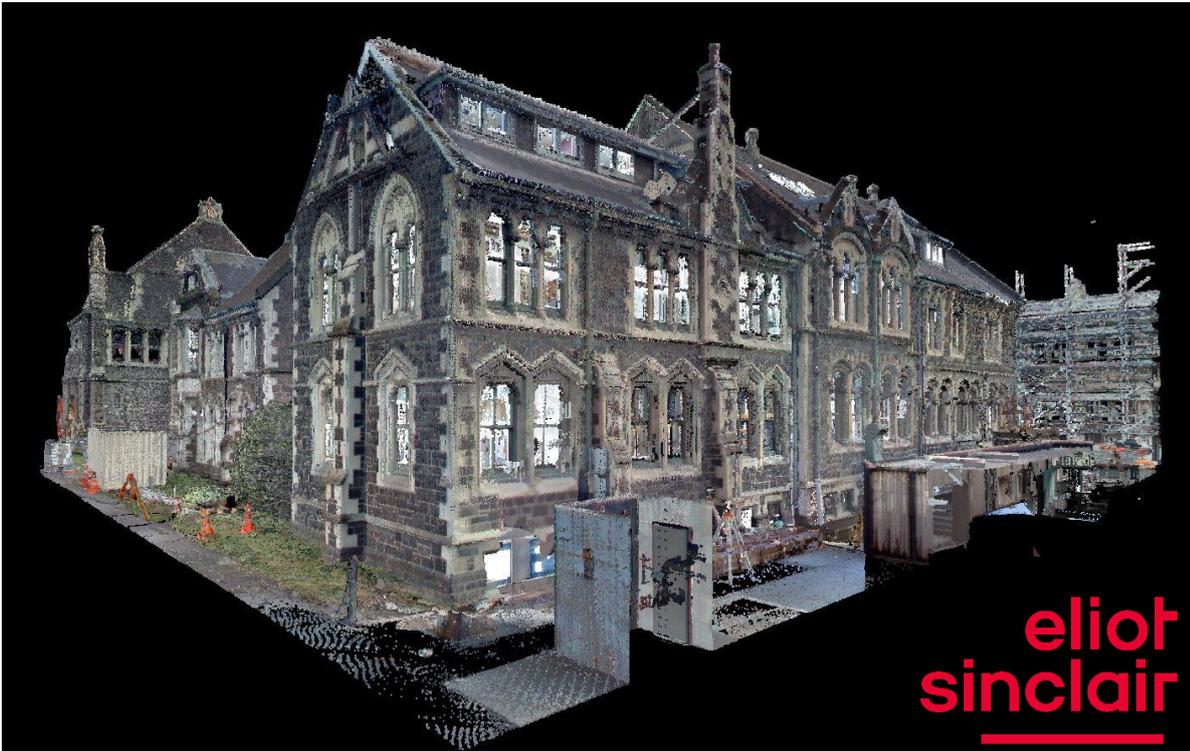
[Figure 10] A sample of the survey-accurate point cloud captured (Courtesy of Eliot Sinclair)
