AUSTRALASIAN ENGINEERING HERITAGE CONFERENCE PAPERS 2022

THE TALE OF TWO BRIDGES: HOW UNDERSTANDING HERITAGE SIGNIFICANCE CAN GUIDE THE TREATMENT OF OUR COUNTRY'S UNIQUE STRUCTURES

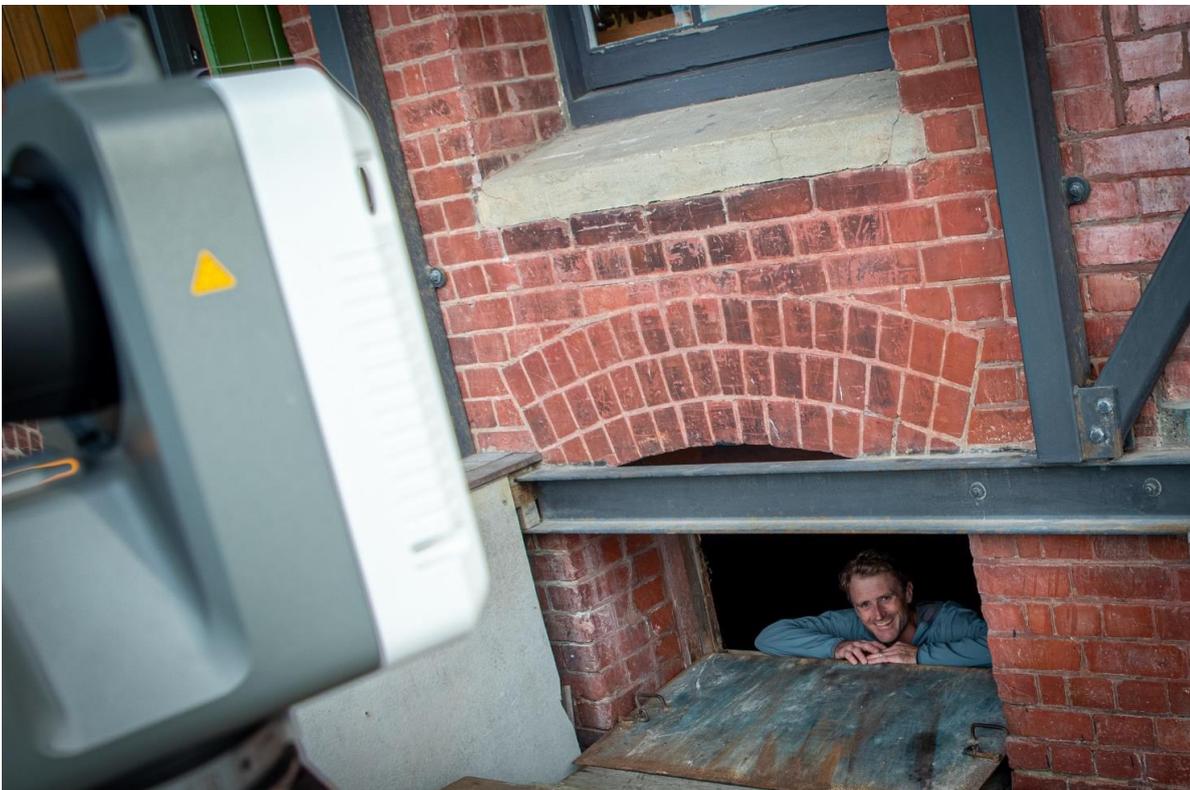
[Figure 11] The author looking on as the Leica RTC360 scans the outside of the NG Building (Photo Credit: Maksym Khovalko)

The building was scanned inside and out. Cloud-to-cloud registration was used for the majority of the registration and was complemented with targets for checks outside. Scans were captured in several open doors and windows, allowing several loops to be closed to ensure confidence in the final registration.

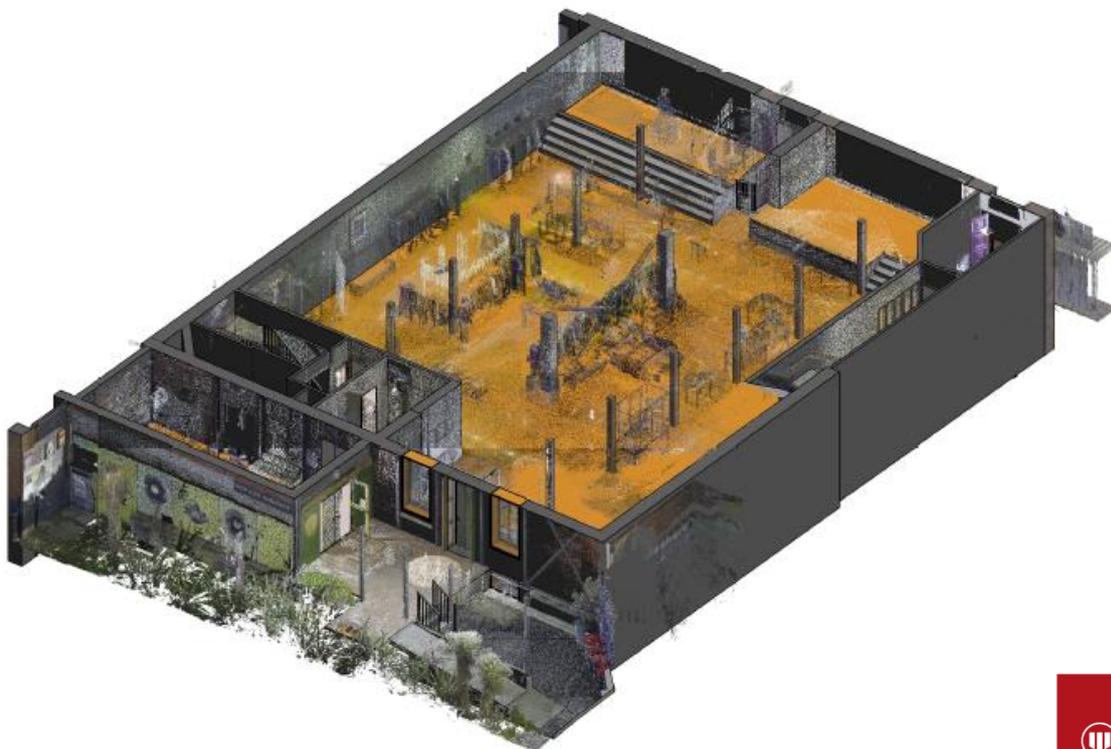
[Figure 12] The 3D model overlaid on the point cloud it was extracted from

- A rendered 3D Model of the building
- Floor plans of the basement and ground floors
- Sections through the basement and ground floors
- A high-quality photorealistic mesh of the outside of the building, which will serve as an accurate record of the original location and state of the building

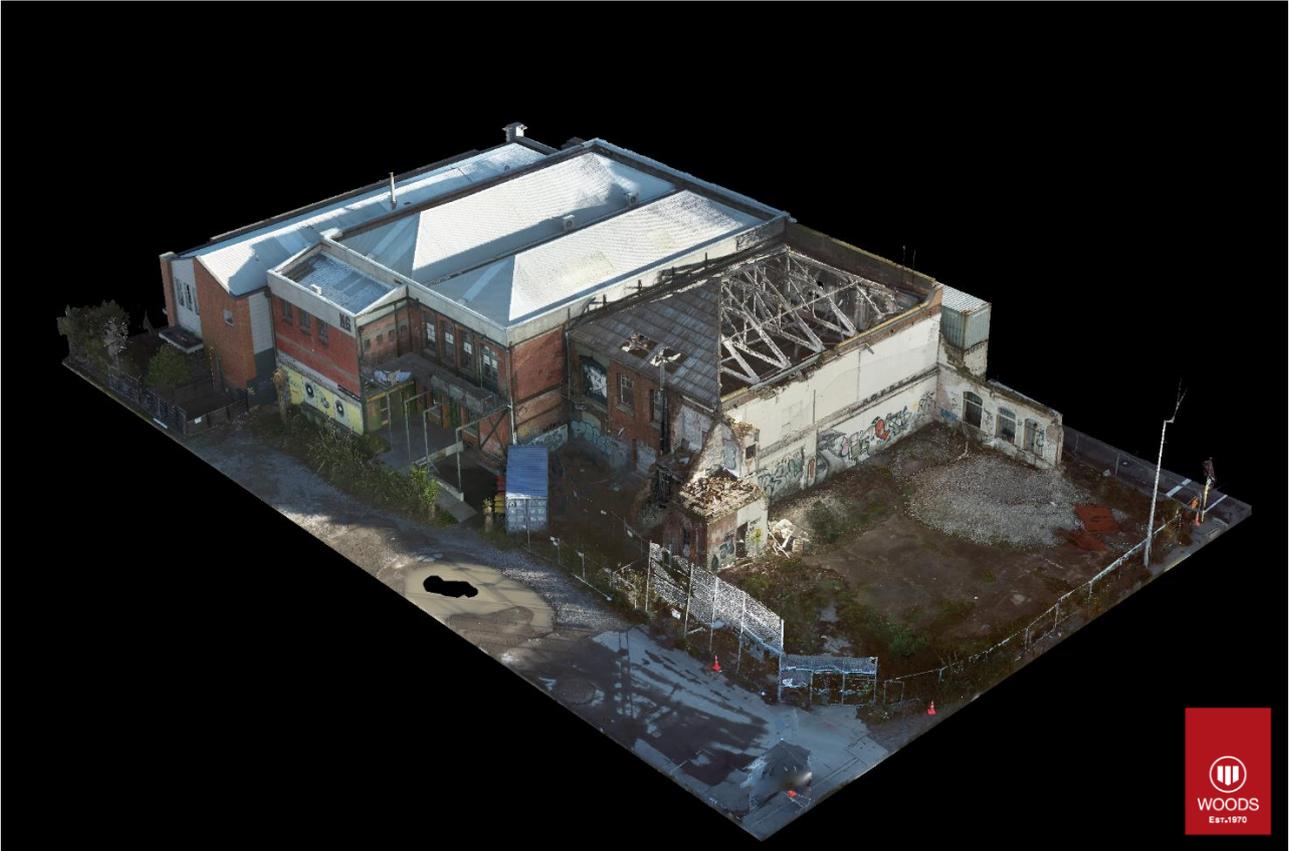
[Figure 15] 3D Reality Mesh of the NG Building in its original location

The full, immersive 3D reality mesh and rendered 3D models will be a valuable record of how this important building once stood in its original location.

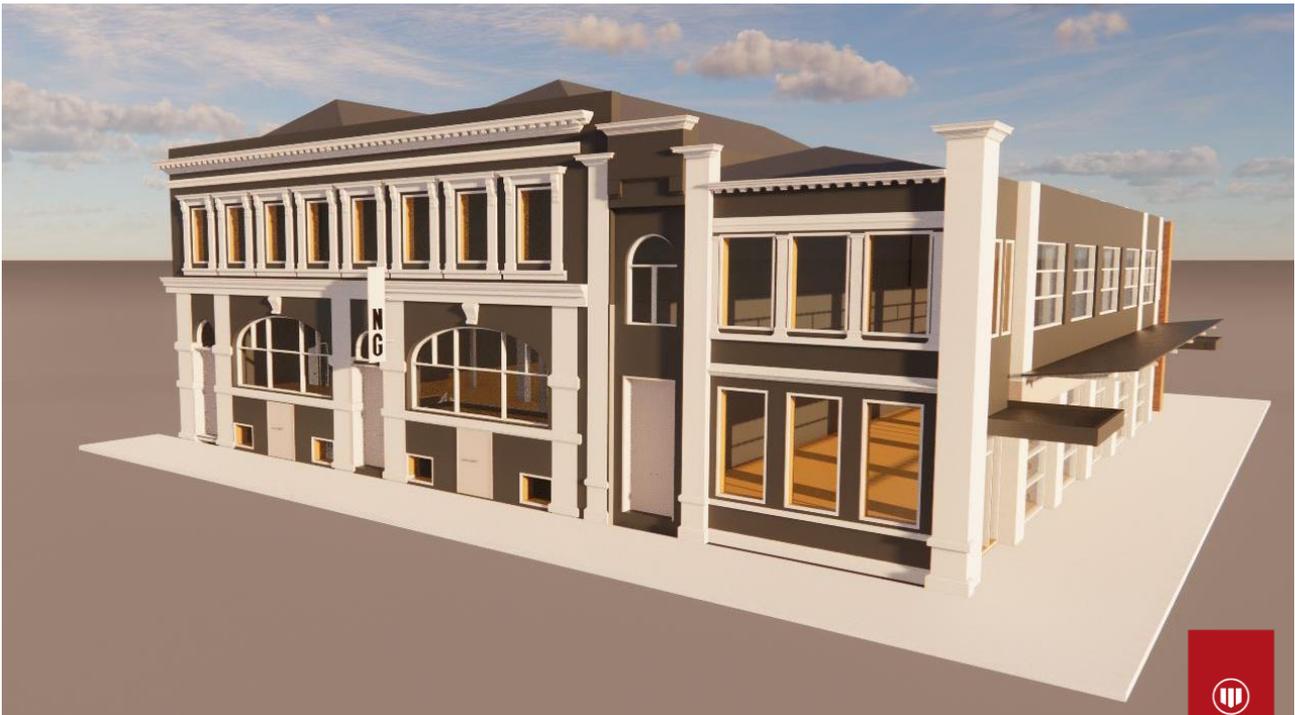
[Figure 14] A rendered 3D Model of the NG Building

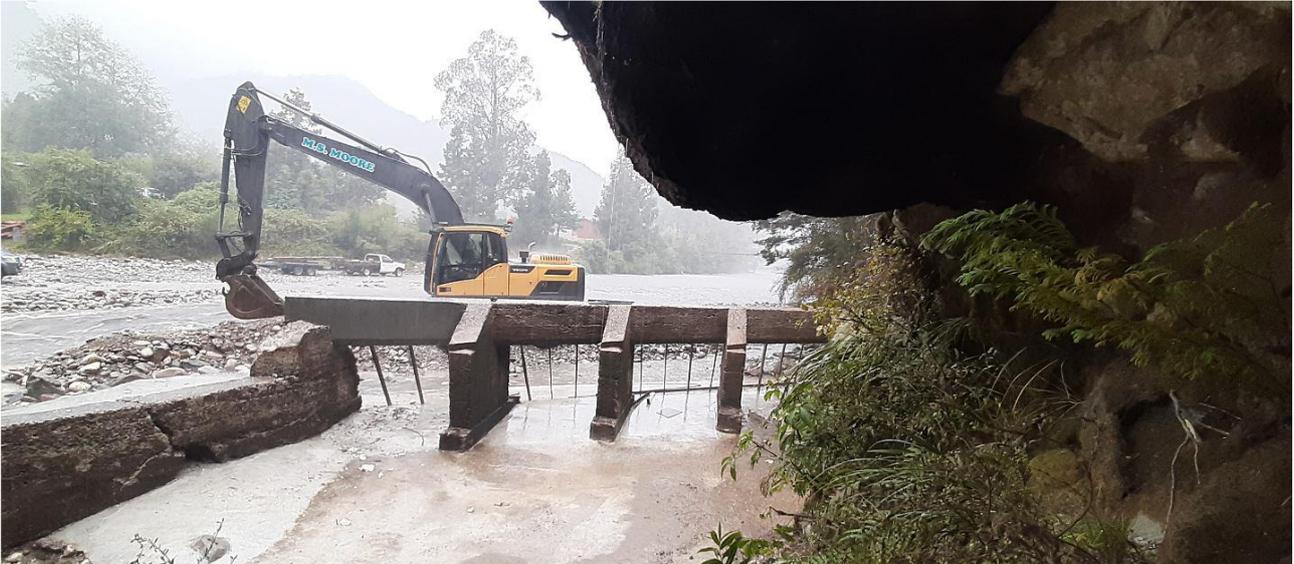
[Figure 7] Intake. Photo supplied by Reefton Powerhouse Charitable Trust Inc.

To date (late 2020) re-instating the headrace from the original river off-take structure, passing through the tunnel and round the foot of the bluff has been completed. This involved extensive rock bunding south of the tunnel replacing the later one-sided concrete wall, which had superseded the original wooden flume.

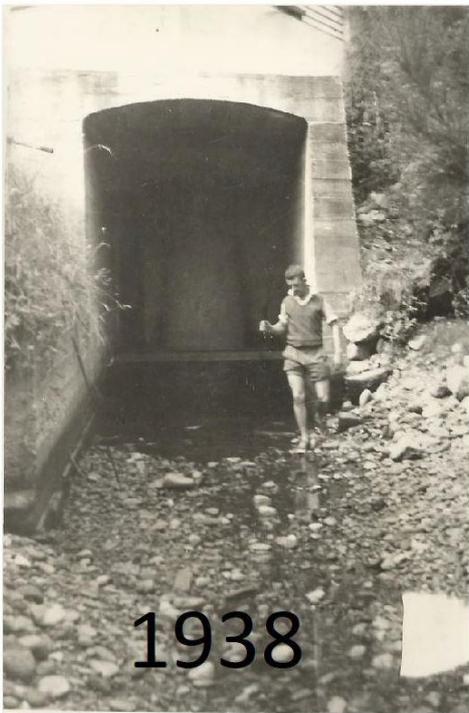
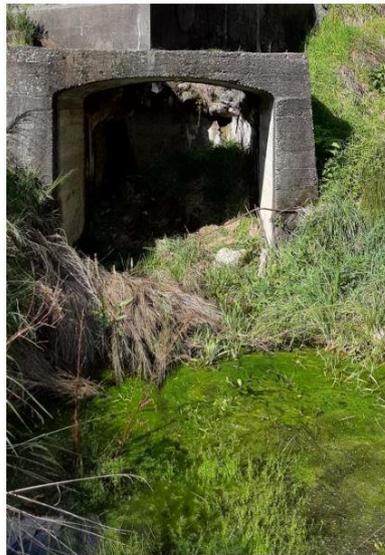
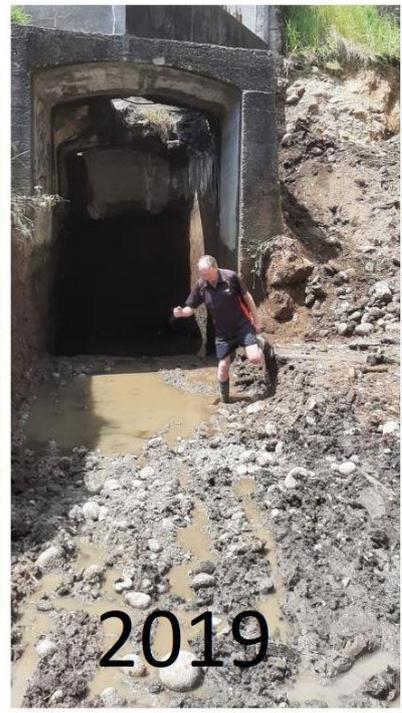
[Figure 8] Tunnel exit. Photo supplied by Reefton Powerhouse Charitable Trust Inc.

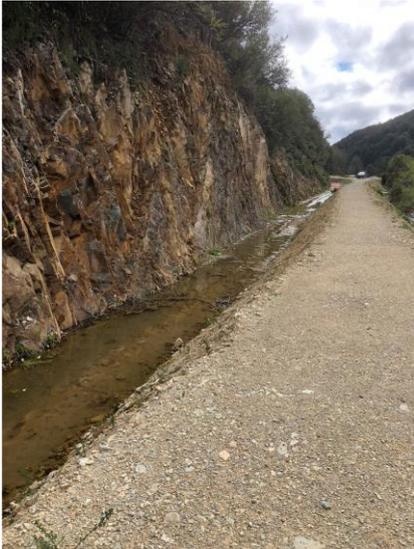
Left: [Figure 9] Headrace. Photo by author.

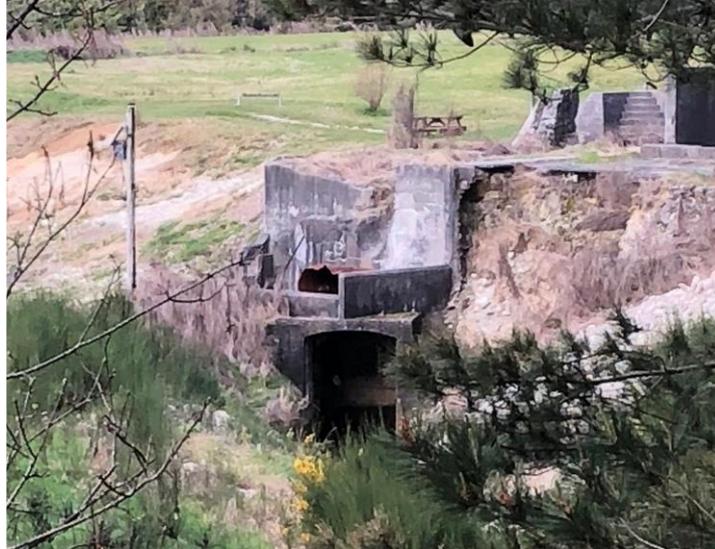
Right: [Figure 10] Old station headworks and foundations. Photo by author.

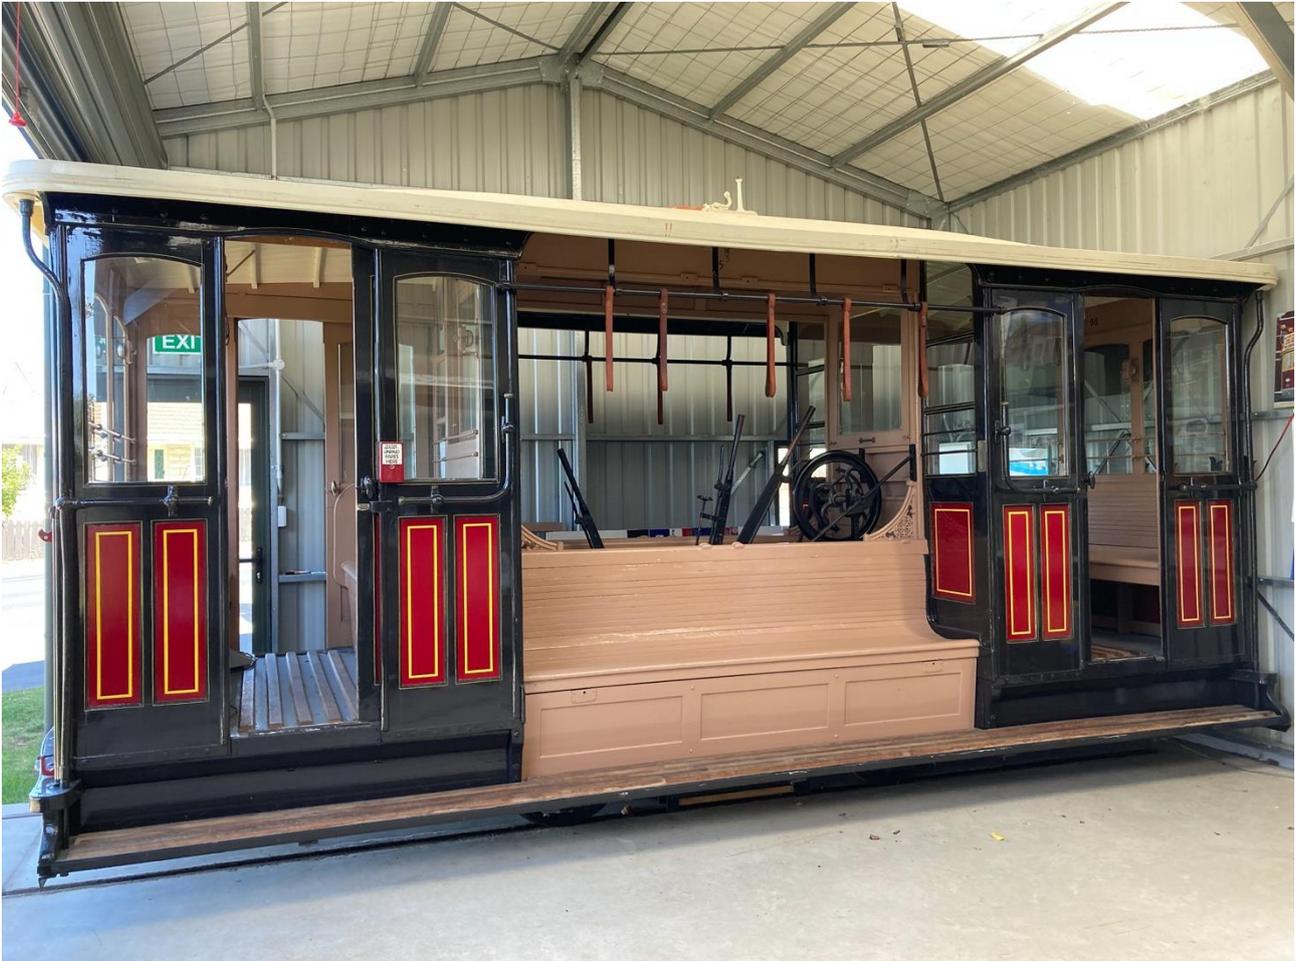
[Figure 6] Restored Roslyn cable car at the Cable Car House, Mornington. Note Fell brake handwheel along with grip lever and regular brake levers. (Photo G M Browne, Sep 2021).

Figure 6 shows a recently restored Roslyn line cable car reminiscent of the original enclosed third car made by Cossens & Black. Note the grip and brake levers and the vertical handwheel for the emergency fell brake that was installed after the 1906 Highgate to Kaikorai Valley Rd extension was opened.

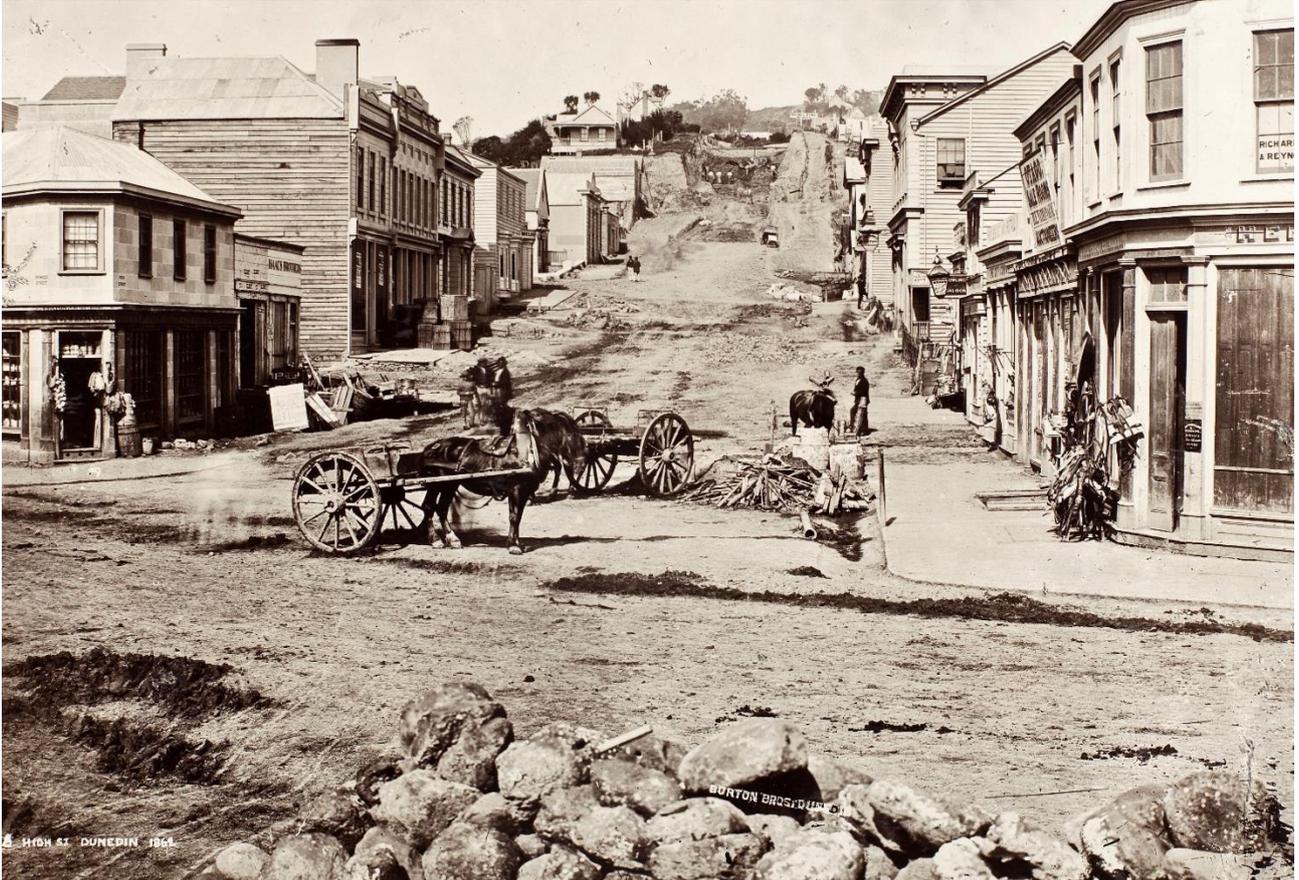
[Figure 7] Looking up High Street from the Exchange (In Princess St.,) and part of the Dunedin CBD. A big manual excavation is underway in the middle distance to form High Street. 20 years later, the Mornington Cable Car bottom terminus was positioned just above the upper pair of wheels. High Street, Dunedin, 1862. From the album: Early Dunedin, Meluish - Burton - Muir & Moodie, 1862, Dunedin, by William Meluish, Muir & Moodie studio. Te Papa (O.030520).

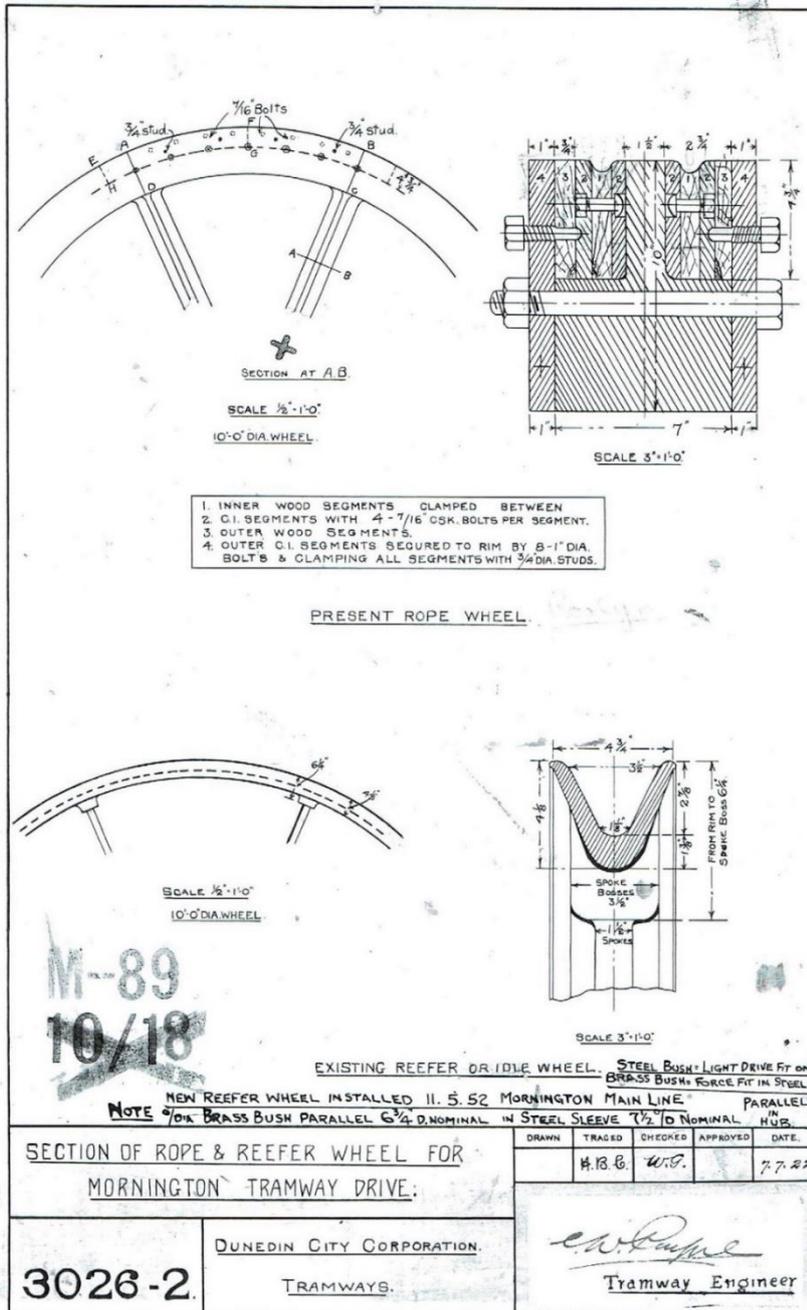
[Figure 11] Timber inserts forming parts of the reefer or idle wheel used in the Mornington winding gear. The wheel of the 1948 news item above? DCC. Archives. Transport Department Series List. M-89. Section of Rope and Reefer Wheel for Mornington Tramway Drive.

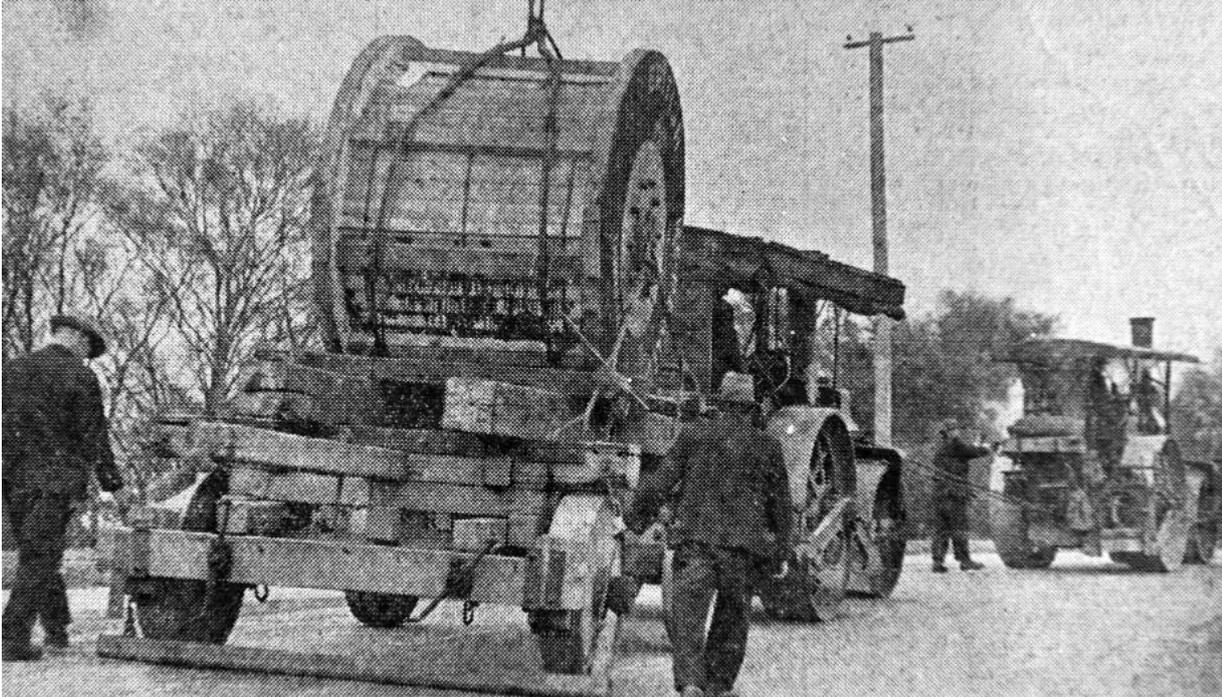
NEW CABLE FOR MORNINGTON SERVICE.—Weighing 12 tons, this cable was drawn up the hill to the power house this morning, two steam-rollers of the Corporation works department being required to haul the load. This picture was taken just after leaving the upper end of Stafford street.

[Figure 12] 1938 Logistics. Evening Star 17 August 1938, p7. 12 tons (12 tonne) of new cable was hauled from the flat area of Dunedin up steep Stafford St to the Mornington Tramsheds for storage and subsequent cable repair or replacement which was done at night in the early decades and later on Sundays to avoid interrupting passenger services.

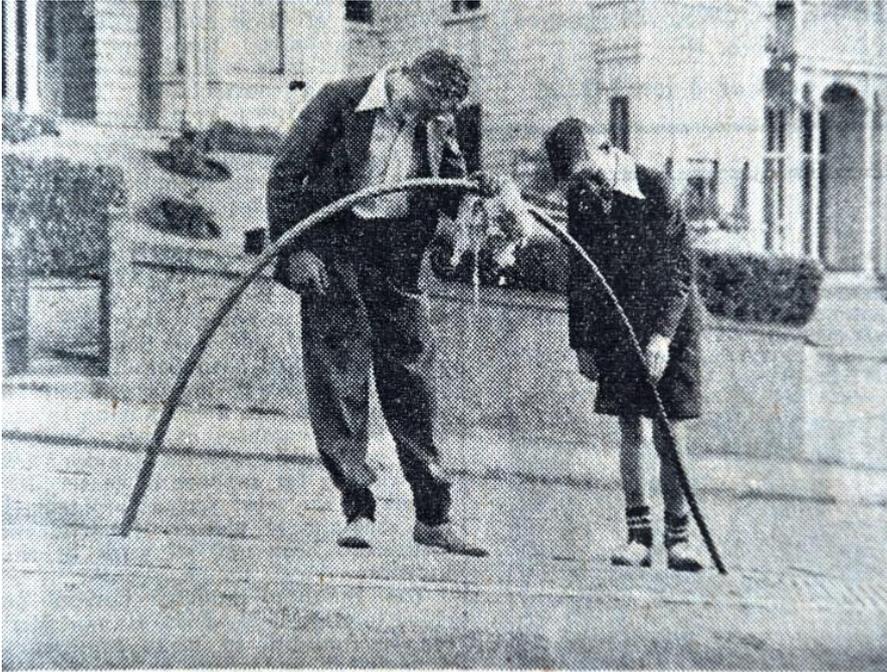
CABLE DAMAGED.—The surge in the cable following this morning's accident to a cable car at the bottom of the High street hill caused the cable to force its way through the centre aperture not far from the Maitland street intersection. The cable was cut and twisted, and will need to be spliced.

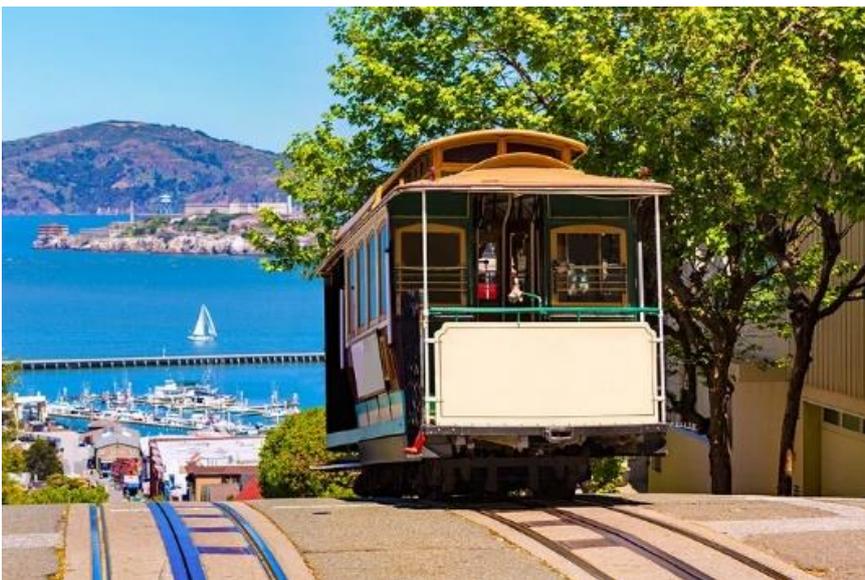
[Figure 14] Hyde Street Cable Car leaving Fisherman's Wharf area, San Francisco.
<https://www.planetware.com/california/san-francisco-itineraries-for-travelers-us-ca-546.htm#:~:text=Hyde%20Street%20Cable%20Car%20leaving%20Fisherman%27s%20Wharf%20Area>
Closely spaced crown pulleys - under the manhole covers.

Pulley spacings must be limited to minimize the cable deflection angles at both horizontal and vertical curves to minimize cable problems. Two modern day references that would presumably achieve this are a limit of 4 degrees from cableway and lift company [Scartezzini C] or 4½ degrees as per a ski association guidelines. [SAANZ 2011.] To achieve this in the proposed re-establishment of the Mornington line it looks to the author's eye as though the radii of existing convex and concave street curves need to be increased. The photo below of a more modern system shows crown pulleys at closer spacings than on the Mornington line.

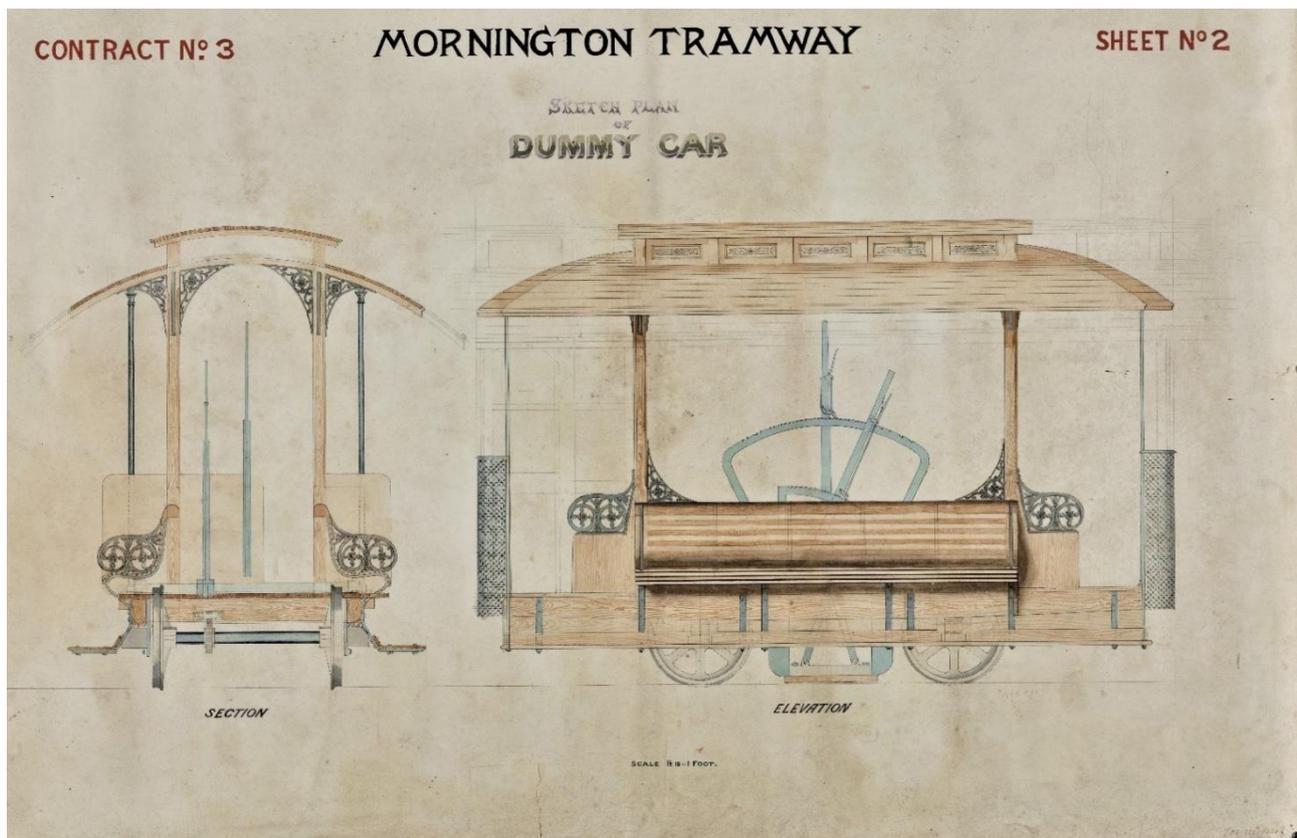
[Figure 15] The drawing for the first Mornington Grip Cars. Drawing: Mornington Tramway, contract no. 3, sheet no. 2. John Reid and Sons Limited records, MS-3801/031/001 Hocken Collections - Uare Taoka o Hākena, University of Otago.

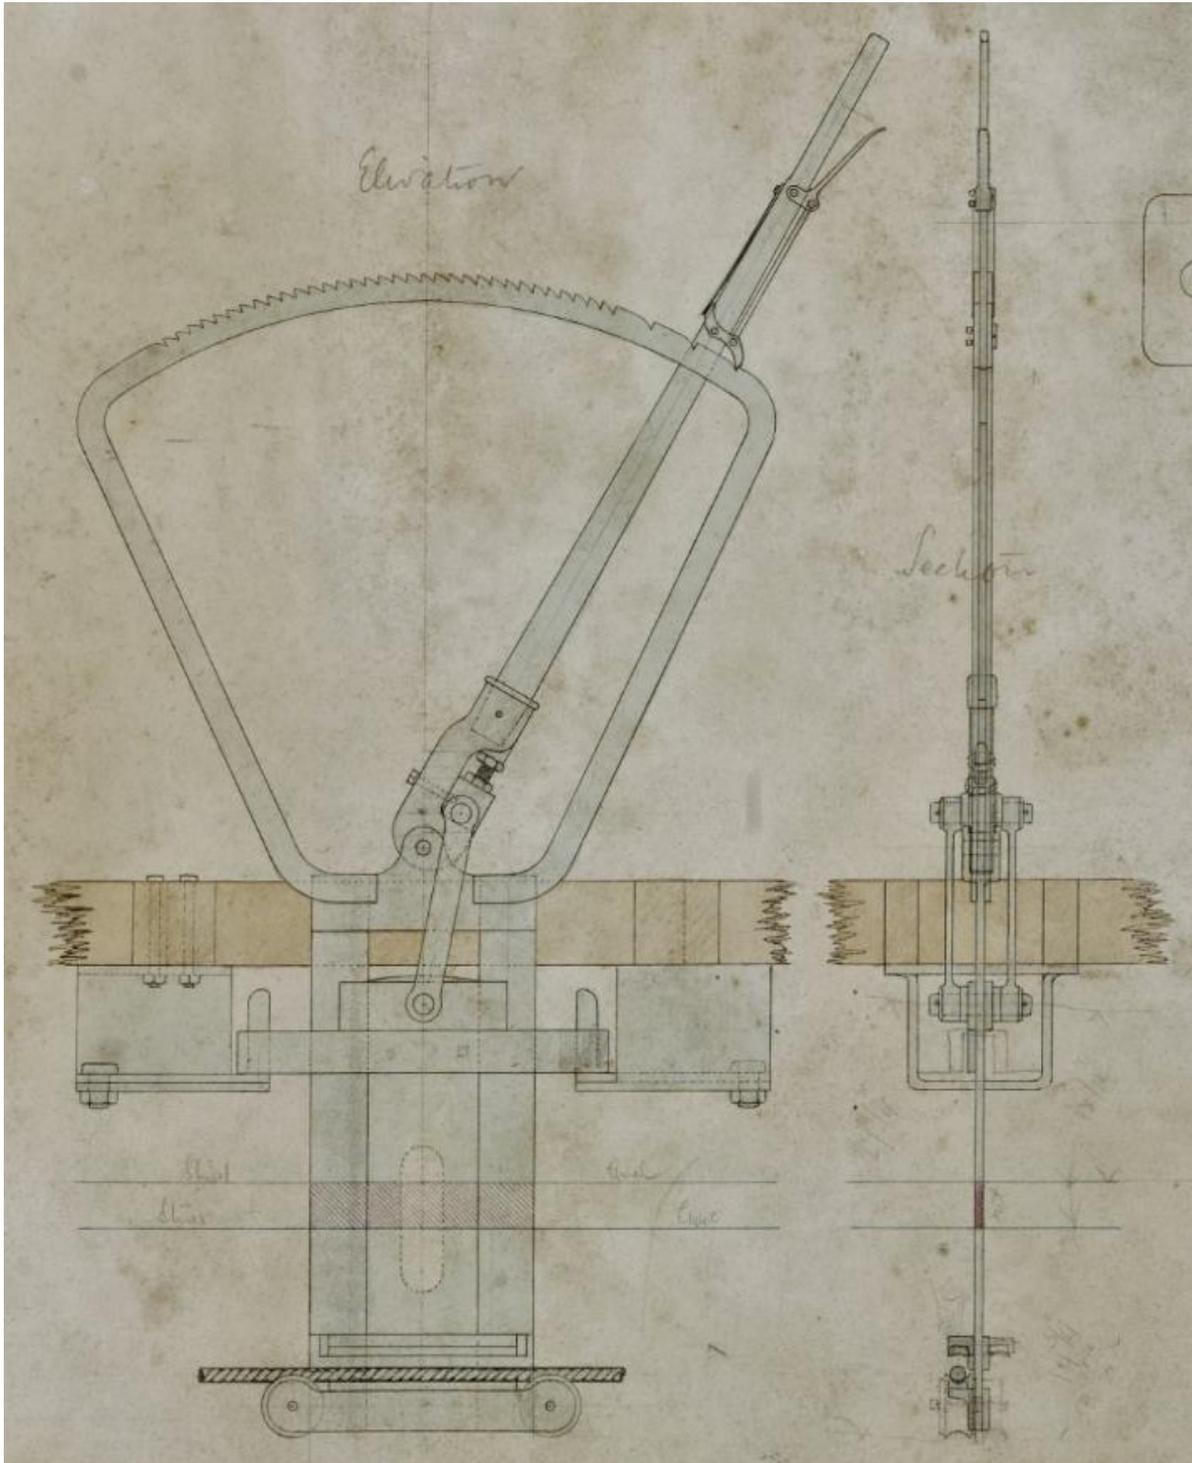
[Figure 16] The Gripper. Part of: Drawing for Mornington Tramway Extension, contract no. 3, sheet no. 4. John Reid and Sons Limited records, MS-3801/031/002 Hocken collections - Uare Taaka o Hākena, University of Otago. [Undated] [Author cropped.]

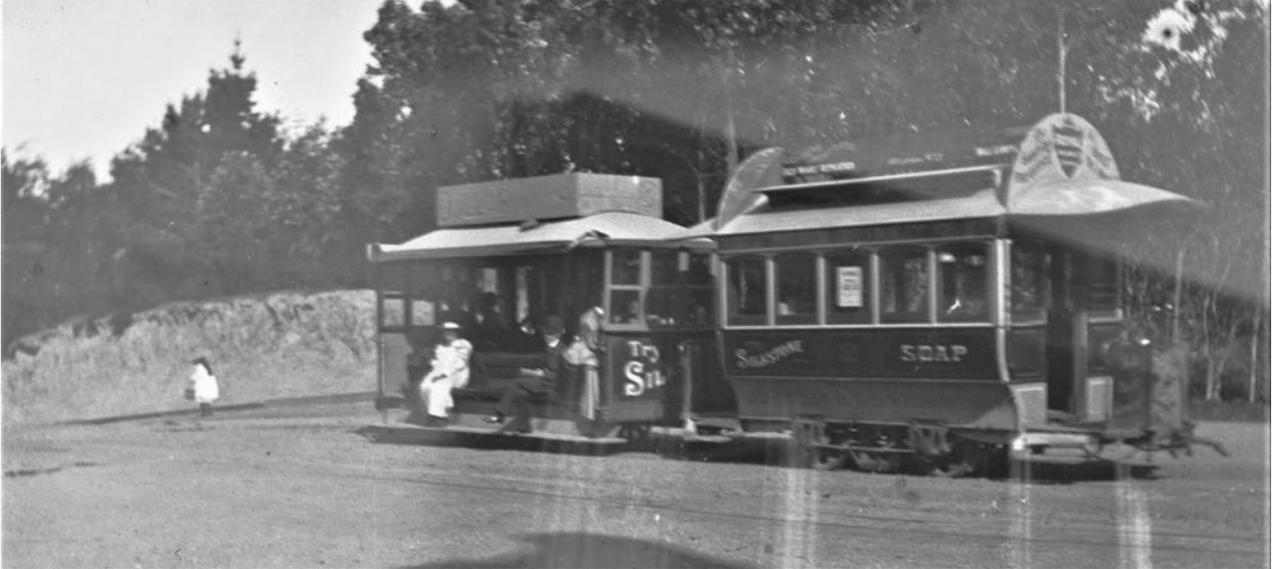
[Figure 17] Grip Car (basically as per Figure 15 drawing), and Trailer. Author Identified as pre ≈ 1900 and at Queen's Drive. Nelson Provincial Museum, Bartel Collection: 324213. [Author cropped].

- Grip car
 - Features identifying the date
 - The short length of the cabins. Lengthened early 1900s [Stewart G.]
 - The rounded ends.
 - No door into the narrow cabin.
 - The small square windows at the ends. (Initially no windows at all, just open ends.) These changed after February 1903.
- Trailer
 - Trailers were connected to cars at peak loading times substantially increasing carrying capacity. Note the distinctive pre 1903 style with the high rounded roof and advertising.
- Right hand running
 - The car and trailer head downhill to the city terminus (trailer at rear), but are on the wrong side of High Street because this was in the days of right hand running. The uphill line can just be seen in the foreground.

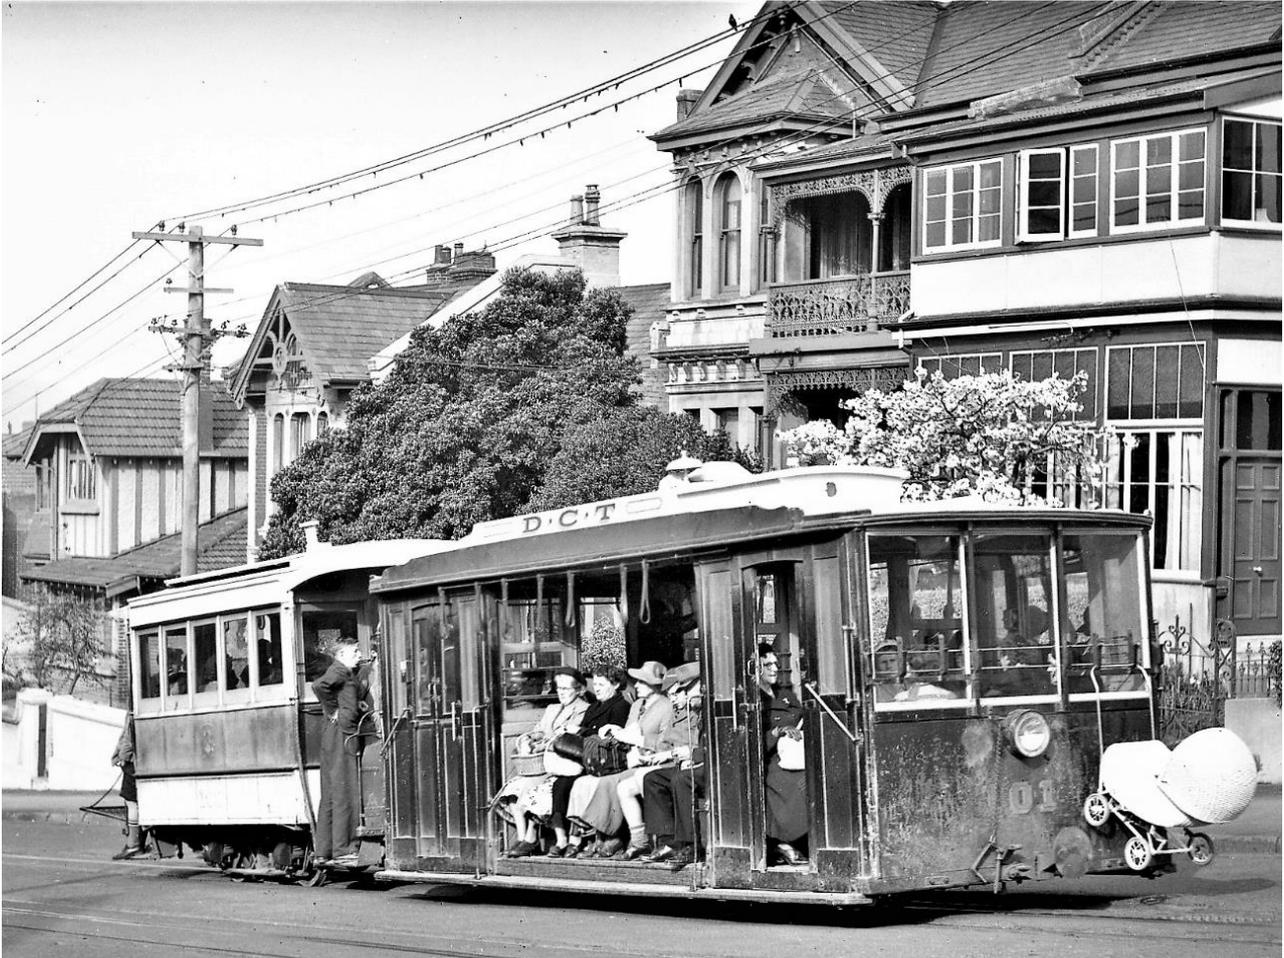
[Figure 18] Grip car 101 and trailer ascending High Street. Photo: G Stewart, July 1956.

- Car 101 was the standard type used after February 1903 (apart from temporary cars) until close down. A big improvement on the original ones, being now enclosed, with double the amount of seating, and wide sliding doors.

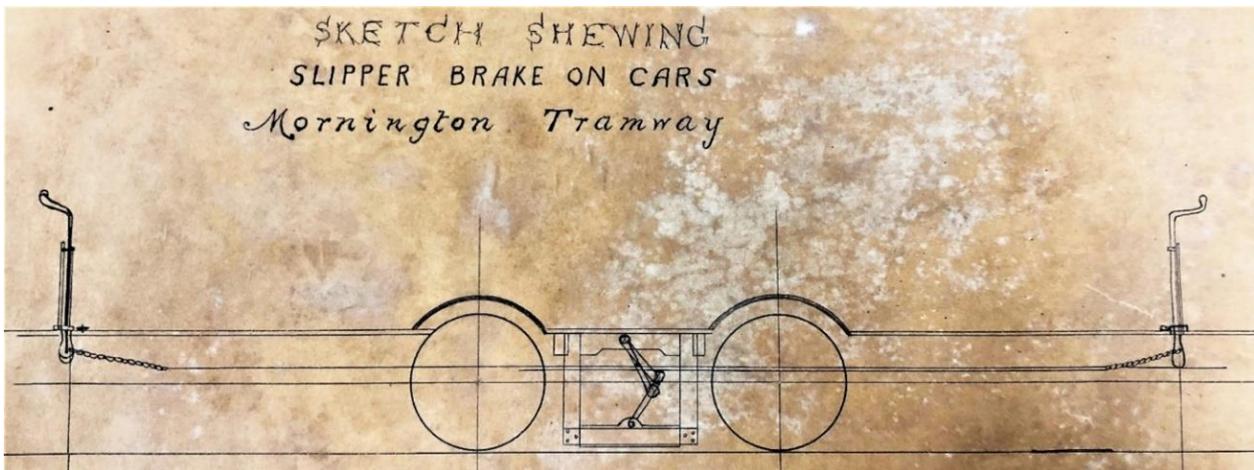
[Figure 19] The Basics of the slipper brake as used on trailers. 'Sketch shewing slipper brake on cars'. John Reid and Sons Limited records, MS-3801/036/003 Hocken Collections - Uare Taoka o Hākena, University of Otago.

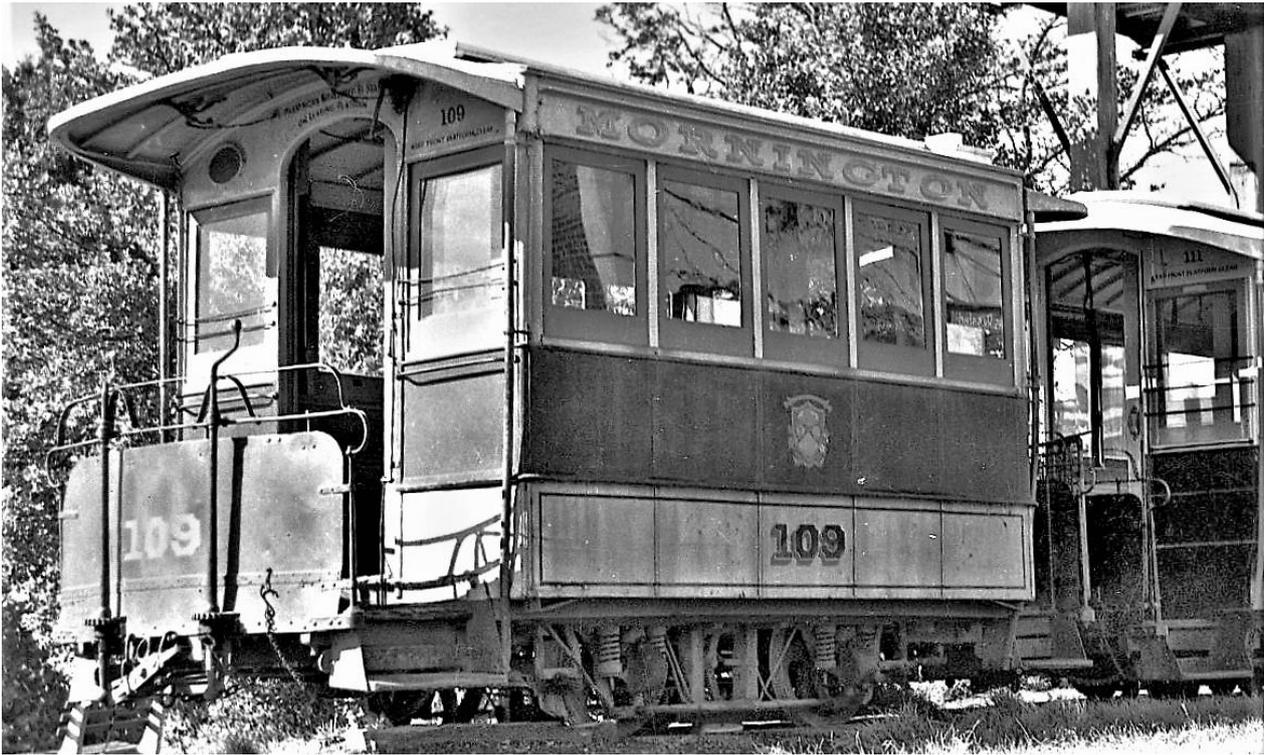
[Figure 20] The uphill end of trailer 109 shown sitting on the ‘trailer siding’ which was at right angles to the Mornington terminus. Photo: G Stewart, October 1951. [Author cropped]

- The slipper brake parts can be seen in 109 just as in the 1880s drawing. No real change in 70 years.
- Just below the trailer platform in the centre is a rectangular steel box. The conductor swung it out and connected it to the back of a cable car for uphill travel.

In Figure 20, wheel brake shoes are just discernible on the outer sides of the two wheels, and are shown schematically in Figure 21 below. Later grip cars had brake shoes on both sides of a wheel but the trailers only on the outer sides.

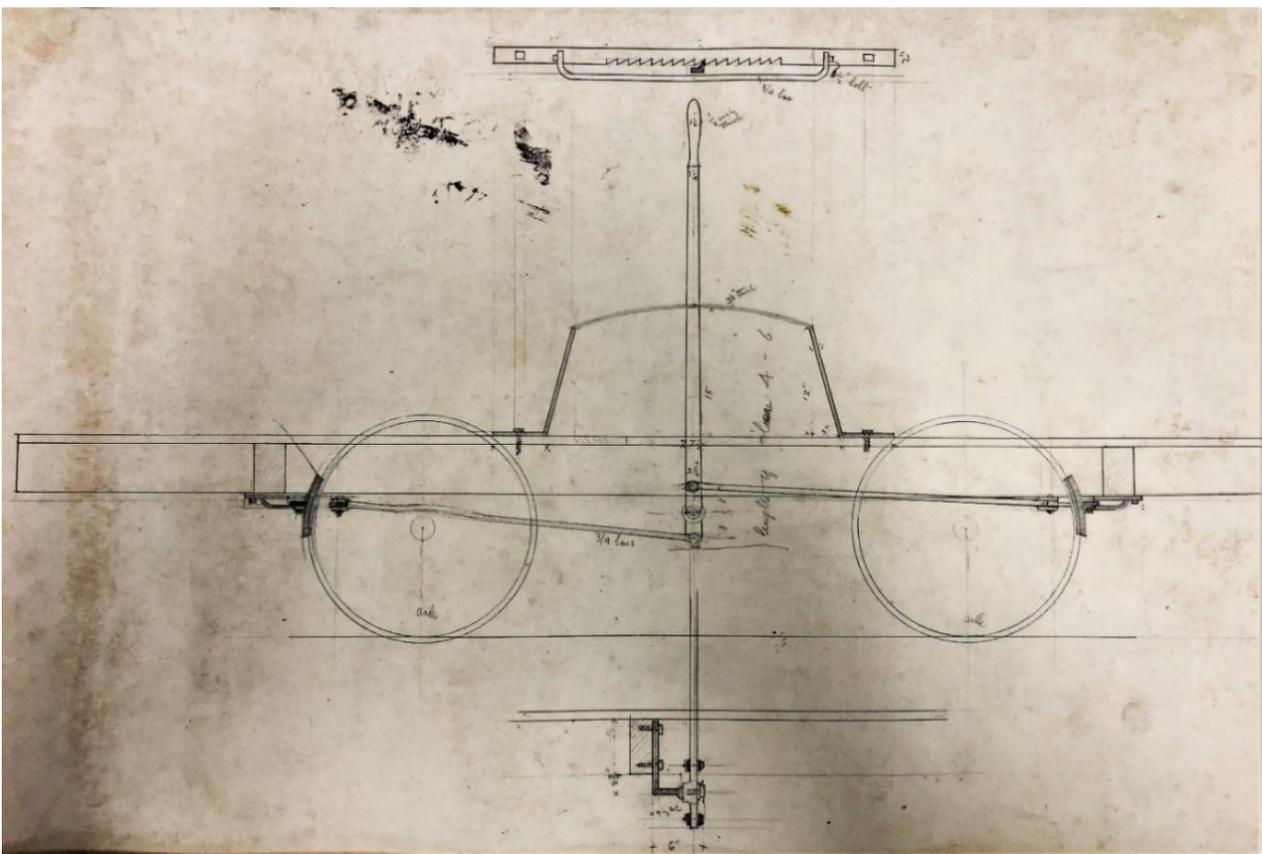
[Figure 21] A Sketch of early wheel brakes with a simple quadrant. Untitled undated drawing signed by Duncan. MS-3986-009 Hocken Collections - Uare Taoka o Hākena, University of Otago.

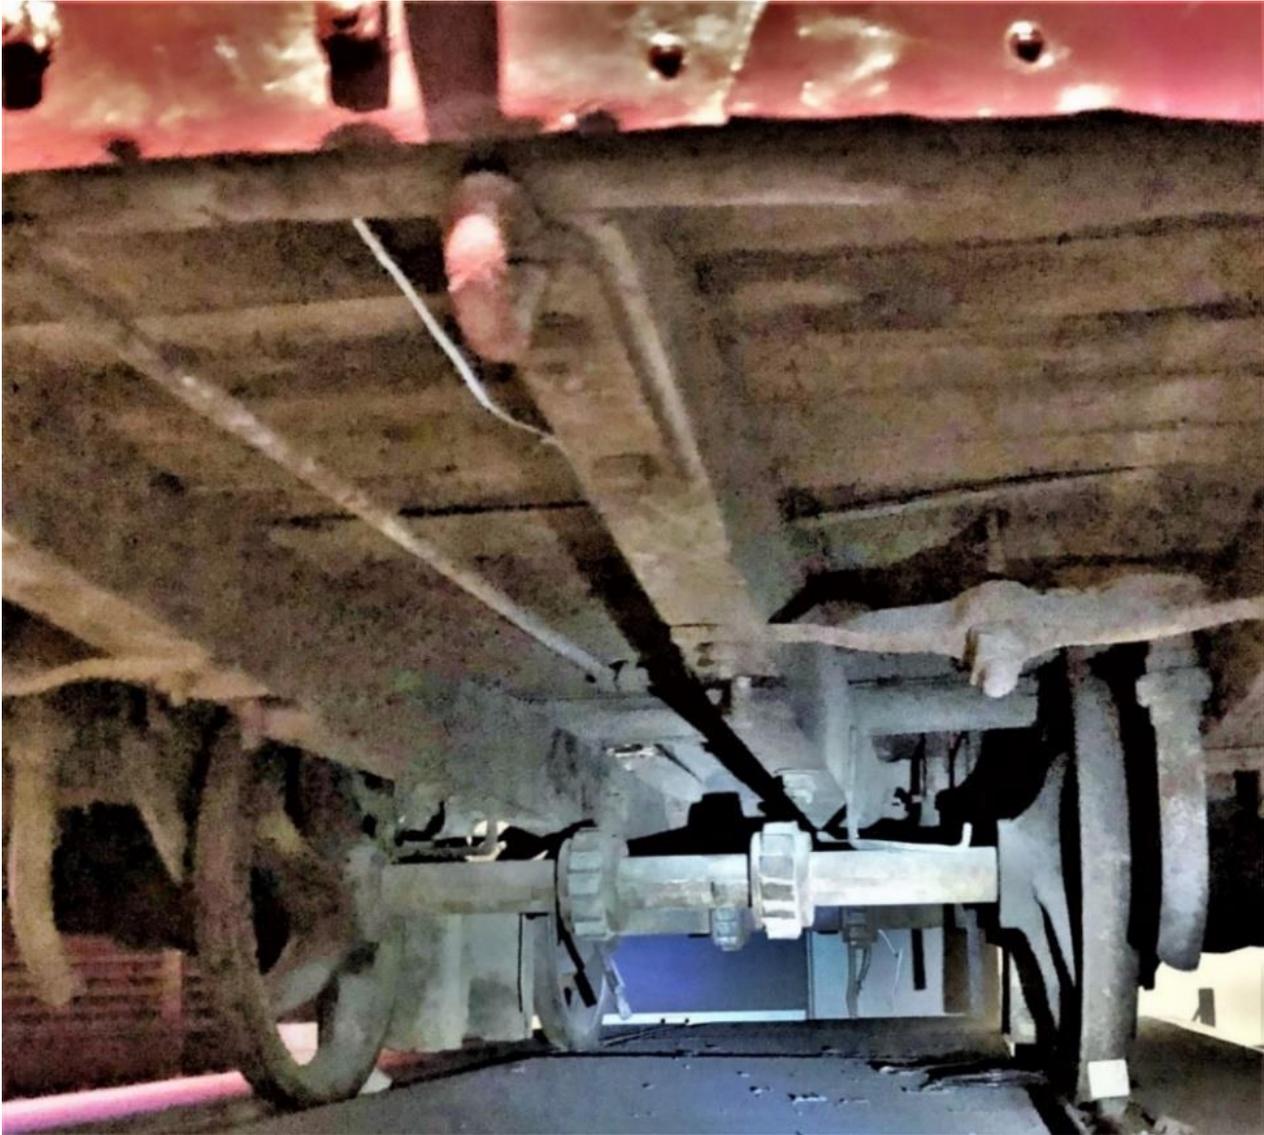
[Figure 22] Underneath the Maryhill Car 106, Built 1906. [Photo: On location at toitū Otago Settlers Museum. MacGregor I. D., Jun 2020.]
