AUSTRALASIAN ENGINEERING HERITAGE CONFERENCE PAPERS 2022

THE TALE OF TWO BRIDGES: HOW UNDERSTANDING HERITAGE SIGNIFICANCE CAN GUIDE THE TREATMENT OF OUR COUNTRY'S UNIQUE STRUCTURES

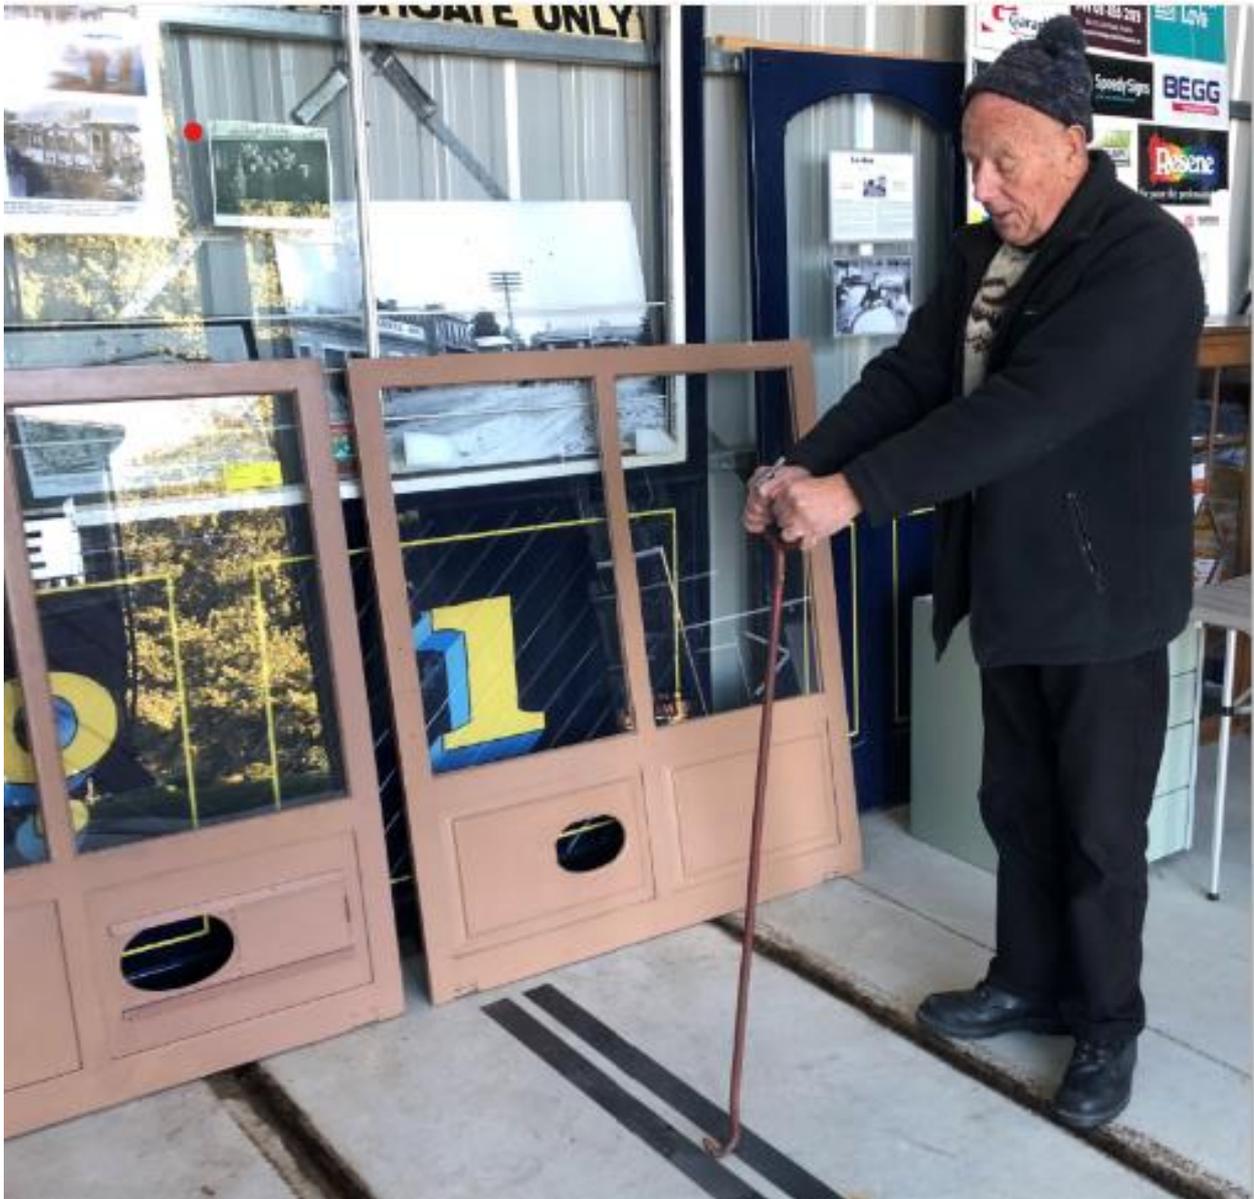
[Figure 24] Neville Jemmett (Chairman: Dunedin Heritage Light Rail Trust) holds a Cable Hook, inside the Trust's Cable Car House at Mornington. Photo: ID MacGregor, June 2020.

- Before departing some termini, the hook had to be inserted down through the slot and the cable pulled up into the gripper. Short hard work.
- The 2 wind shields (beige colour) were fitted to one side of the grip man's well to stop wind and rain going through. Not introduced until June 1913 they were "much appreciated by the drivers". [DCC Archives (e)]
- At the bottom, oval openings enabled the grip man to collect fares from outside passengers if no conductor.

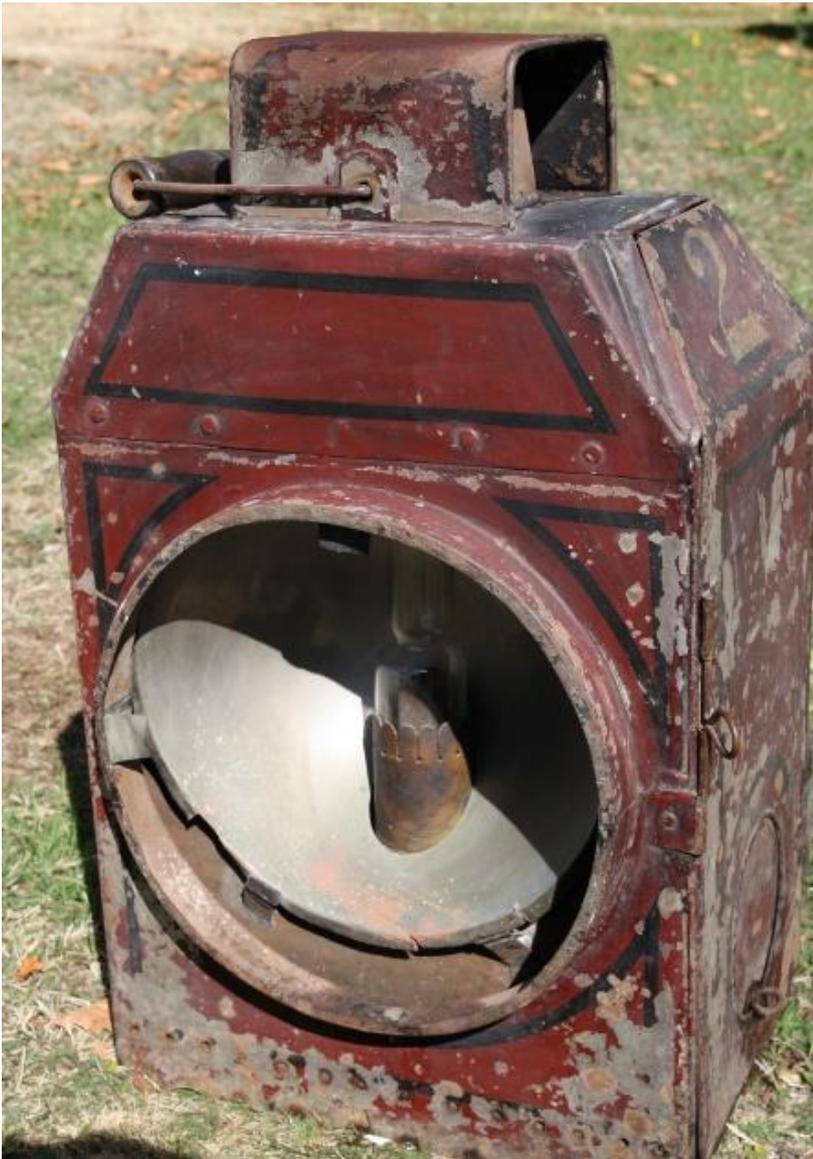
[Figure 25] A Kerosene Headlight from the exterior of a Roslyn Car. Photo: ID MacGregor, April 2020. Courtesy D McAra, Ferrymead.

- A second kerosene lamp hung in the grip man's well with some light going through to the passenger cabins and fumes escaping through the roof vent one of which is seen in the foreground of Figure 23. No vent can be seen in Figure 15 nor in a photo taken just after the Roslyn line opened [Stewart G p144] and the author believes the vents were added shortly after the first cars were built. Vents are seen in numerous photos where they remained as a form of decoration until the system closed. [McAra D, 2021]
- The 1921-22 Annual report [DCC Archives (f)] recorded that the kerosene lamps were replaced by 6-volt lighting from an Edison battery recharged daily, that the electric lighting was a decided improvement, and they were looking at improving the headlights. A battery is in the restored Roslyn car in Cable Car House, Mornington.

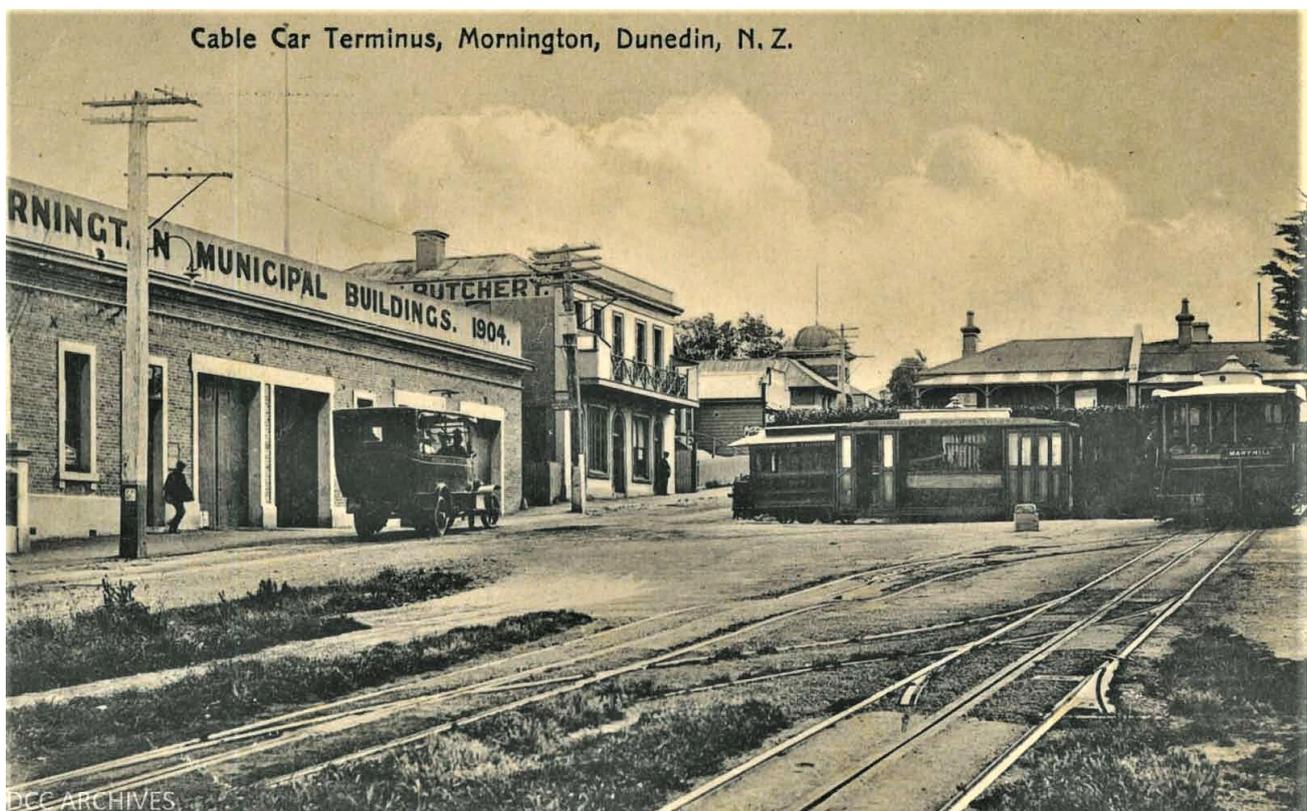
[Figure 26] The Mornington Terminus looking up Eglinton Road and into Mailer Street during the brief period the Char-a-banc ran - Nov 1912 > mid 1914. The system was still right hand running and so downhill is the left line. DCC. Archives. 15015486069. Flickr.

- The char-a-banc (bus) replaced the short-lived Elgin Rd cable car line but was not a success, breaking down shortly after inauguration and then getting worse. It also ran along Glenpark Av in lieu of some Maryhill cable car services and damaged the track. [Campbell and Hargreaves p34-39.]
- On the left, behind the big closed double doors was the cable storage into which the drum of cable in Figure 13 had to be reversed by one of the towing steam rollers.
- In the centre a trailer can be seen behind a cable car, and is being temporarily held on a length of old Elgin Road line until retrieved for a lunch time or evening peak load. The car itself is stored on the line running from the turntable (behind the right most car) through the open doors and into the tram shed.

The new method had the car stopping short of the turntable, running back down under gravity through new points and a short length of new track onto the downhill line. Much labour and time saved. The new operation was called the 'loop line' in the MTC's Annual Report [ES 18 Jul 1890 p4], and elsewhere (confusingly) 'the shunt'. (Ref Figure 26 below).

In 1888 Tramway Engineer Lowden constructed a dip (seen below, Figure 26) near the top of the down line allowing the cable to be automatically fed into the gripper. [Details, Stewart G. p202] Previously it had had to be hooked up into the gripper manually. Another labour and time saving technique. And Dunedin producing another world first?

- Between the two cars and on the downhill line are two white zones which are sections of the tunnel rebuilt in the late 1940s or early 50s in (heavily?) reinforced concrete to form a turning circle for Elgin Rd and Belleknowes buses and to the best of the author's knowledge totally survived the heavy bus loadings. The turning circle allowed the buses to turn round, go back up the street and pick up passengers on the far side of the street outside the tramsheds just out of view on the right. Previously the buses reversed from where the passengers are standing back around the end of the terminus to park behind the cable cars in Figure 26 and then pick up passengers, a process considered somewhat dangerous.

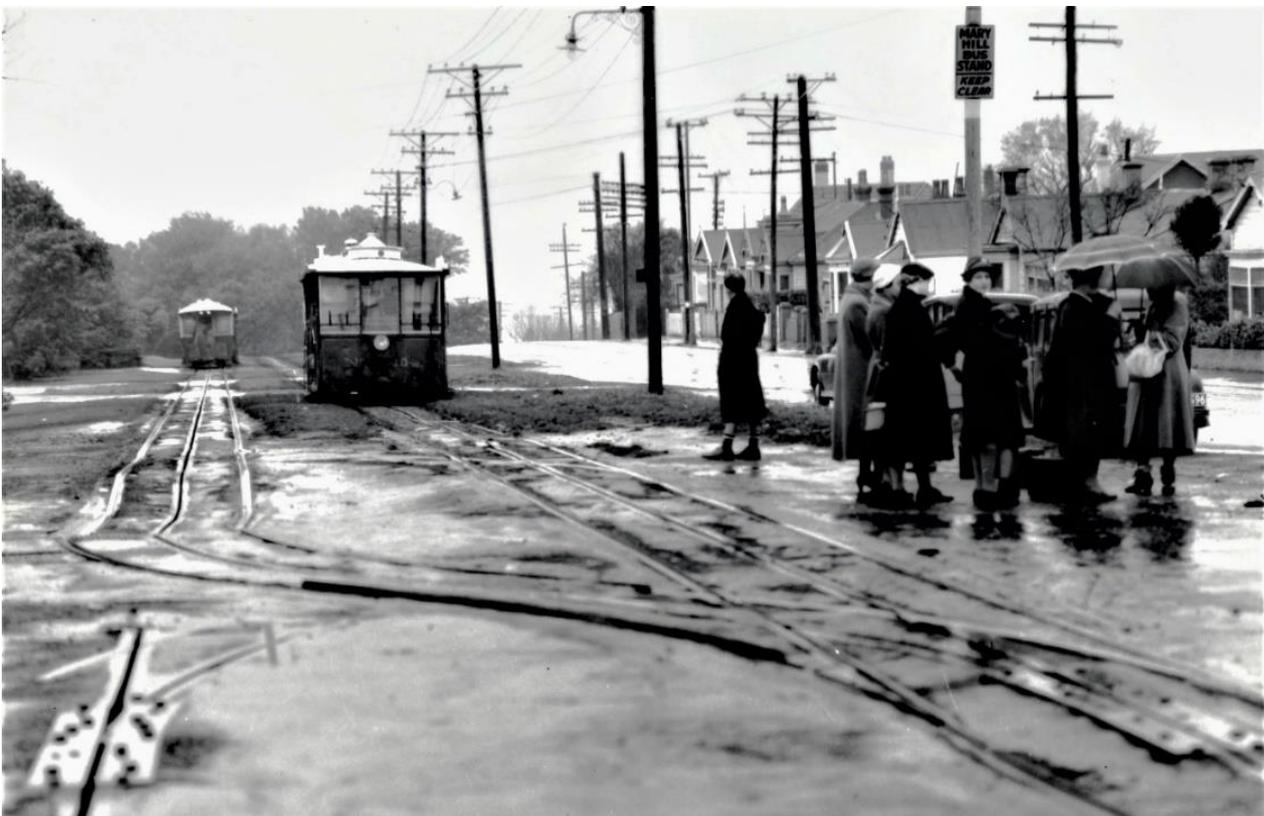
[Figure 27] Mornington Terminus looking down Eglington Rd. A Car and Trailer Ascending at the Right. Descending Trailer (and car) at Left, both on Reserve Land and not a Street. G Stewart, October 1951.

- Front left corner, track remains from right hand running:
 - Between the steel plates and sliding underneath, a ‘kicker’ spans the slot.
 - When the grip car came uphill its centre gripper plate moved the kicker right. Once past, a spring pushed the kicker back left. Then on the journey back the kicker ensured that centre gripper plate curved right into the slot of the downhill line.
 - In some places a kicker’s function was to prevent the cable coming out of the slot if there was a malfunction.

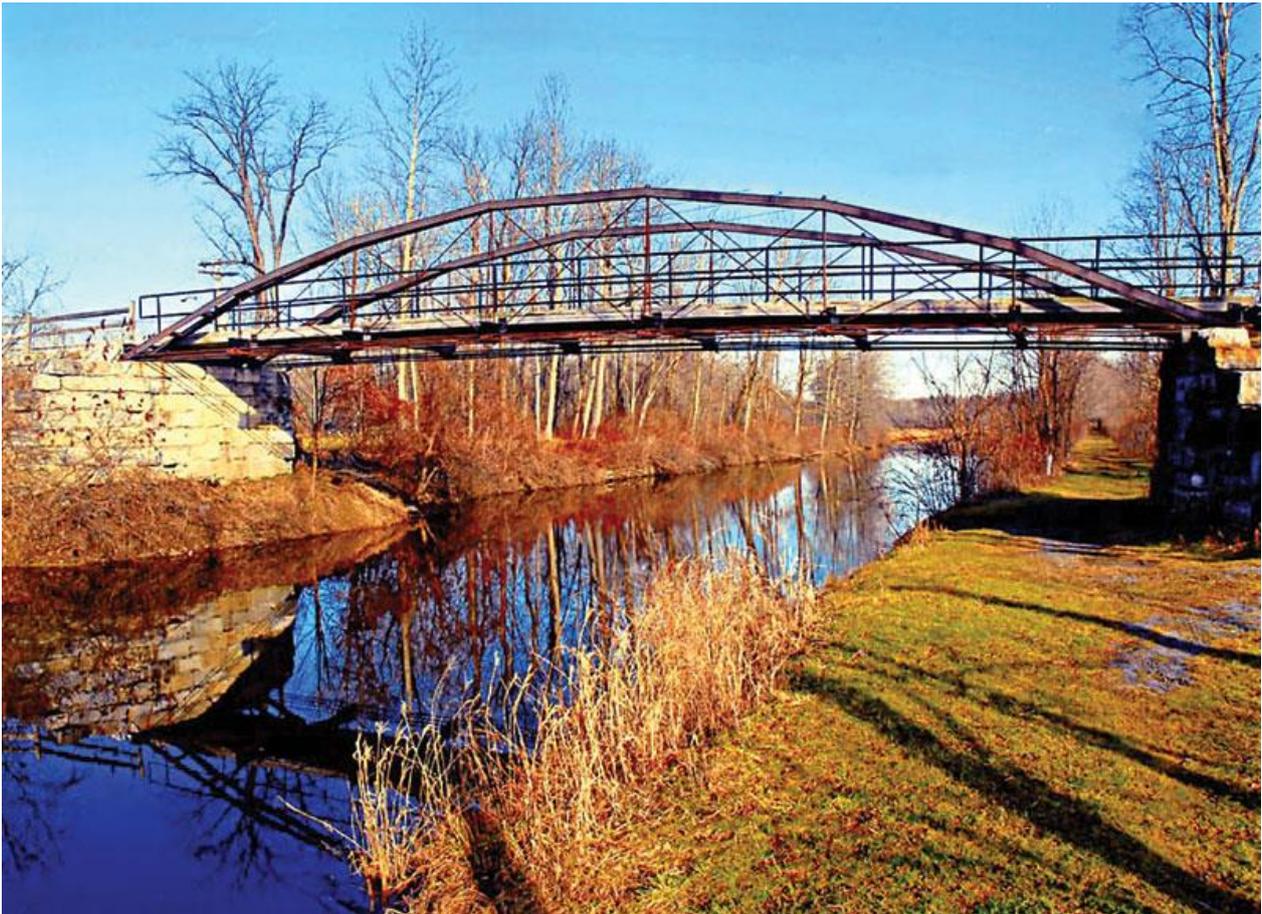
[Figure 1] Vischers Ferry Bridge across the enlarged Erie Canal (relocated from 2 earlier sites. [13])

The bowstring truss design was invented by Squire Whipple and awarded US patent No 2064 on April 2nd 1841 [13] It was the first-ever all metal truss design, using a combination of cast and wrought iron and at the time used for bridges over shipping canals. Nowadays, the design is more usually restricted to large span roof trusses.

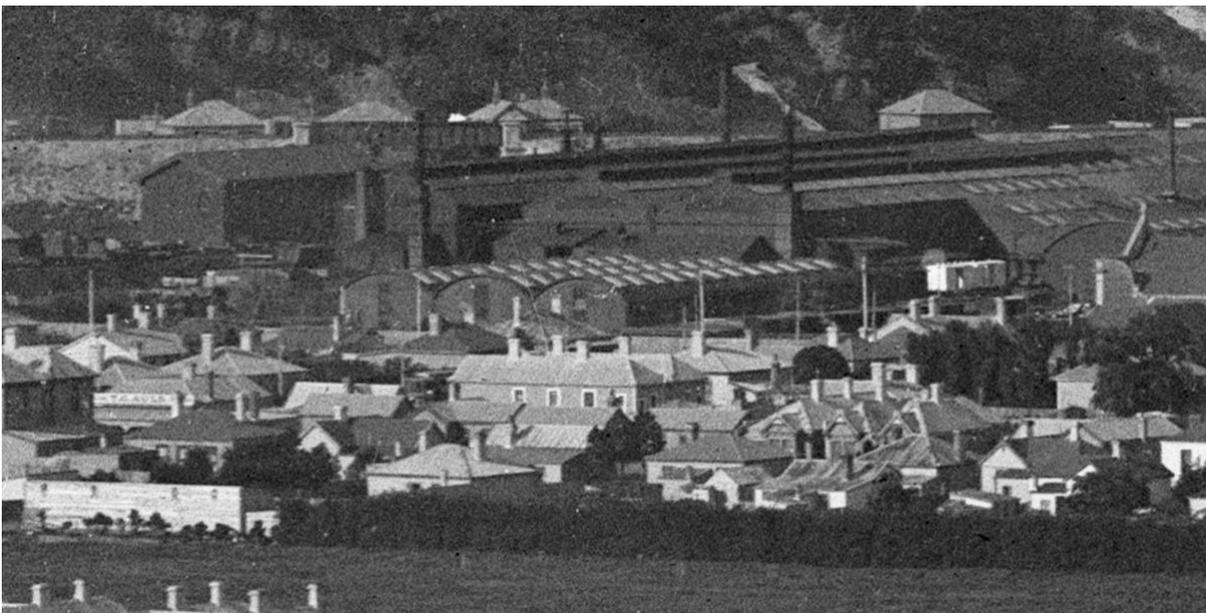
[Figure 3] A view of Hillside Workshops from the south east c. 1910, with the Carriage Painting Shop recognisable by its 3 curved roof sections. The original Machine Shop is immediately behind it and you can just see the curved roof of one part of the larger Carriage Repair shop to the right. The mainline is in the background, now on a high embankment. This is a small section enlarged out of the photo entitled "The Flat, Dunedin" made available by Te Papa [18]

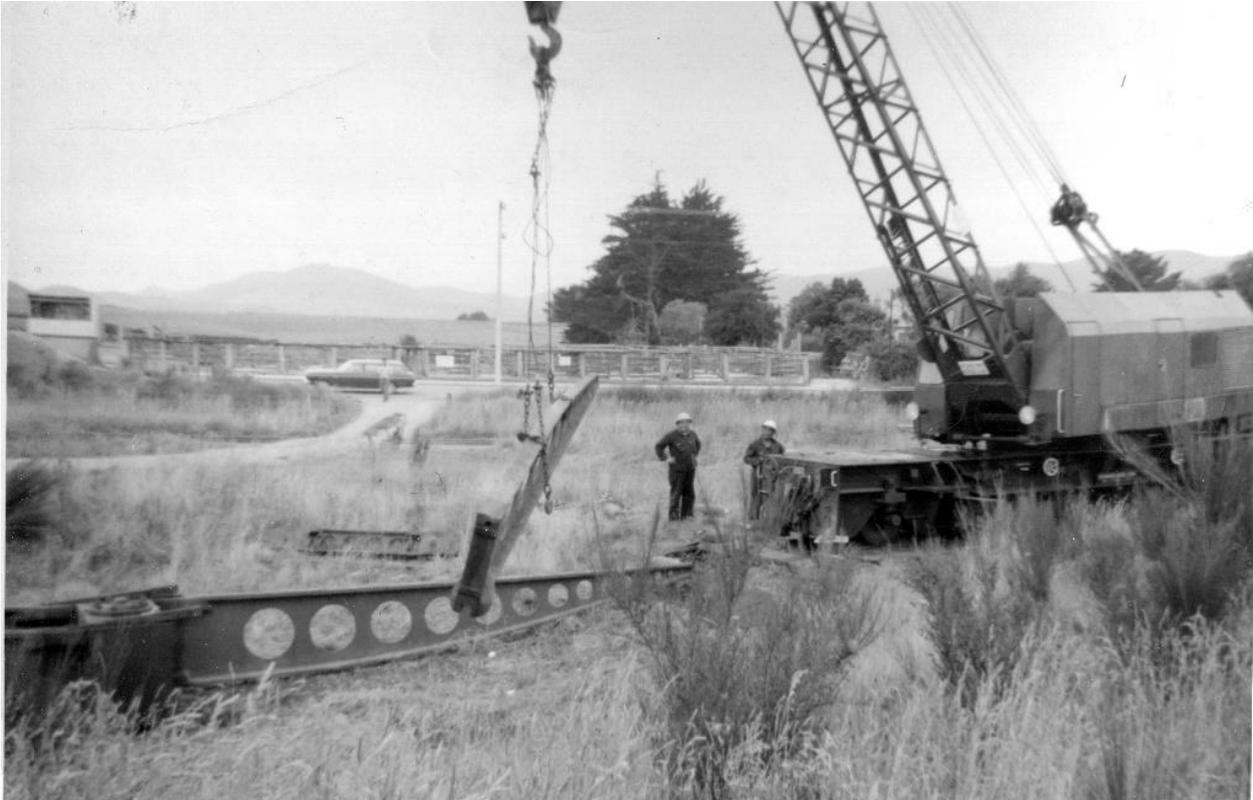
[Figure 8] Dismantling a turntable. A comparatively modern photo, thought to have been taken at Tuatapere in 1977 with the turntable destined for Clyde. While this is a larger 55ft table manufactured in New Zealand, it retained the modular construction exactly as designed by William Sellers. From the author's own collection.

The other important design feature of the turntables was that they could be easily dismantled for relocation at a new site, a feature that was very attractive to railways in times of expanding networks. A detailed analysis of New Zealand's turntables shows that most tables were relocated at least once over their life-span and some of them quite a number of times [41].

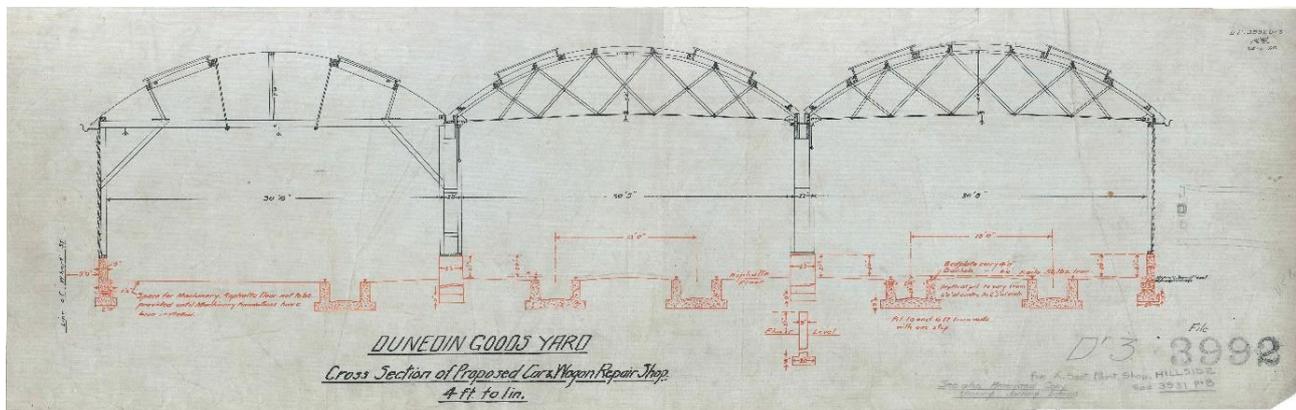
[Figure 9] NZR Drawing Dun3992 dated 24/02/1926 showing a cross-section through the building as it was to be built in Dunedin Yard. I have not been able to locate the drawing that shows the cross-section of when it was still a carriage Painting shop at Hillside.

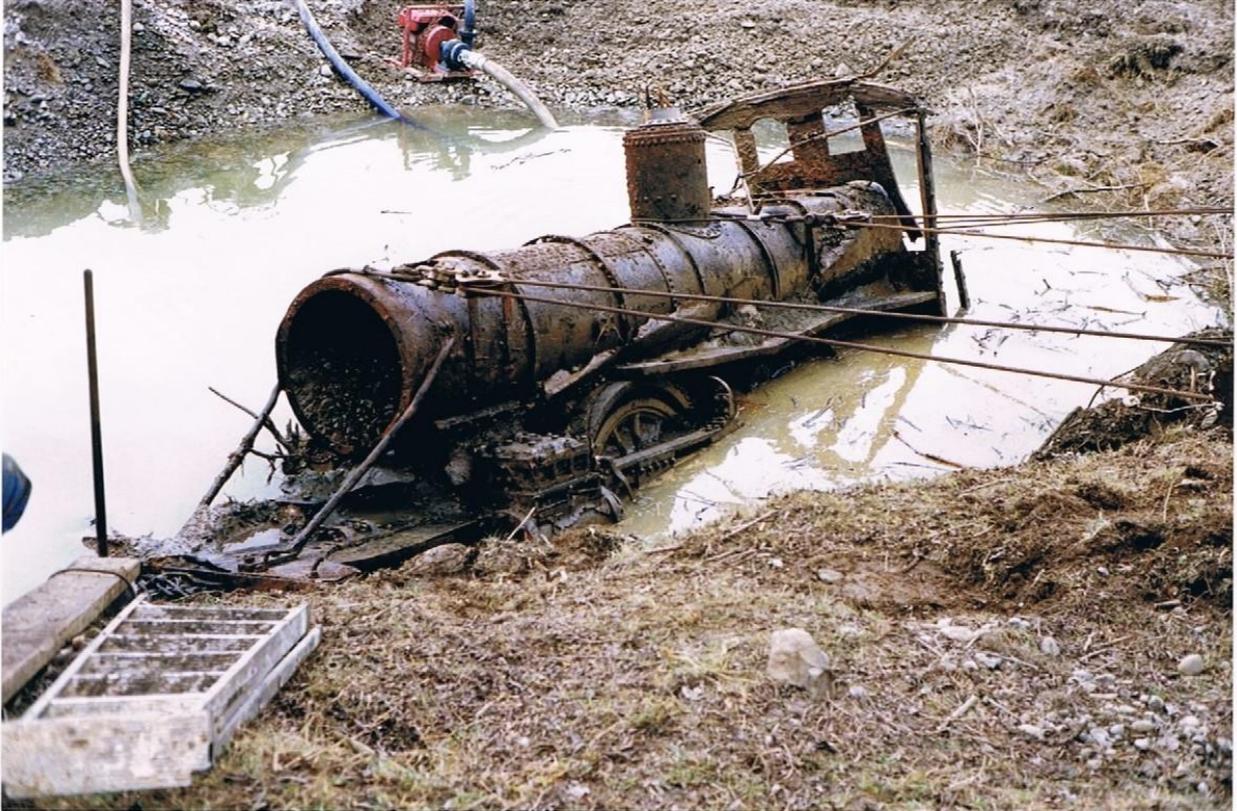
[Figure 11] Locomotive K92 in the process of being recovered from the Oreti River bank at Mararoa in 1985. Photo from the Waimea Plains Railway Trust archive.

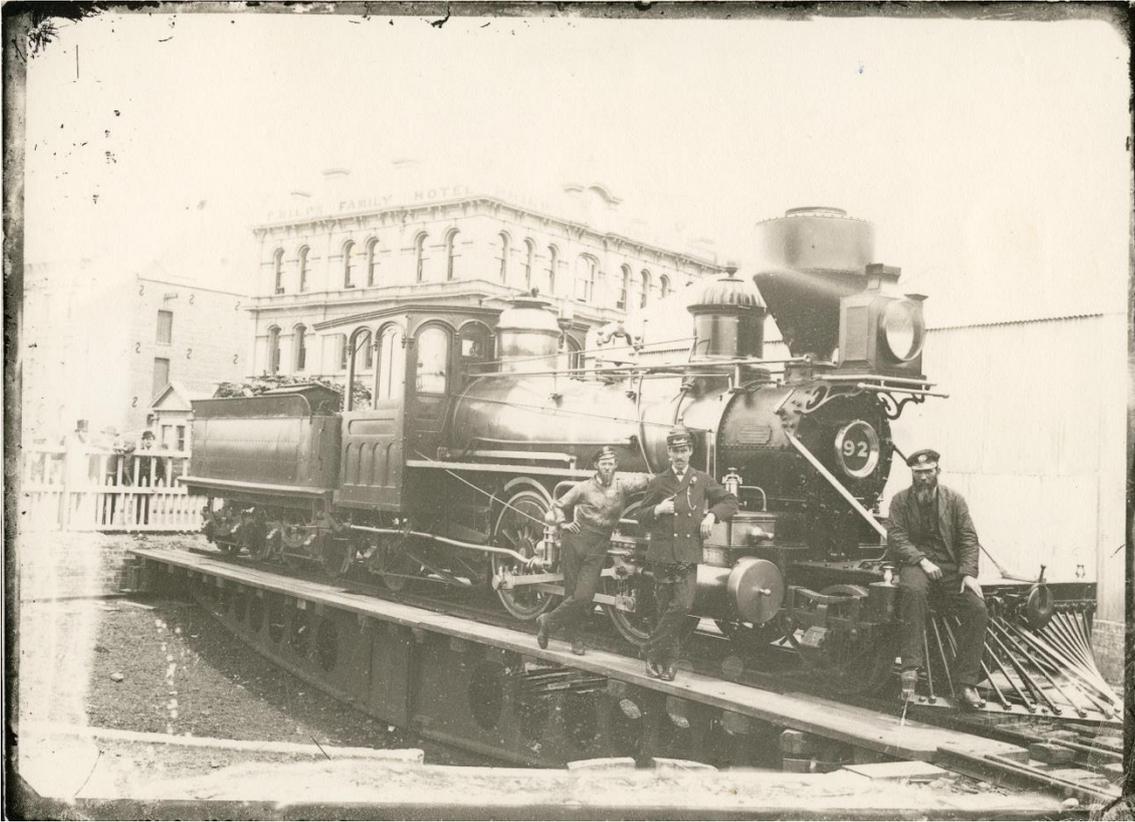
[Figure 13] Locomotive K92 on Sellers turntable 669 at Dunedin c.1892. Hocken File S14-560.

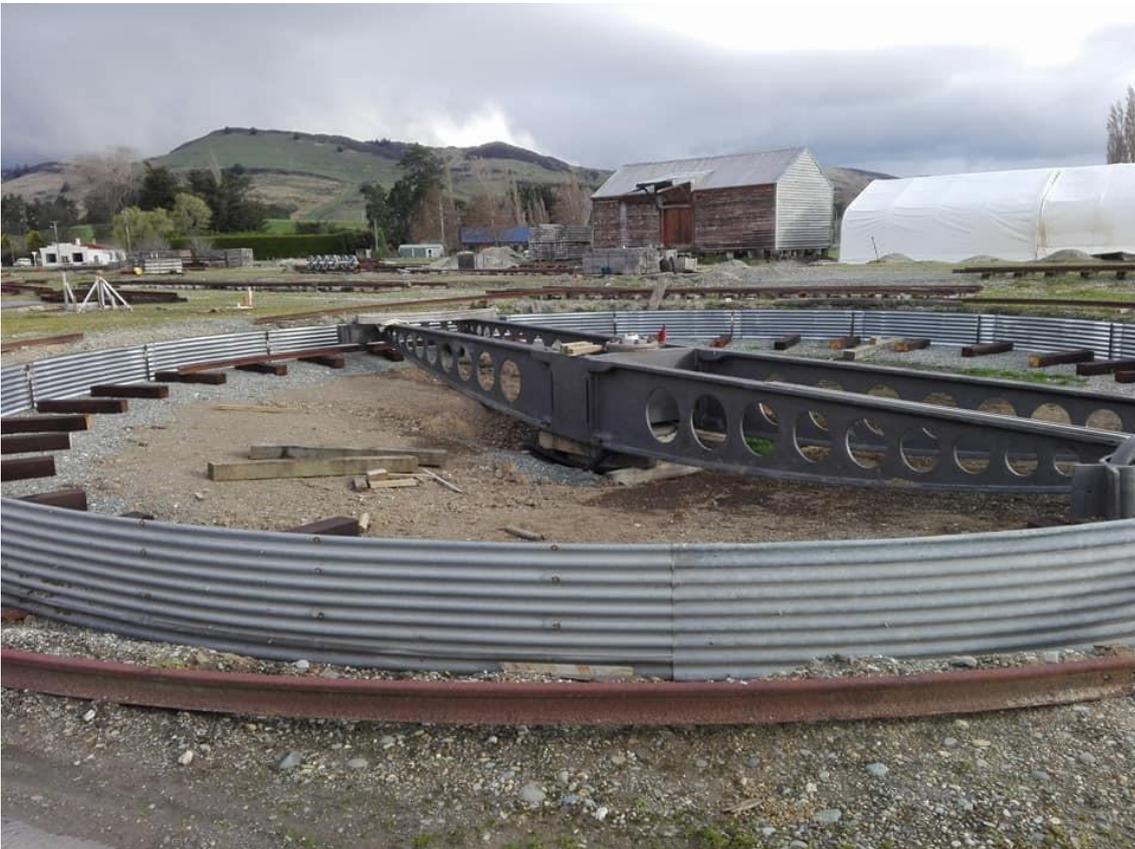
[Figure 14] Sellers turntable No.669 reinstalled at Mandeville but awaiting resources to complete the pit walls and track. Photo by the author.

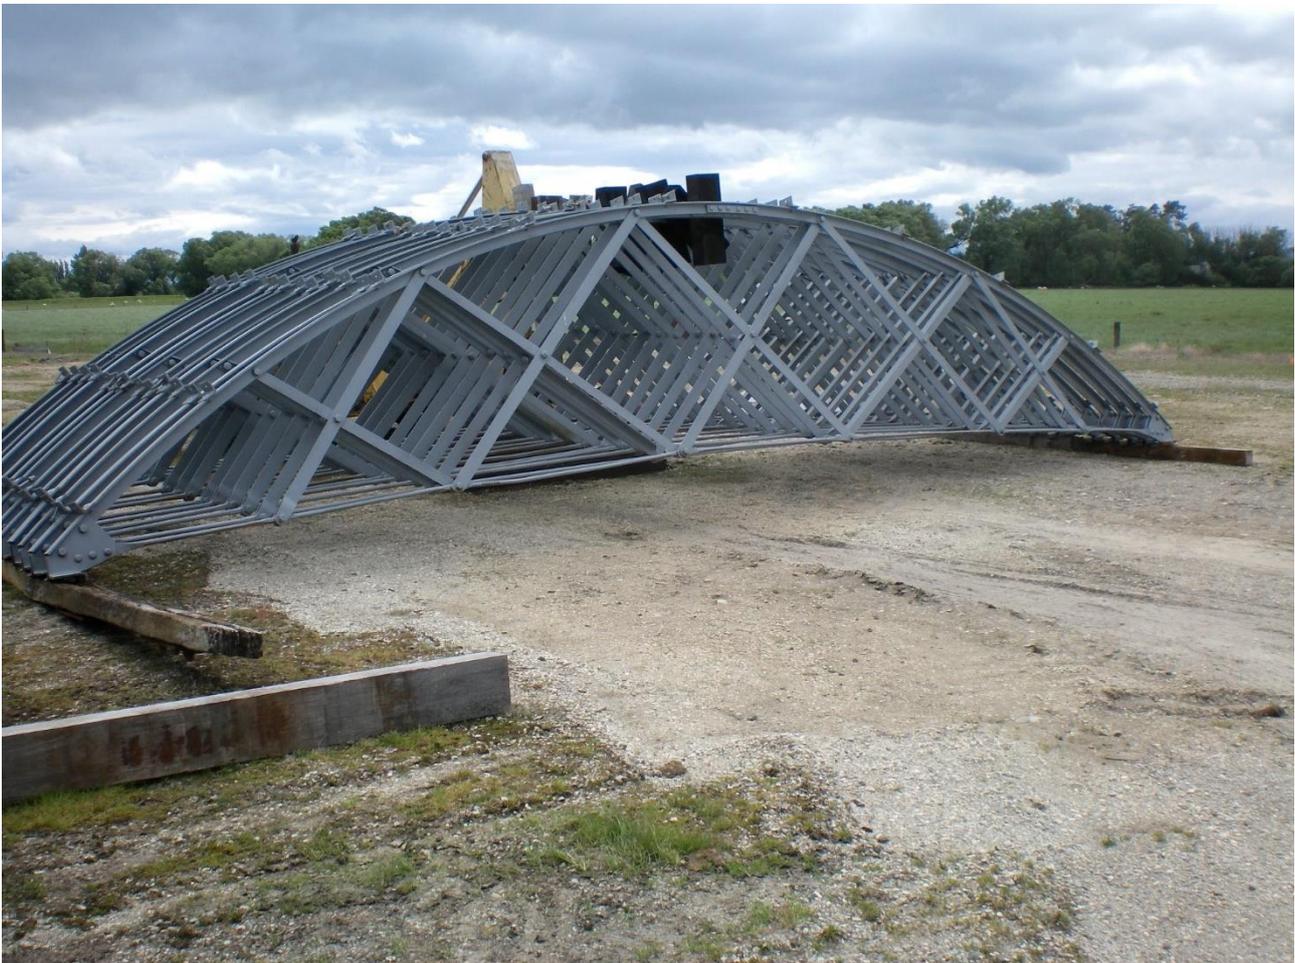
[Figure 15] The first set of trusses after cleaning and painting, ready for erection. Photo by the author.

During cleaning and painting of the roof trusses, some intriguing marks were uncovered. These showed that the trusses comprised sets, with some having each truss end-joint numbered and a manufacturers mark stamped in some of them. Some of the angle irons clearly showed the rolling mills brand.

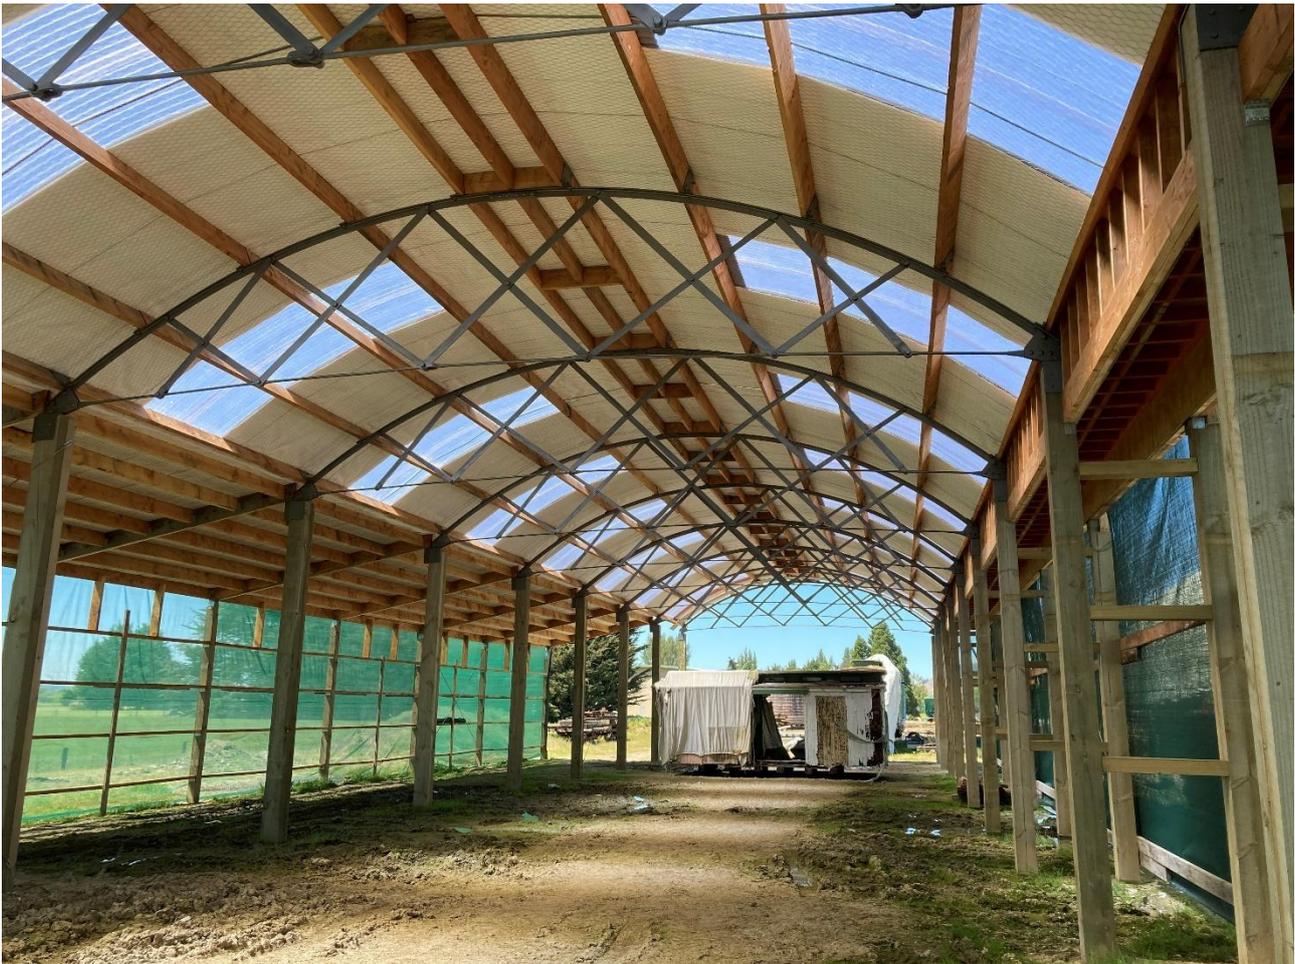
[Figure 16] Stage 1 of the Gully building erected at Mandeville in 2020. The wrought iron trusses give the space an airy feel with minimal impact on the interior space. It is hoped the building can be completed in 2022. Photo by the author.

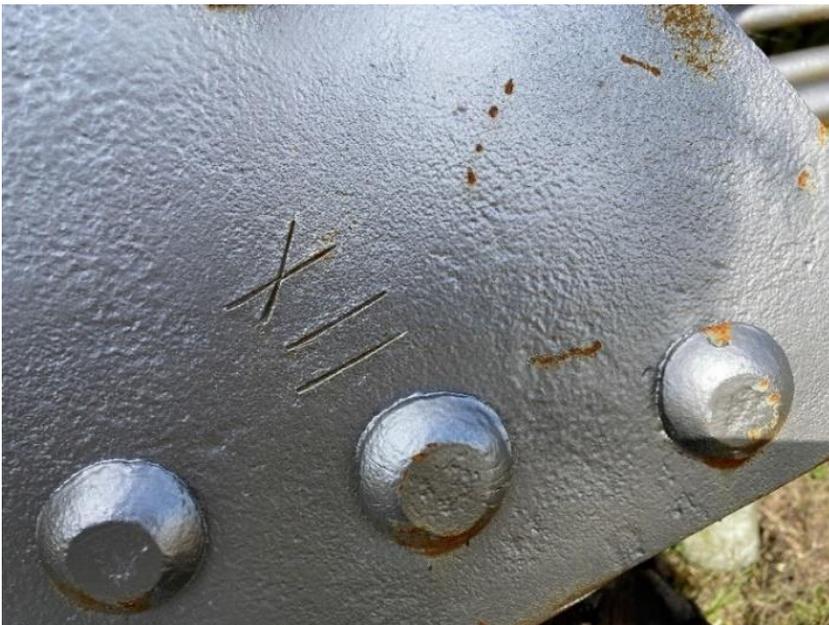
[Figure 17] Joint 12 with Roman numeral markings. Photo by the author.

The most obvious marks are at the joints at each end of the trusses. These are often numbered either with Roman numerals using a chisel, or a pattern of dots using a punch. Joints were numbered rather than trusses, with the numbers being consecutive on either end for those trusses that had them.

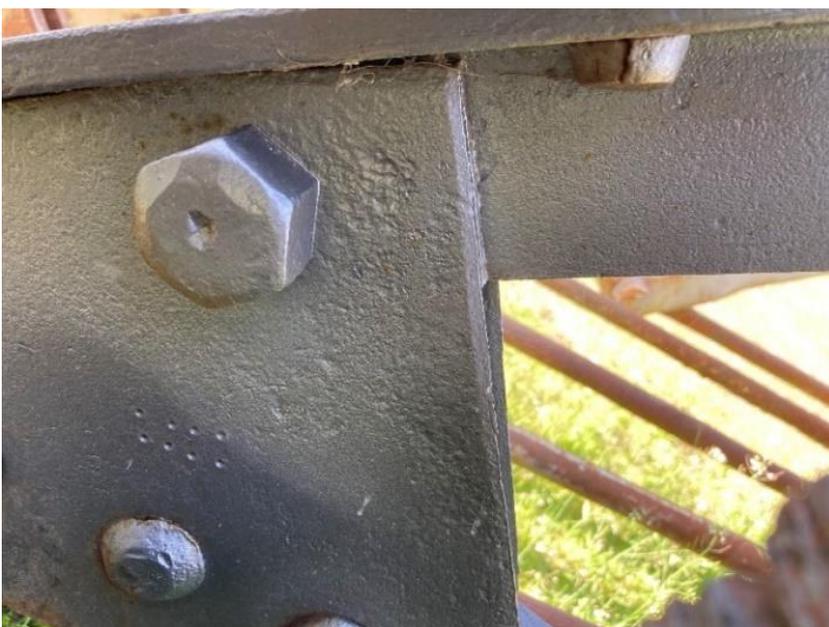
[Figure 18] Joint 8 with dot pattern markings. Photo by the author.

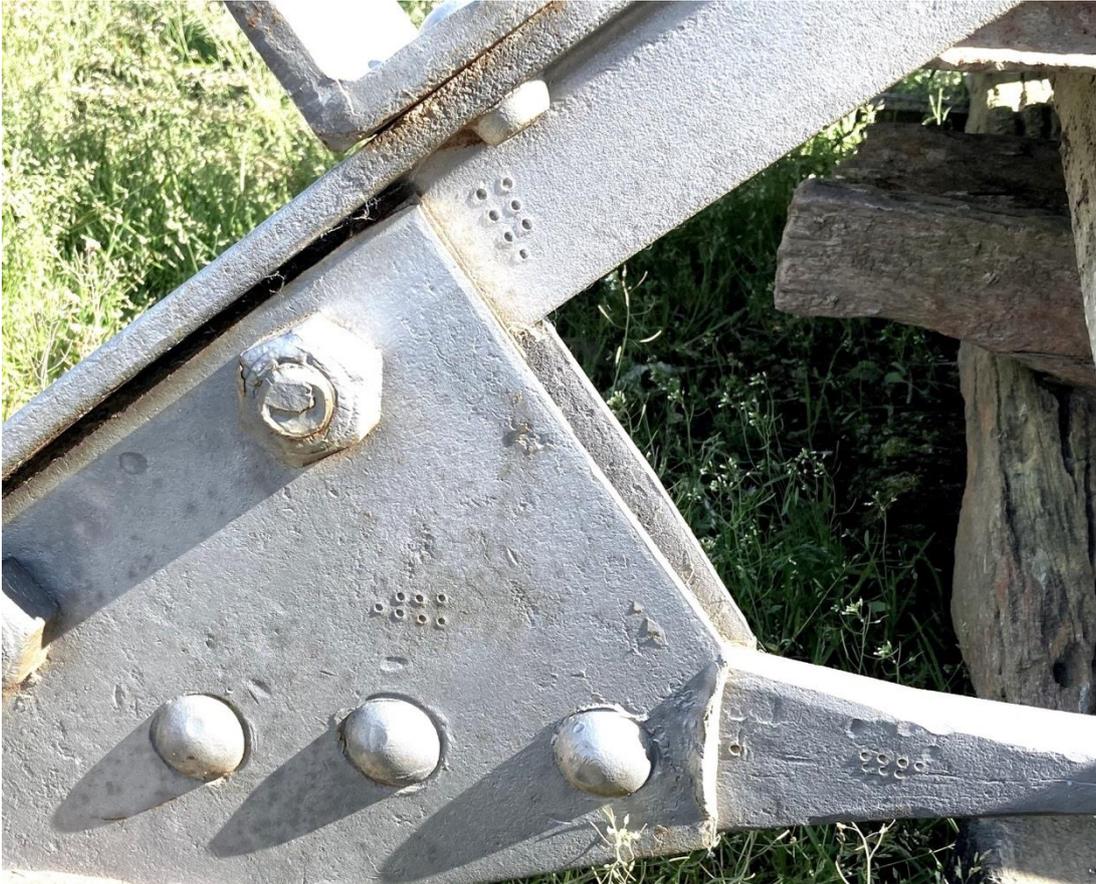
[Figure 19] Joint 7 with dot markings visible on each member. Note the This is the opposite end of the truss that has Joint 8. Photo by the author.

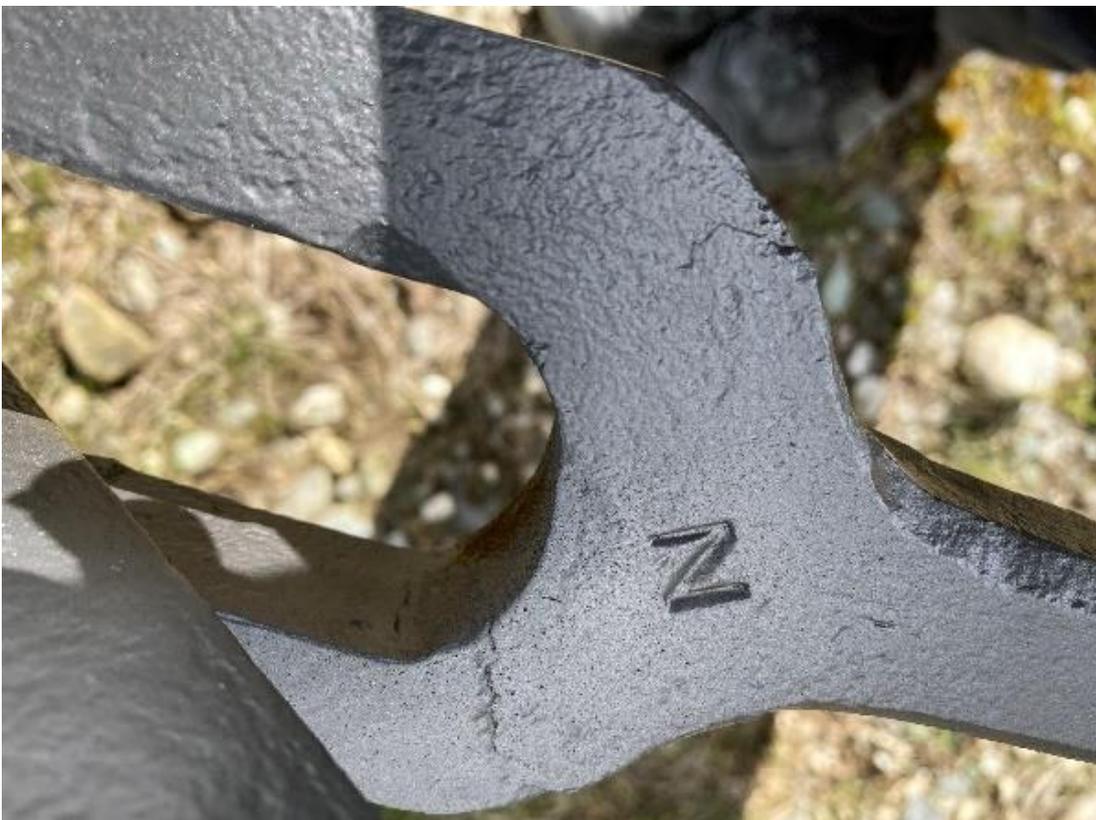
[Figure 20] Possibly an Inspectors mark, only found on a few of these forked rod ends. Photo by the author.

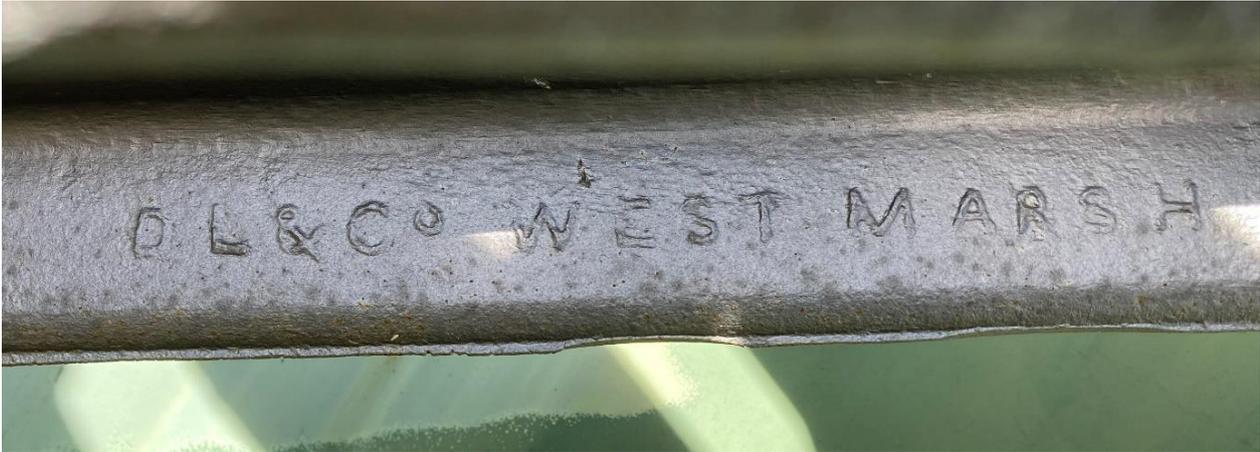
[Figure 21] the Dorman Long brand rolled into some of the angle Irons. Photo by the author.

The one Iron Mill that is clearly identified is Dorman Long & Co of West Marsh, eventually a major player in the British steel industry and now absorbed into British Steel. Their brand is rolled into some of the angle irons that are used on the trusses, but no other Mill identifications have been found. Surprisingly, the top Tee section has no rolling brand.

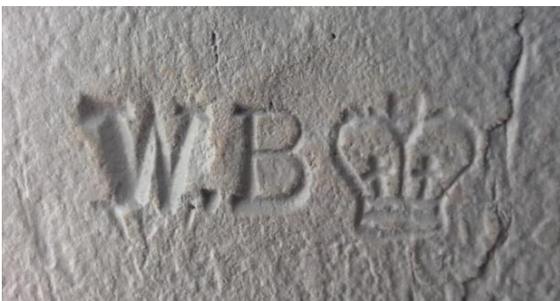
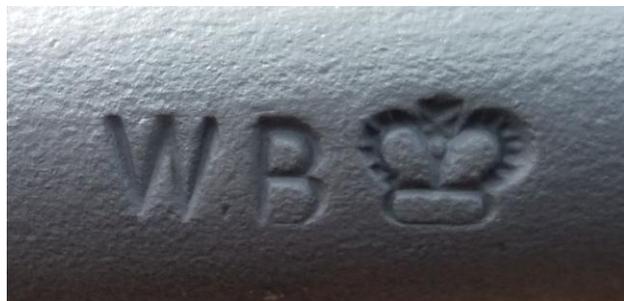
[Figure 22 and 17] Two variations of a works stamp on a joint plate and on a tie-rod. Photo by the author.

There is however one mark that stands out from others which has only been found in a very few locations and then in two different styles. It is assumed that it might be a later mark of William Barrows & Sons, owners of the Bloomfield Ironworks, Tipton. This is based on the initials W.B and the particular style of Crown accompanying one of the versions. While the iron Mill used BBH as the 'brand' letters (from an earlier company name of Bramah, Barrows and Hall), it is possible that the W.B was used for items manufactured to order. It is then also possible that the slightly different marks represent the two different orders, one from around 1875 and one from around 1880, with only a few items per order stamped this way.

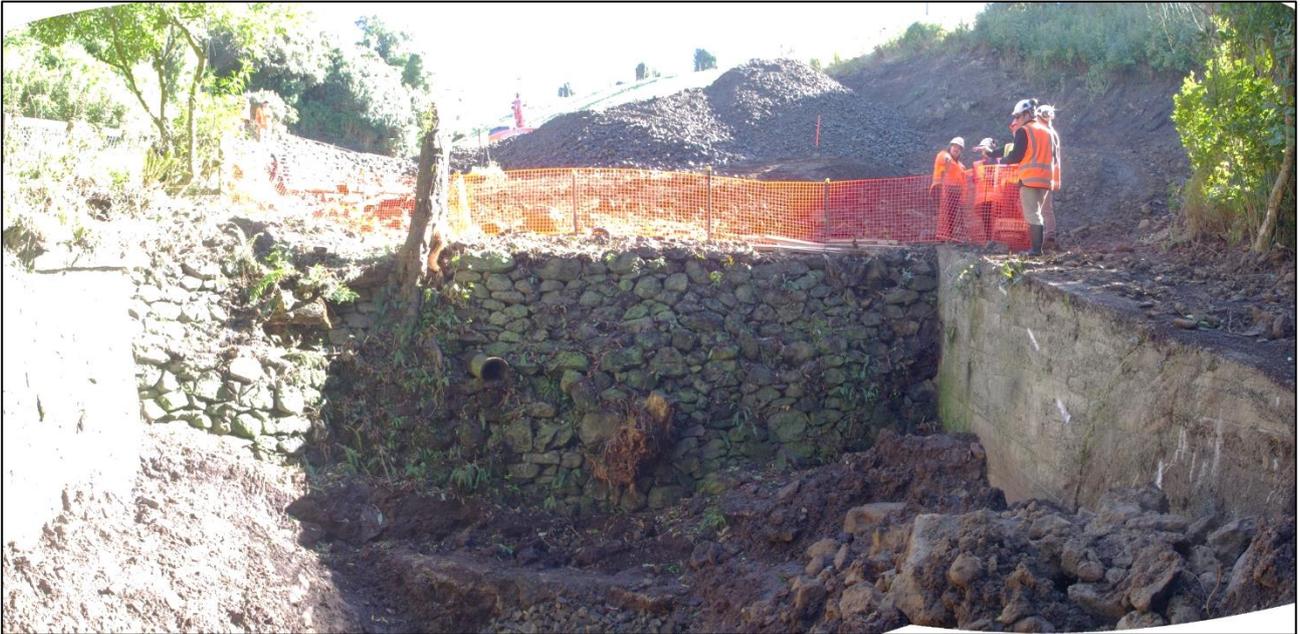
[Figure 2] View looking upstream of the dry-stone wall at the stilling basin portion of the early overflow system following clearing of vegetation, dumped spoil and debris. Current spillway chute is to the right of this image.

Nine years after initial reports of serious leaks, Mr Hay, Town Engineer of Dunedin, reported to the City of Dunedin about a leak in the dam. The residents of Woodhaugh and surrounding areas raised concerns about the leaks in the area [5, p.204.]. Here, Hay identified water leaking at the dry-stone retaining wall at the toe of the embankment. This feature situated at the end of the wooden flume formed part of the Overflow Management System. Hay describes this wall as “built to prevent a slope of loose clay and boulders coming in contact with the water from the bye-wash shoot [spillway chute] that discharges into the stream-bed at this point” [7, p.6-8.].

This leak had three defined flows, a west, middle and east branch (ibid.). Hay excavated (with the help of labourers) a small stone-culvert behind the retaining wall. He noted that this “old artificial channel... must have been built not later than 1875, when the upper basin was constructed, and the material excavated therefrom tipped over the outer face of the main reservoir dam” (ibid.). Obstructions were found within the east and west branches, and once these were cleared out, water flowed freely.

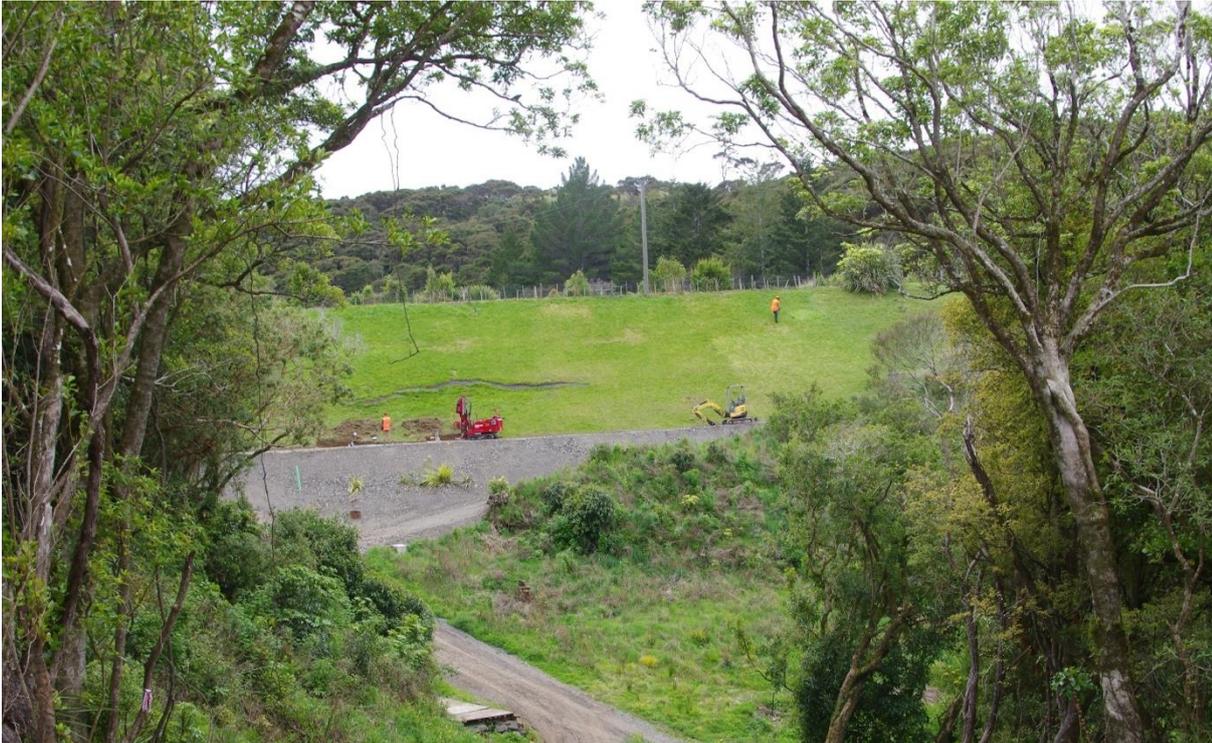
[Figure 3] View of head scarp on embankment shoulder after temporary stabilising fill was placed (investigations in progress)
