AUSTRALASIAN ENGINEERING HERITAGE CONFERENCE PAPERS 2022

THE TALE OF TWO BRIDGES: HOW UNDERSTANDING HERITAGE SIGNIFICANCE CAN GUIDE THE TREATMENT OF OUR COUNTRY'S UNIQUE STRUCTURES

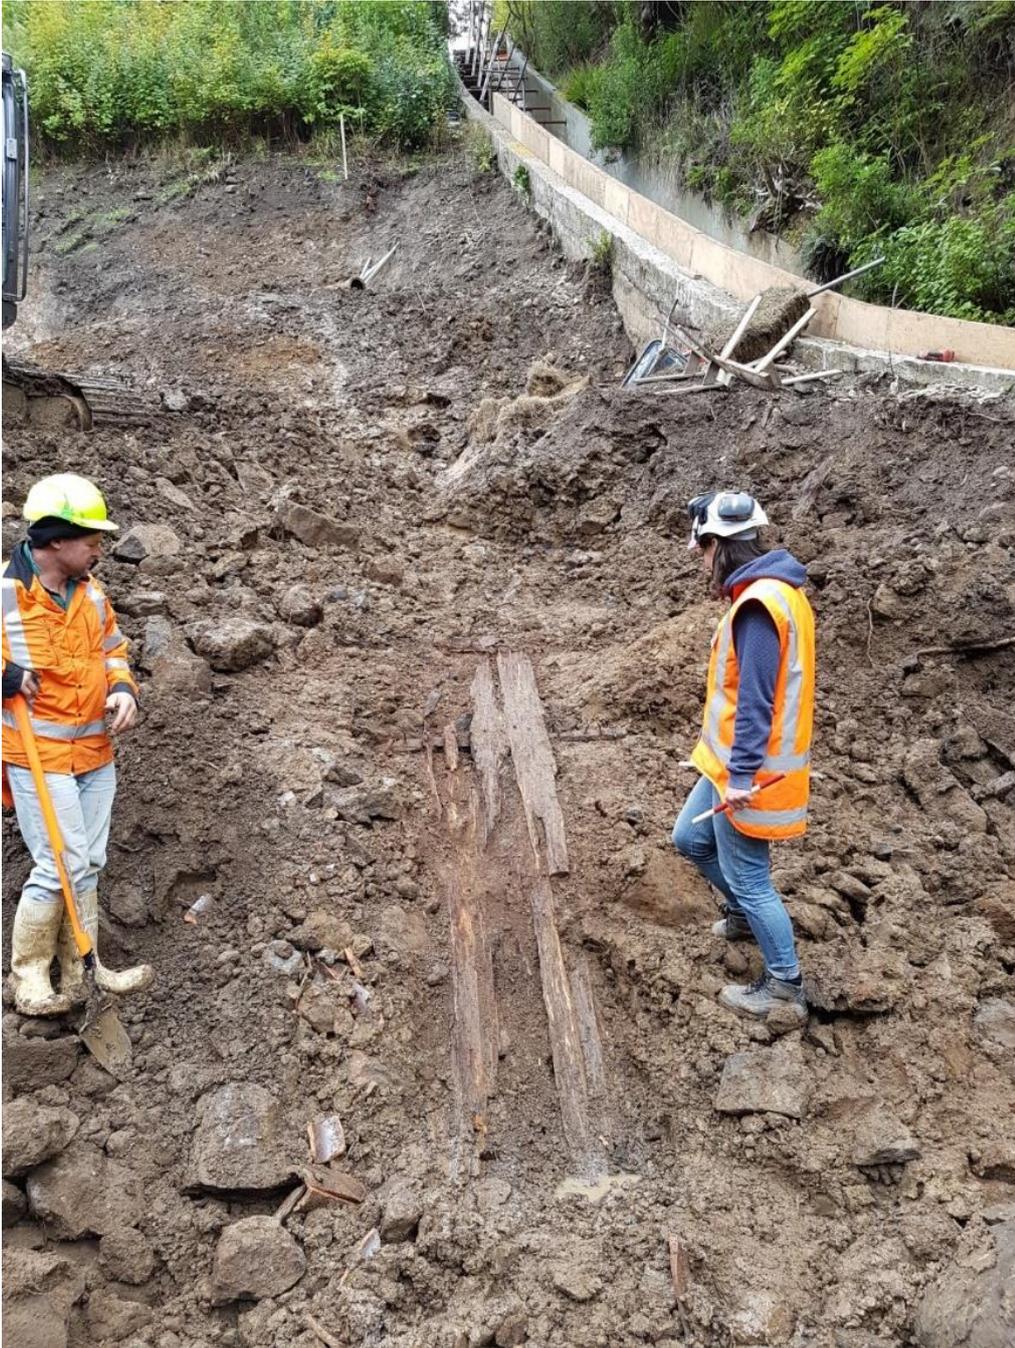
[Figure 4] Exposure of remnants of original 1865 timber flume. (Replacement 1926 concrete spillway in background)

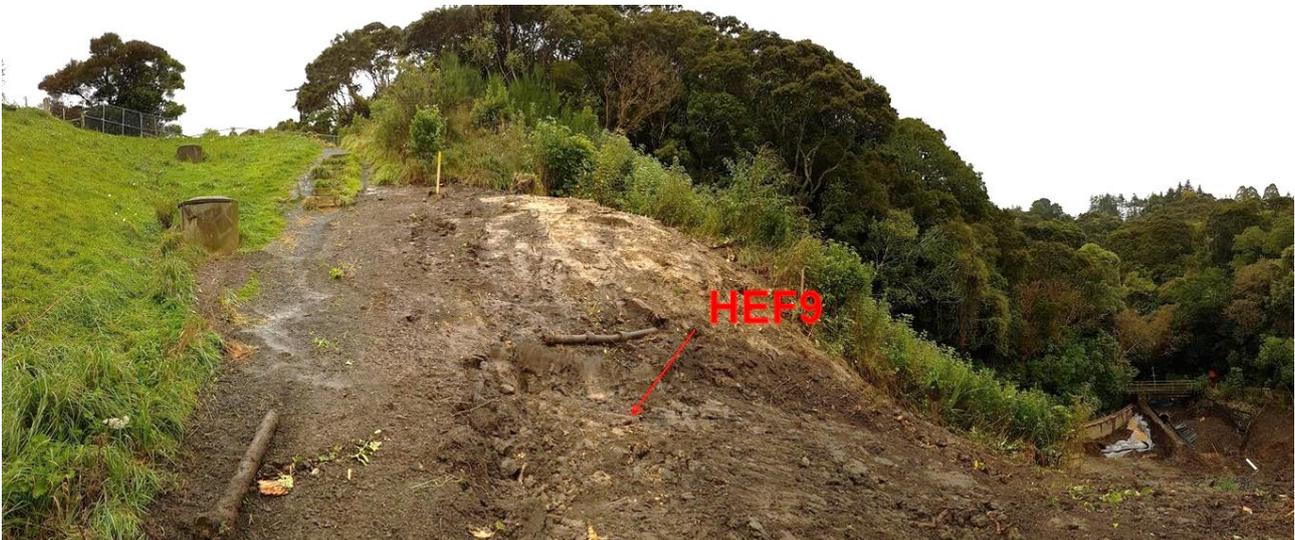
[Figure 5] View of various shallow drainage features exposed during buttress foundation preparation in vicinity of true left abutment, plus shallow collector manholes shown at left of image

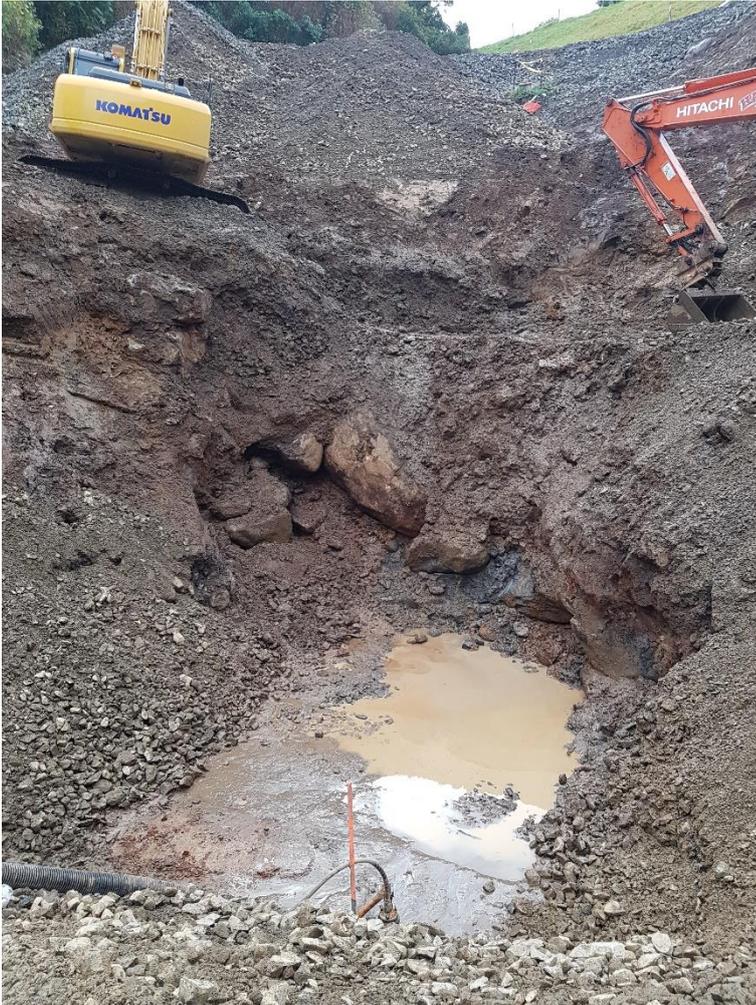
[Figure 6] Buttress foundation preparation at creek channel showing basalt boulders

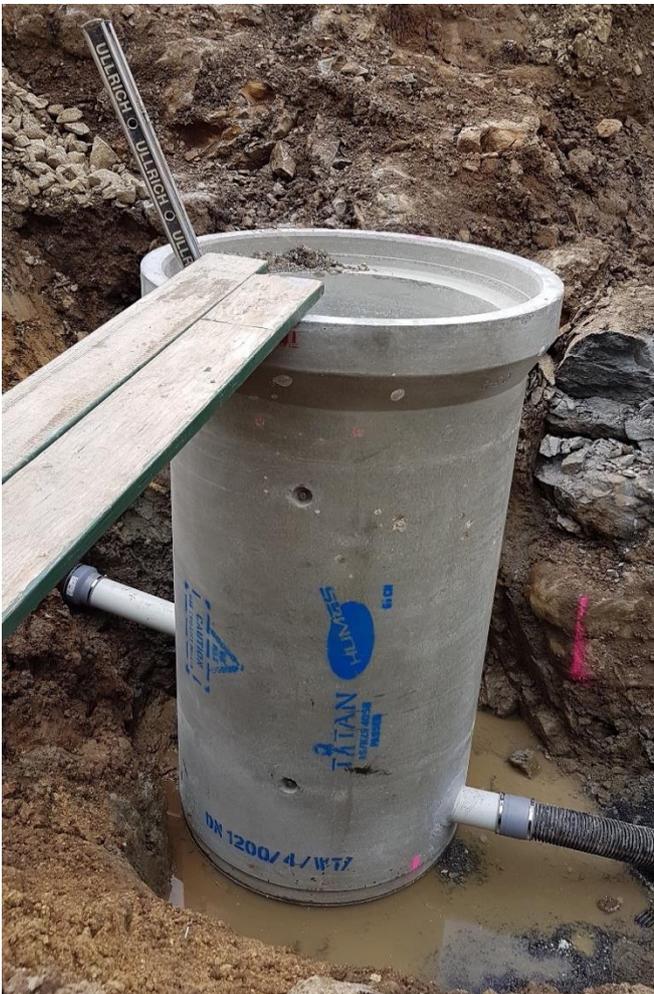
[Figure 7] Addition of western manhole to facilitate monitoring of discovered creek channel drain extending back to dam core trench

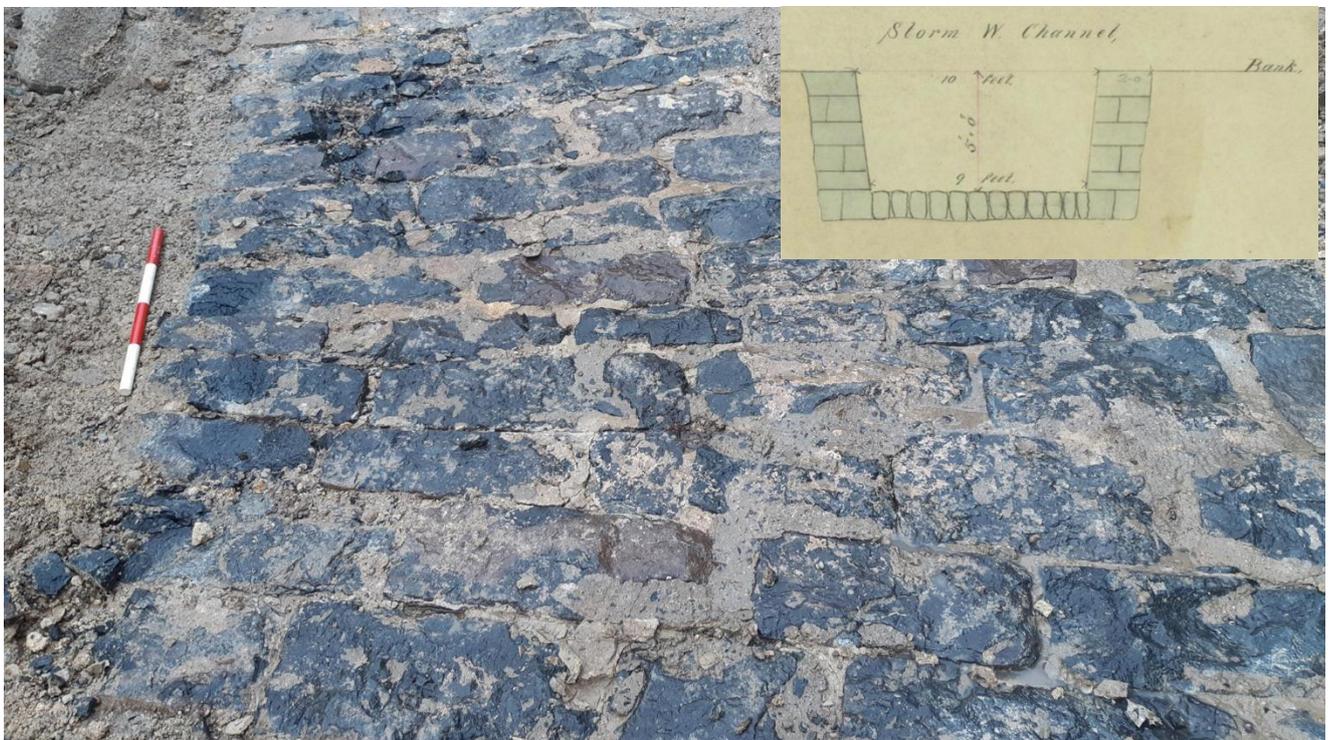
[Figure 8] Bluestone pitching exposed under later lining

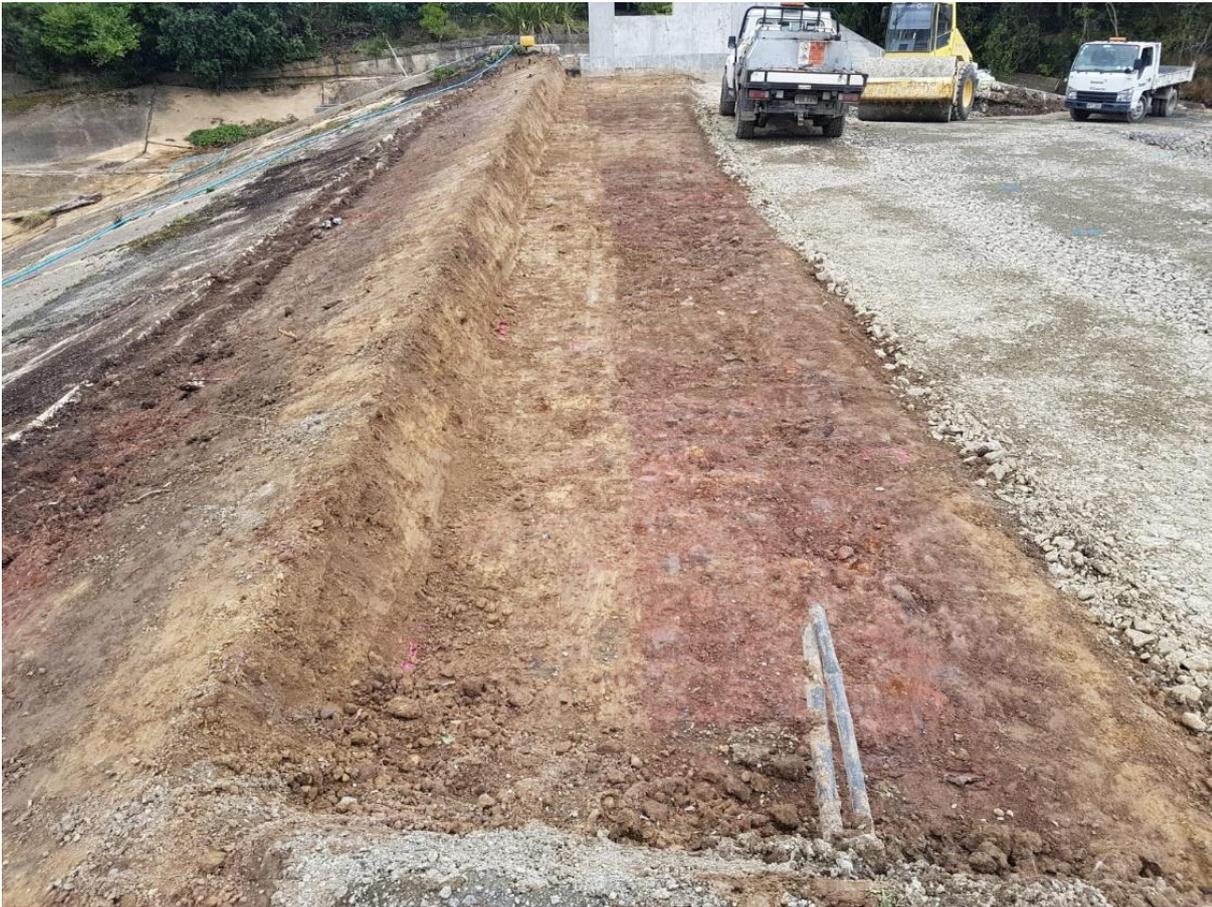
[Figure 9] Stripped dam crest exposing trenched core capping zone. Buttress placement to right of image has temporary cover extended over obscured new sand and gravel filter layers below

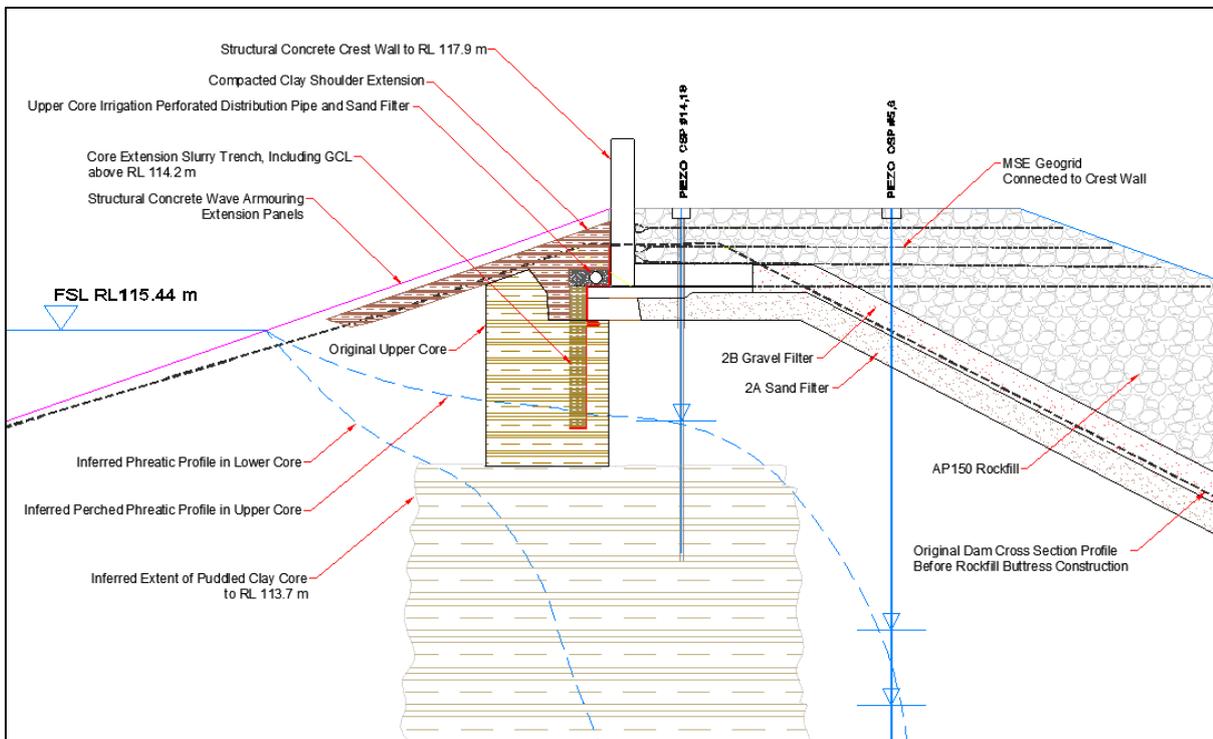
[Figure 10] Crest raising cross section showing interface with original upper core (dashed line indicates original dam section)

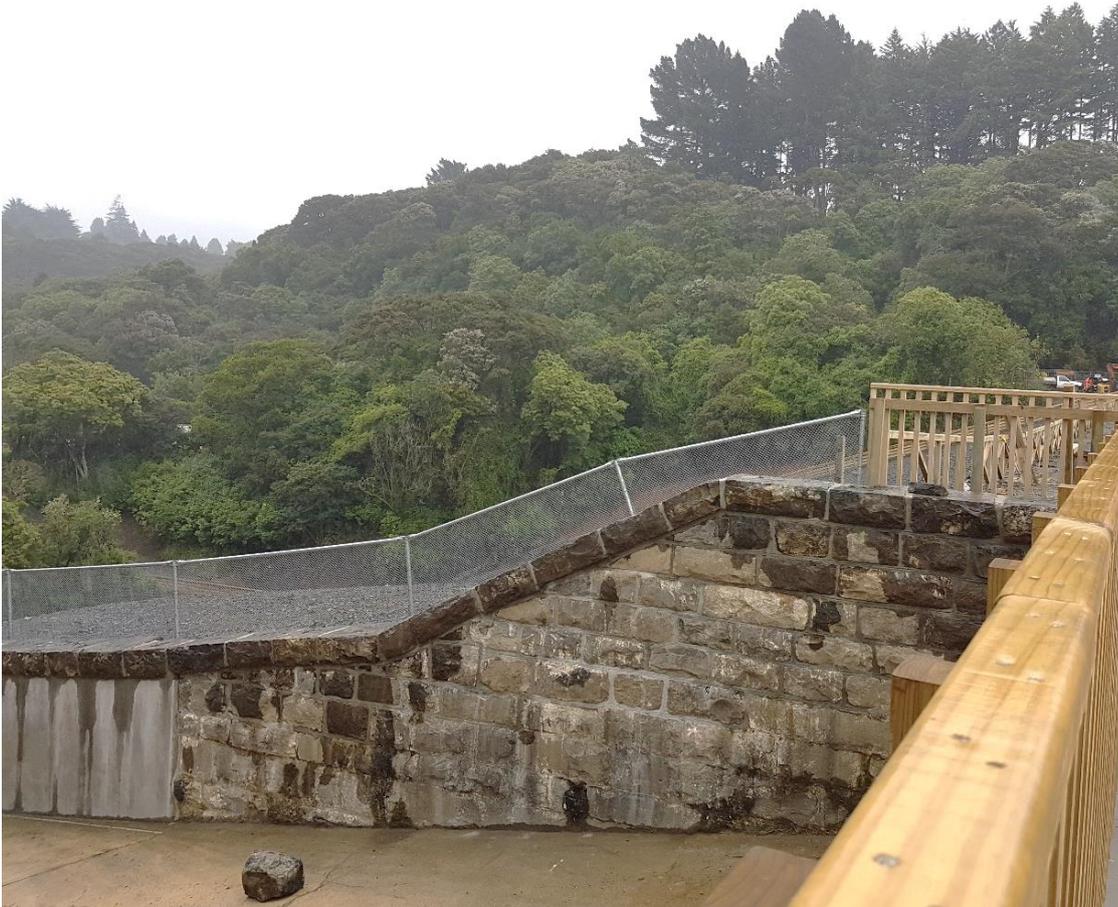
[Figure 11] View of bluestone facing on the raised spillway wall utilising material recovered from site during the project

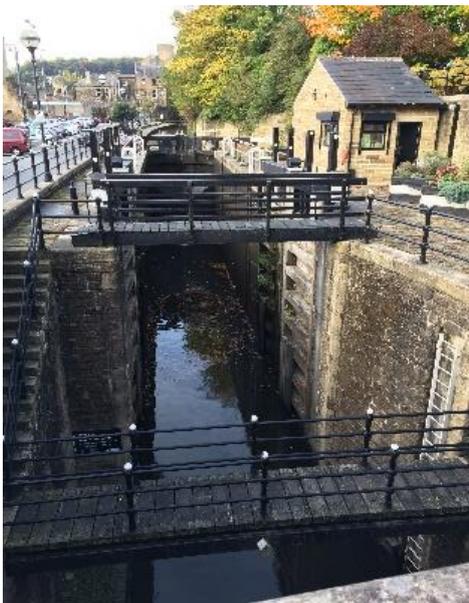
[Figure 2] Tuel Lane Lock, Sowerby Bridge, Rochdale Canal

Rochdale Canal was built to provide a navigable connection between Sowerby Bridge and Manchester. The route originally included 92 locks, but Locks 3 and 4 were replaced with a single deep lock in 1996 – Tuel Lane Lock – which has a fall of six metres and is the deepest canal lock in the UK.

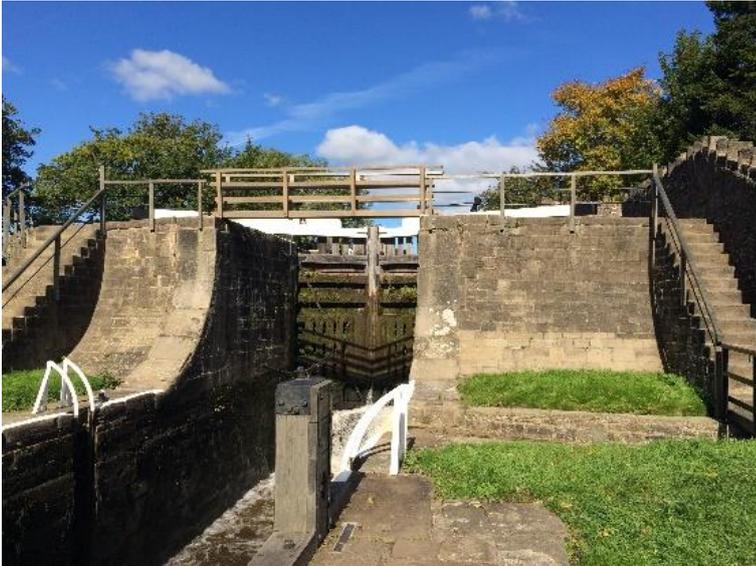
[Figure 4] Bingley Five Rise Staircase Lock, Bingley, Leeds and Liverpool Canal

On the Leeds and Liverpool Canal, the most well-known heritage structures are two impressive staircase locks at Bingley. The Bingley Five Rise Locks was opened in 1774 and was built to raise the canal eighteen vertical metres. It is the steepest lock staircase in Britain. A second lock staircase, the Bingley Three Rise Locks, is a short distance downstream.

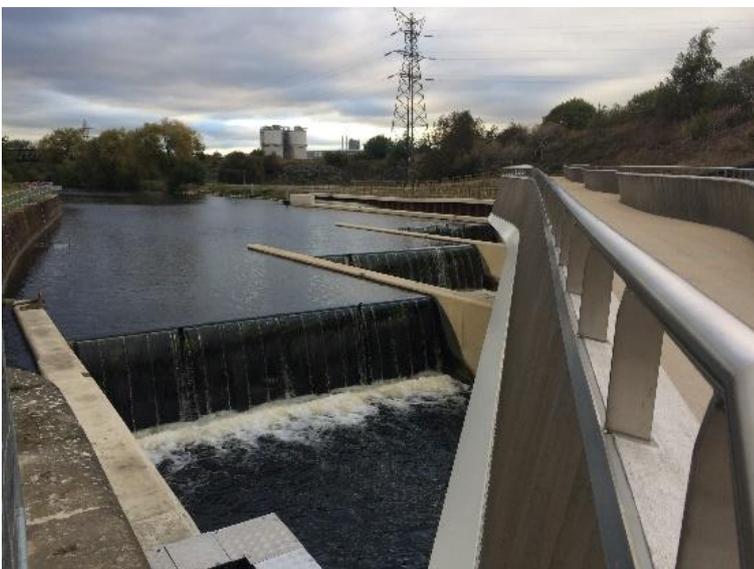
[Figure 6] Knostrop Weir and Bridge, Aire and Calder Navigation

Of the many new flood protection improvements, Knostrop Weir is most notable. Opened in October 2017, Knostrop Weir and the similar Crown Point Weir near Leeds Dock are the first mechanical flood protection weirs in the UK. They have bottom-hinged steel plates supported by bladders that inflate or deflate as required to control the river's level. Knostrop Weir also has an integrated footbridge which forms part of a 12-kilometre river/canal-side path between Leeds and Castleford. The weir and footbridge are evidence that engineering heritage can be beautiful as well as functional, and that heritage can be for future focused as well as from the past.

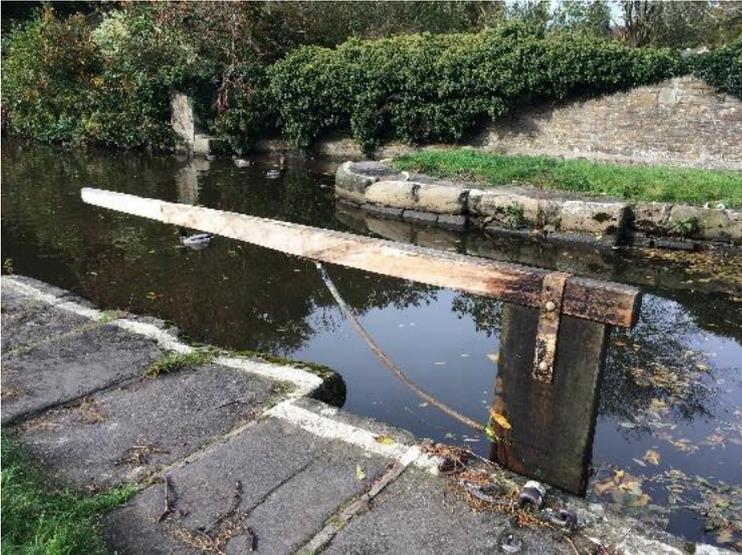
One of the simplest lock mechanisms is the ‘**Jack Clough**’ on the Leeds and Liverpool Canal. These are paddles attached to long handles, which work as levers to move the paddles.

[Figure 12] 'Jack Clough' lock mechanism at Higherland Lock, Leeds and Liverpool Canal

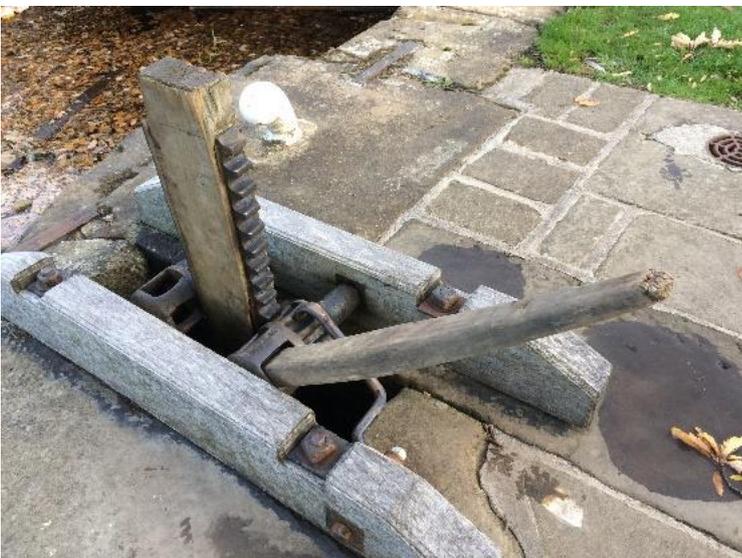
The Calder and Hebble Navigation is unusual in that it requires a **handspike** (a length of 5-by-10-centimetre timber shaped at one end) in addition to the windlass to operate the mechanisms along its length. The handspike is used to lever open simple lock gear which in turn lifts the paddles.

[Figure 13] Handspike and lock mechanism at Kirklees Low Lock, Calder and Hebble Navigation

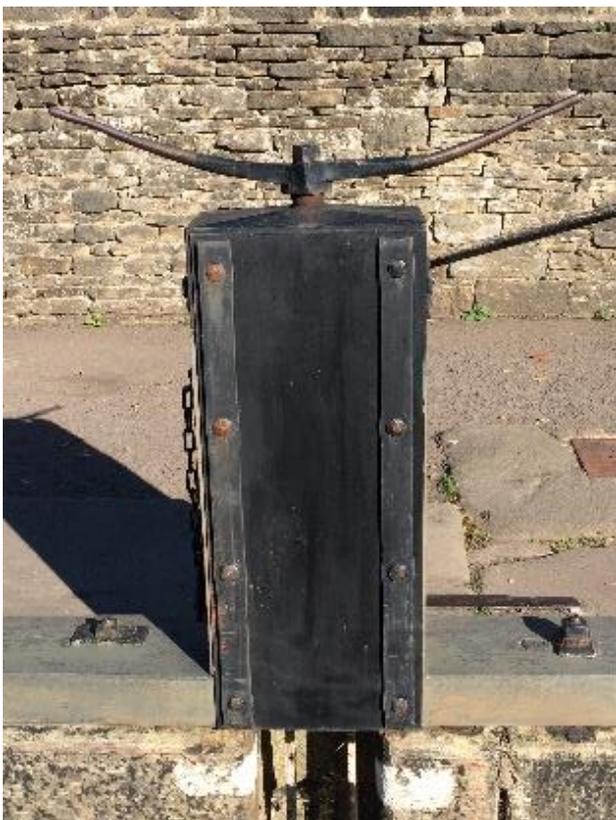
The most common mechanism is a **simple ratchet** turned using a windlass (or portable metal handle). This fits onto a ratchet spindle to raise and lower the paddle. This system also provides instant visual indication as to whether the paddle is lowered or raised. There are also **box cloughs** on some locks on this canal around Gargrave.

[Figure 14] Box clough lock mechanism, Bingley Five Rise Lock Staircase, Bingley, Leeds and Liverpool Canal

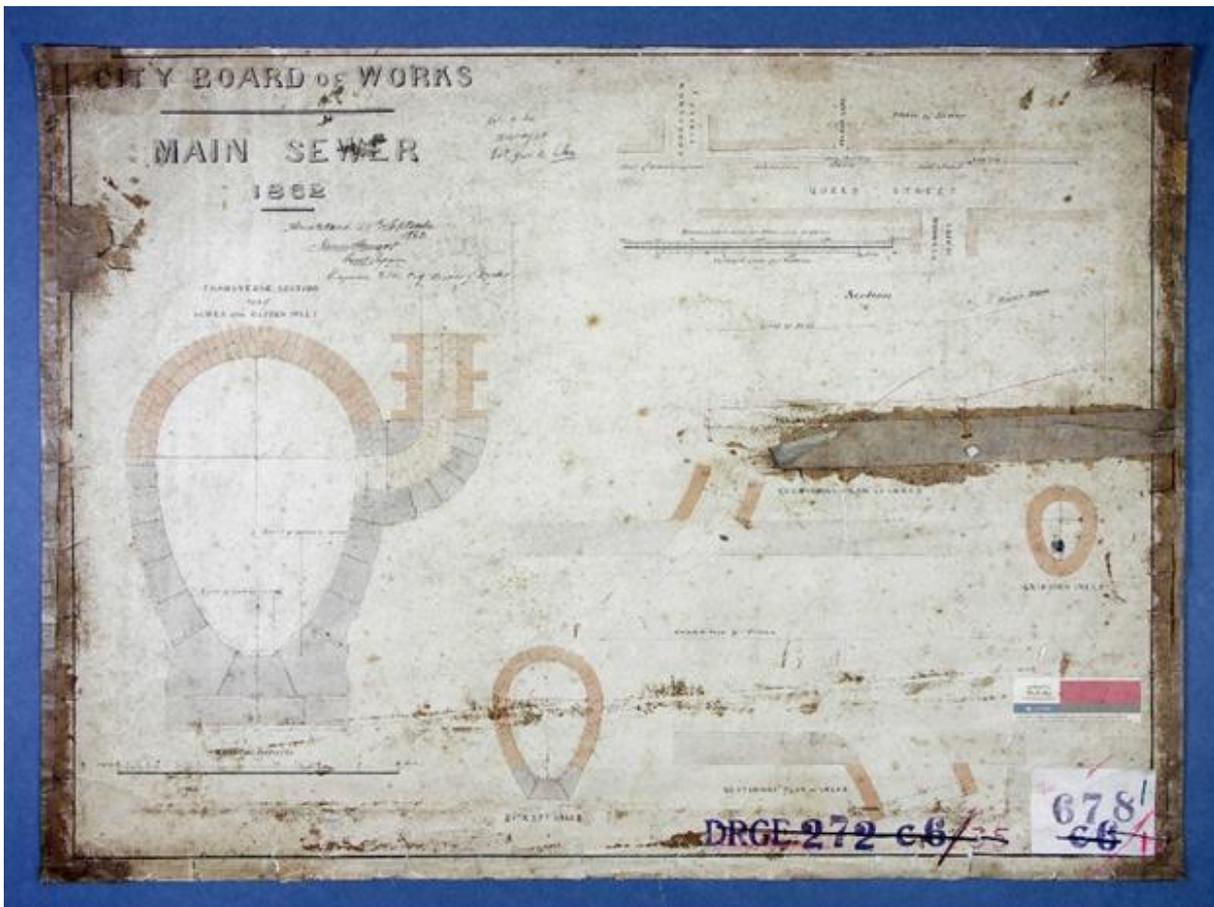
[Figure 2] James Stewart's design for Queen Street Sewer 1862. Auckland Council Archives ACC 015 678-001

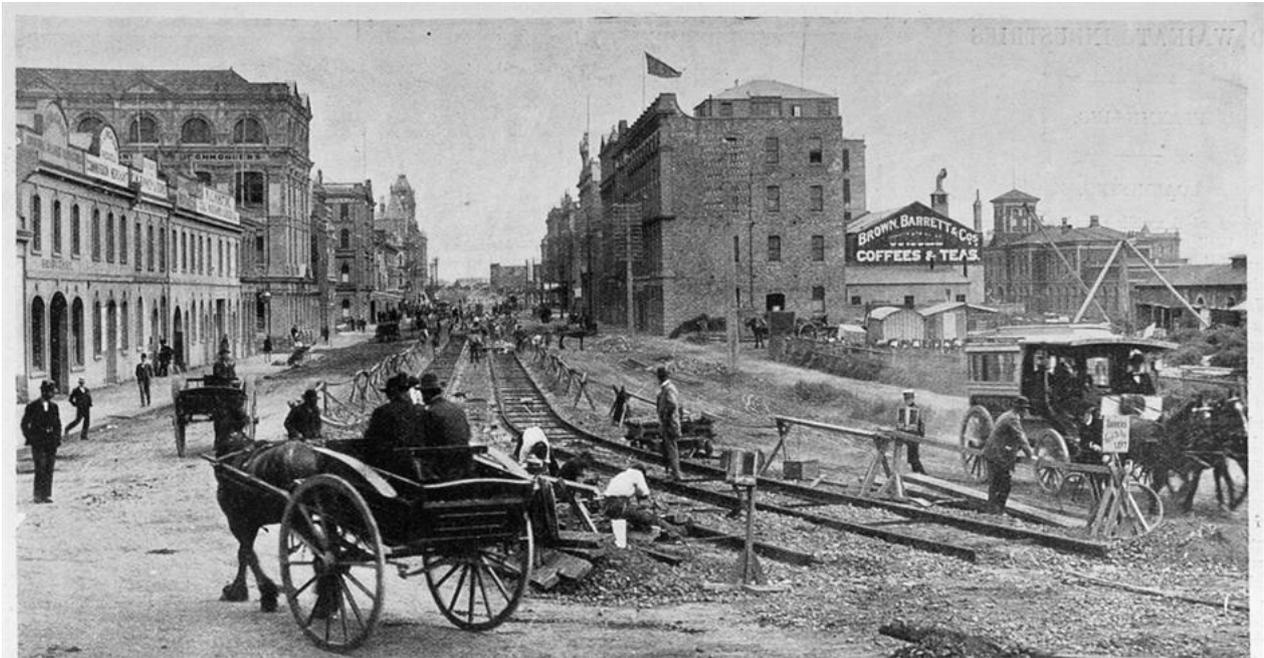
[Figure 4] Laying tram tracks in Custom Street Auckland November 1901. Sir George Grey Special Collections AWNS-19011107-5-1

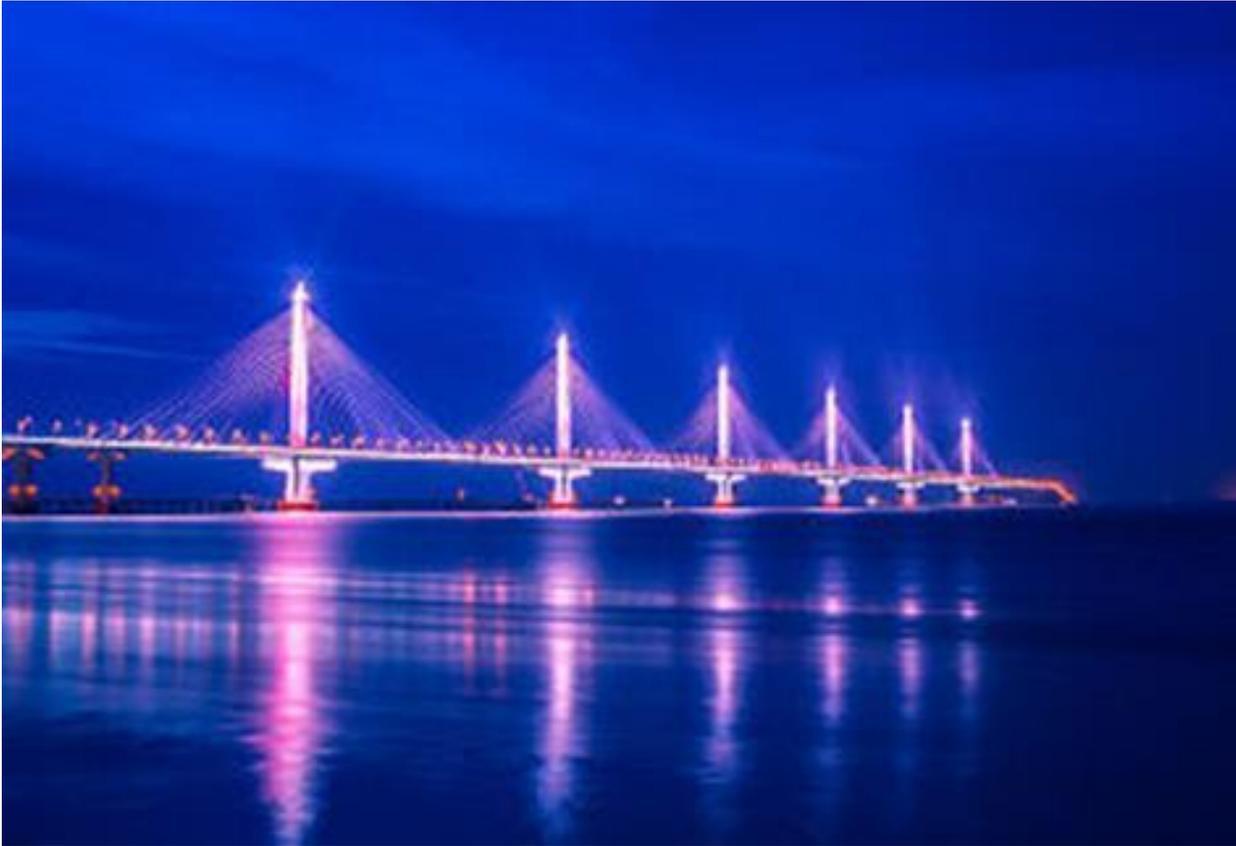
The world's longest cable-stayed bridge is the JiaShao Bridge, 10,138 m long across the Qiantang River at the mouth of Hangzhou Bay in China. The main span is 2,680m in length. The bridge forms part of the 69.5km Jiaxing-Shaoxing River-crossing Expressway and consists of eight traffic lanes. The bridge is 55.6m wide and features six single-column pylons. It was opened to traffic in July 2013.

[Figure 7] JiaShao (Jiaying-Shaoxing) Bridge, China. Wikipedia picture.

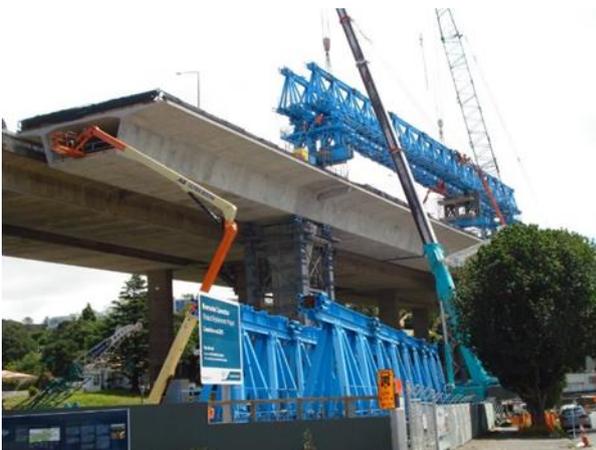
Left: [Figure 8] Newmarket Viaduct replacement bridge. NZTA Picture.

Newmarket Viaduct is a key part of Auckland's motorway system. The first viaduct built in 1966 was not designed to recent earthquake standards and was replaced in 2012.

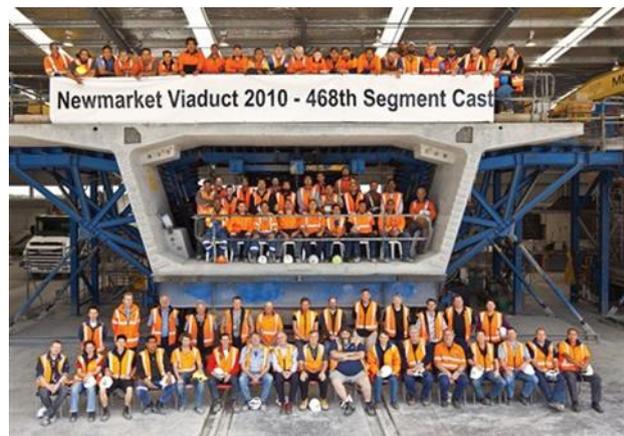
Prestressed concrete bridges can be precast in the factory and then moved to the construction site. In the last few decades, the precast concrete segmental bridge construction has been widely used around the world and for the Newmarket Viaduct.

Right: [Figure 9] Newmarket Viaduct segment. NZTA picture

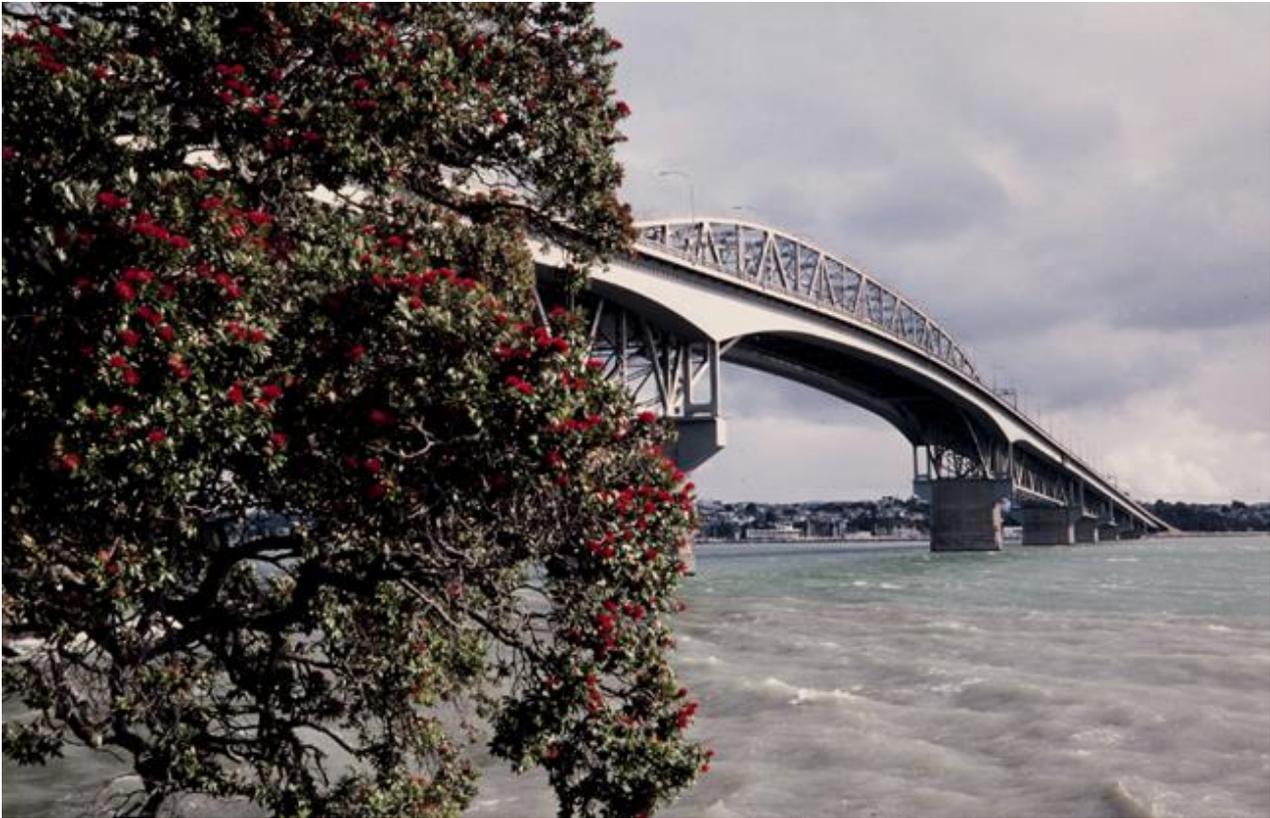
[Figure 10] Auckland Harbour Bridge Clip-ons from Northcote Point. Sir George Grey Special Collections 1021-30

Traffic on Auckland Harbour's new bridge after it first opened in 1959 was far greater than expected. In 1967 a contract was let to a Japanese firm, Ishikawajima-Harima Heavy Industries, for two steel box girder bridges. These bridges were built on each side of the Harbour Bridge, with the only connection at the existing piers using steel structures, colloquially called the 'Nippon clip-ons'. Freeman Fox and Partners were designers and the new bridges were state of the art structures using high tensile steel.

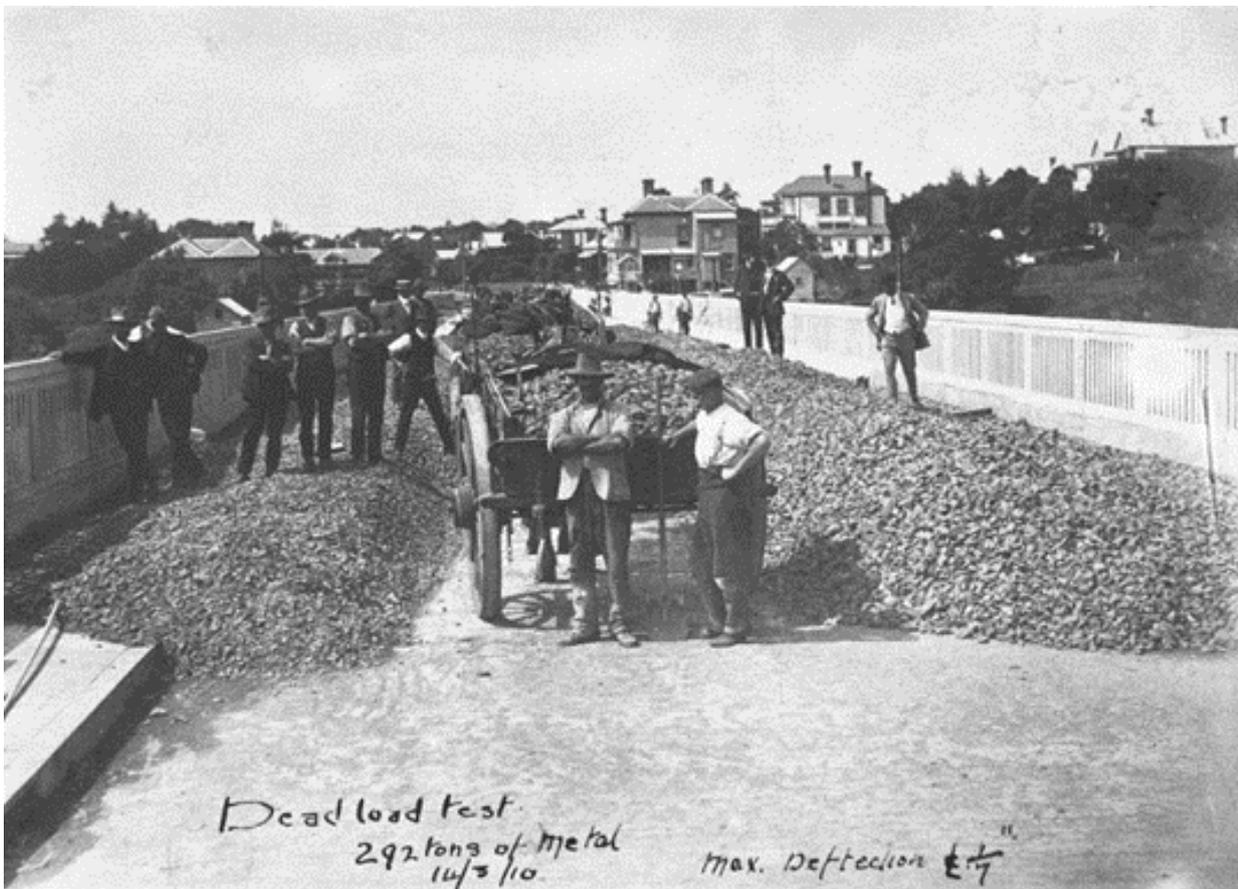
[Figure 11] Load testing Grafton Bridge to 5.4KPa in 1910. Sir George Gray Special Collections A750.

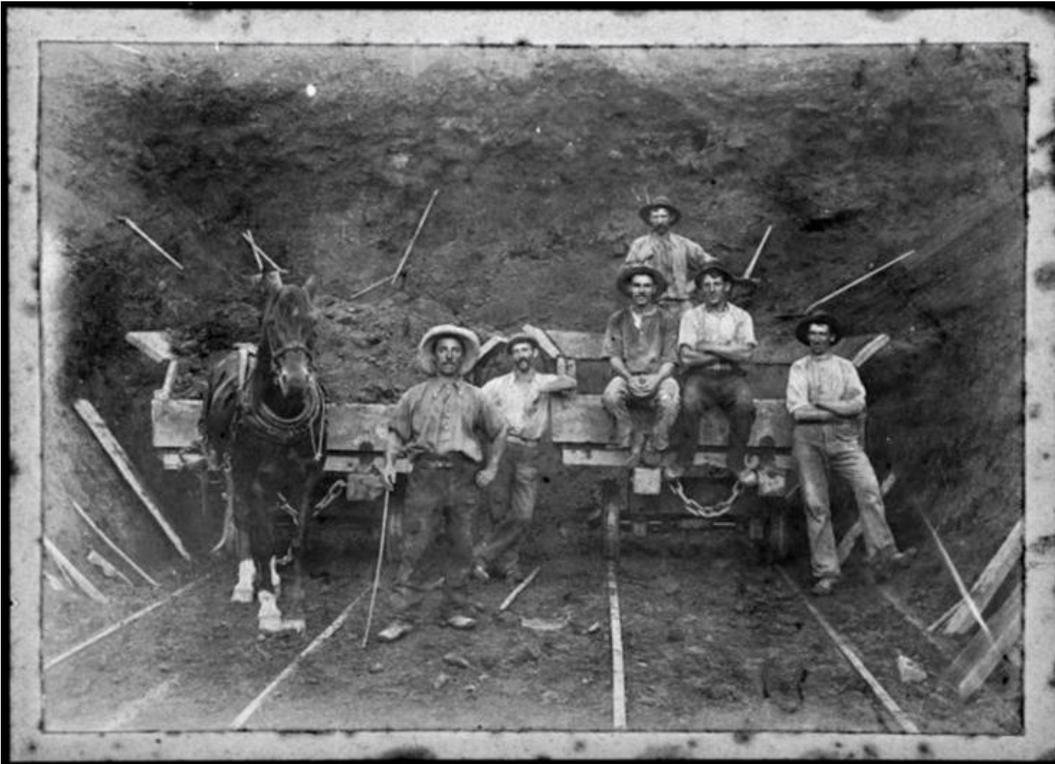
[Figure 13] Excavating Otira Tunnel 1908. Alexander Turnbull Library reference 1/2-056630-F

The Otira Rail Tunnel rail runs under the Southern Alps from Arthur's Pass to Otira - a length of over 8.5 kilometres. At a grade of 1 in 33, the Otira end of the tunnel is over 250 m lower than the Arthur's Pass end. Construction started in 1907 and it opened on 4 August 1923. At the time of its construction, it was one of the longest tunnels in the world.

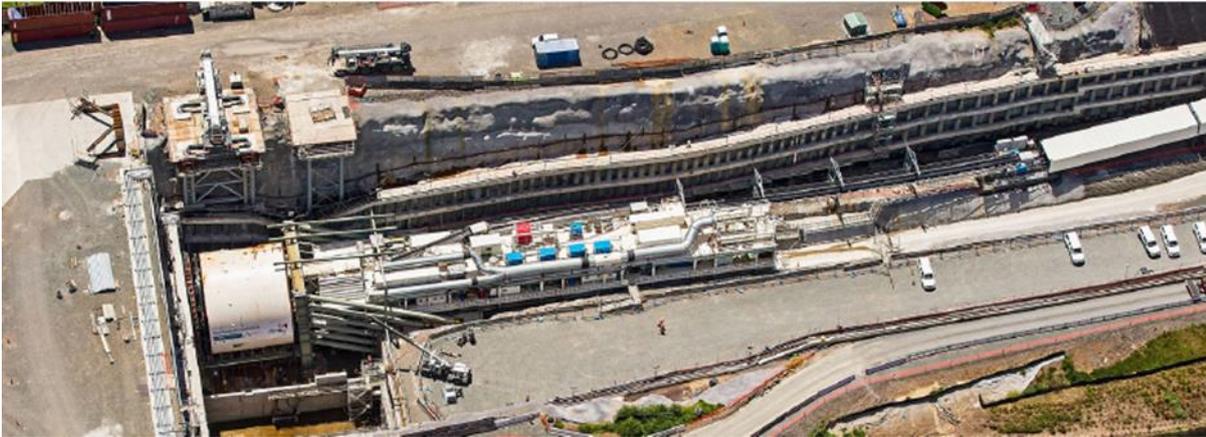
Twin road tunnels 2.4km long were completed in 2017 connecting the Western Ring route motorway to the North-western motorway. The Tunnel boring machine, 87m in length cut a 14m diameter hole that was lined with over 24,000 concrete segments.

[Figure 15] 87m long Alice tunnel boring machine ready to start its journey in December 2013. NZTA picture.
