DISCIPLINARY COMMITTEE – UPHELD COMPLAINTS LESSONS TO BE LEARNT

CASE STUDY
SEPTEMBER 2022 – TRUCK AND TRAILER

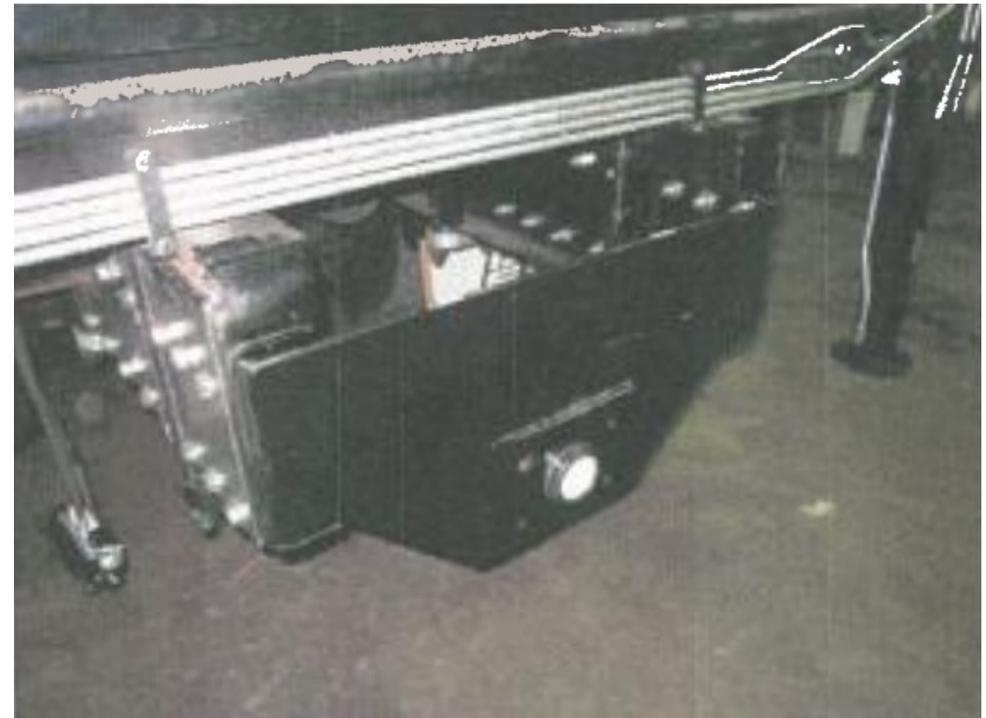
Figure 2 – Draw beam at time of certification. View is of the rear of the truck, with draw beam bolted to the inside of the chassis rails.

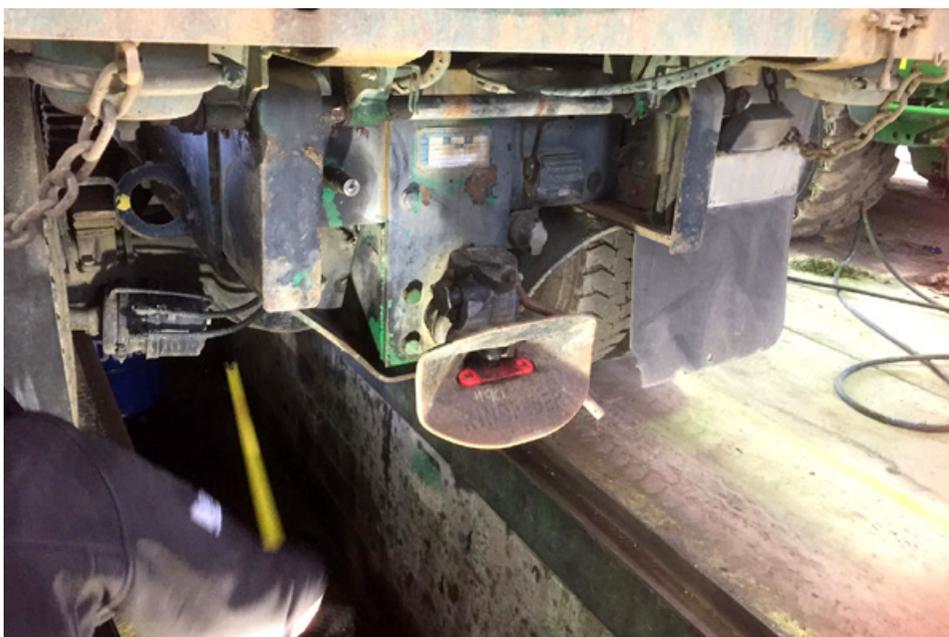
A draw beam is a type of towing connection that is fitted to trucks to allow them to tow heavy trailers. An example is shown in Figure 3, and this shows how a coupling is attached to a draw beam, which in turn is bolted to the chassis of a truck.

Figure 3 – Example draw beam (tsgl.nz/wp-content/uploads/2019/09/Drawbeam-Certification-2.jpg)

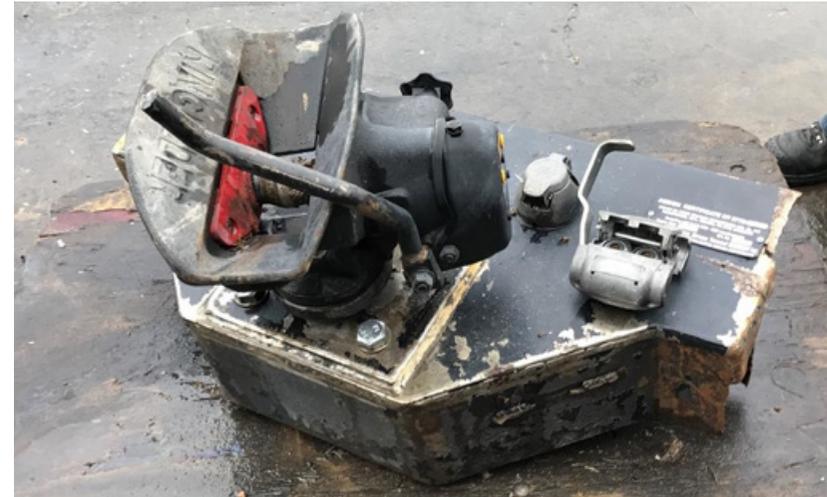
Figure 6: View from the trailer towards the draw beam.

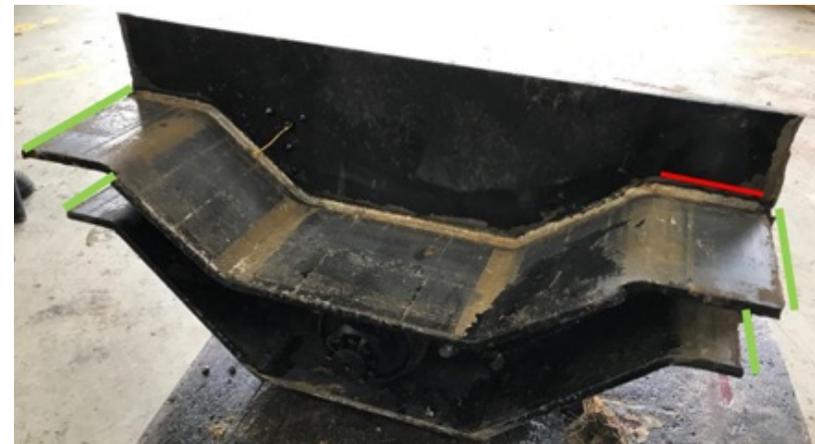
Fatigue analysis carried out as part of the review showed that the stress range in the draw beam adjacent to the end welds was an order of magnitude above the allowable value. Even accounting for conservative assumptions within the analysis, this showed that failure could have been expected significantly earlier than the design life.

The draw beam, in this case, failed after two years in service when a crack developed adjacent to the weld between the side and top plates. This resulted in the central section of the draw beam (Figure 5), complete with the trailer, detaching from the truck. The draw beam side plates remained bolted to the truck chassis.

Figure 7 – Photo showing part of the draw beam after failure. This view is looking from the front of the draw beam, ie towards the trailer. Green lines indicate locations of failed welds to the side plates, and the red line indicates another crack.
