## AN EXERCISE IN LARGE SCALE JOINERY: RESTORATION OF THREE HISTORIC WELLINGTON & MANAWATU RAILWAY CARRIAGES

### Abstract

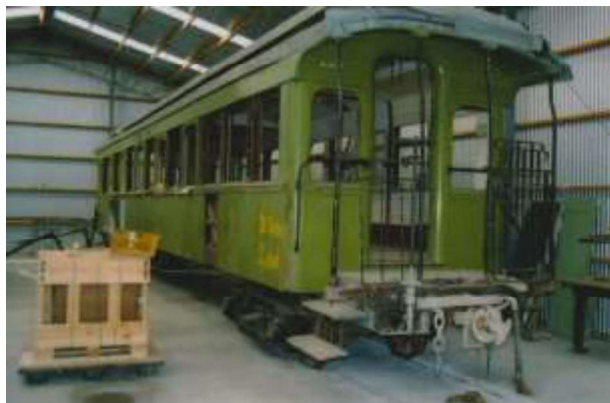
Figure 1: WMR 48 in the project workshop before restoration began, 2004.

When work began in 2004 benches, kitchen facilities, and beds installed by past owners were removed from No. 48. One exterior wall was stripped of its tongue and groove (t & g) timber cladding so the condition of the framing could be assessed. All remaining non-original fittings were removed.

Through 2004–05 the carriage was lifted off its bogies, which were taken apart, sand blasted and painted. All exterior cladding was stripped off the framing and 14 wall studs that had rot in them were replaced. Replacement t & g kauri cladding was obtained, cut to size, and primer painted ready for use later.

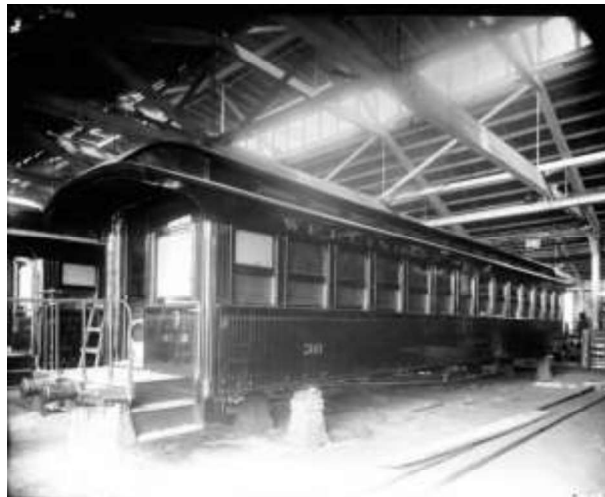
Figure 2: WMR 36 being built by Jackson & Sharp, Philadelphia, Pa., USA, 1902.

Structural and fittings design in these three followed North American practice, as a batch of similar carriages built in 1902 by Jackson & Sharp of Philadelphia, Pa., USA (Figures 2, 3). The main load bearing structure is a composite truss built in to each side wall, comprising wooden floor beams and a steel tie anchored at each end of the body. The tie rises diagonally to a cast post over the bogie centres, then runs horizontally under the window sill to above the other bogie centre. The two end arrangements are mirror images of each other.

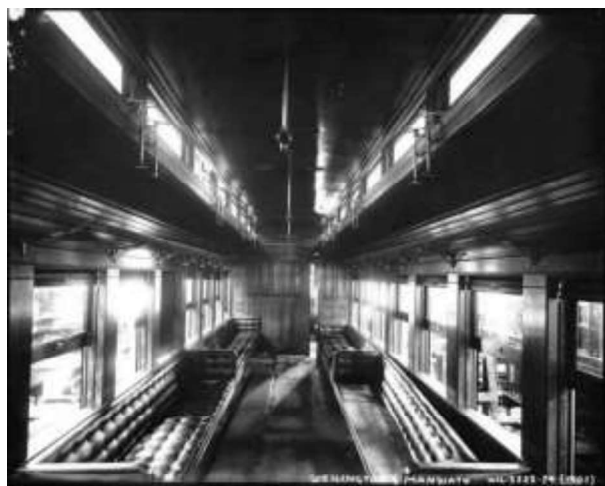
Figure 3: Interior view of 36 as built.

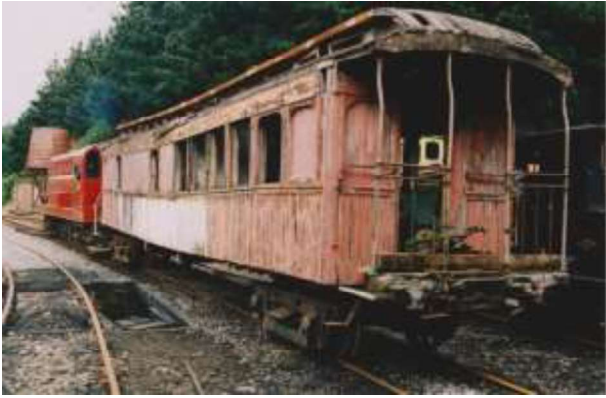
Second to be received was carriage No. 52 which had been built in 1907. This was bought in 1959 by the NZRLS Wanganui Branch. No. 52 was then sold to the traction engine society in Marton. They removed the bogies and the truss rods when these were damaged during unloading. In 1974 ownership of this carriage was transferred to the NZRLS Wellington Branch which later became the Silver Stream Railway. The carriage was stored at Seaview, Lower Hutt, until it was transported to Silverstream in 1988. The body has sagged over time after the truss rods were removed. As a result of prolonged exposure to the weather, this carriage has deteriorated worst of the three, with much rot in structural members (Figure 4).

Figure 4: WMR No. 52 being transported to the project workshop. The body sags after removal of truss rods and much rot is apparent.

No. 52 was donated to the Society in 2003. It had been left exposed to the weather for a long time and was in very poor condition, exacerbated by the removal of the truss rods earlier. The carriage was jacked off its bogies and placed on levelled trestles in the workshop to stabilise and dry out.

In 2012 a separate restoration team stripped the cladding, match-lining and floors. None of this timber was salvageable. The four kauri floor sills had advanced rot in their mid-sections and also need to be replaced.

Timber was bought in 2014 which allowed a start to be made on prefabricating replacement wall studs and diagonal braces that need renewal. Laminated finger-jointed macrocarpa beams have been obtained to replace the rotten kauri floor sills.
