## **IPENZ Engineering Heritage Record Report**

# Horseshoe Bend Suspension Bridge

Written by: Simon Daisley Date: 4 February 2013

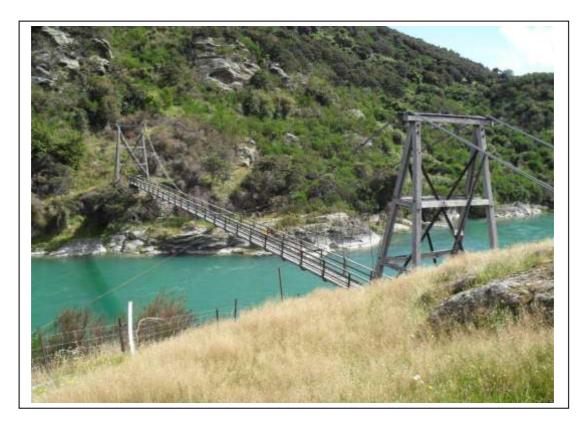
Horseshoe Bend Suspension Bridge, March 2011. Photograph courtesy of J. Dee

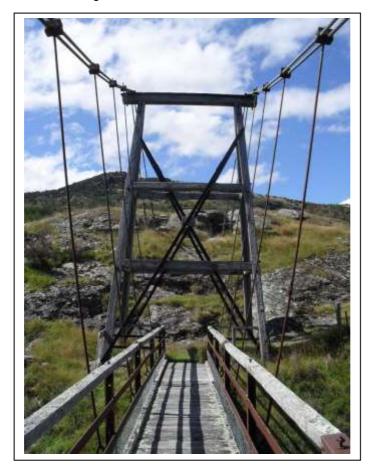
**Figure 2:** Timber A-frame towers of the suspension bridge, 2011. Photograph courtesy of J. Dee

Edie's structure is a departure from the traditional late 19th century form of Central Otago suspension bridge which was characterised by pairs of masonry, or later concrete, towers. At each end of the bridge, standing at a height of 9.3m, is a timber A-frame tower. Each tower has two sets of diagonal bracing made from former rail irons. Steel rod hangers, 50 in total, support the deck, connecting it with the pairs of two suspension cables. The cables are anchored in the bedrock at an elevation set higher than deck level.41

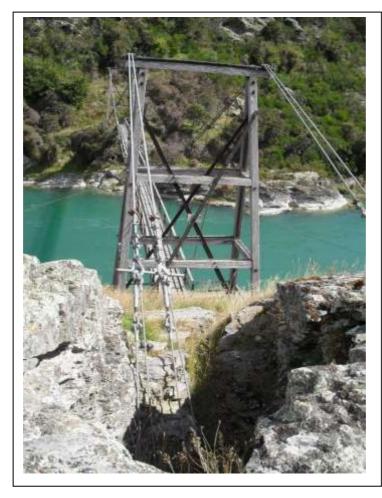
Figure 3: Anchorage of catenary cables, 2011. Photograph courtesy of J. Dee.
