NEW ZEALAND POWER FAILURES LESSONS TO BE LEARNT

June 2022

This document summarises the webinar by Daniel Müller CMEngNZ and Geoff Hunt DistFEngNZ.

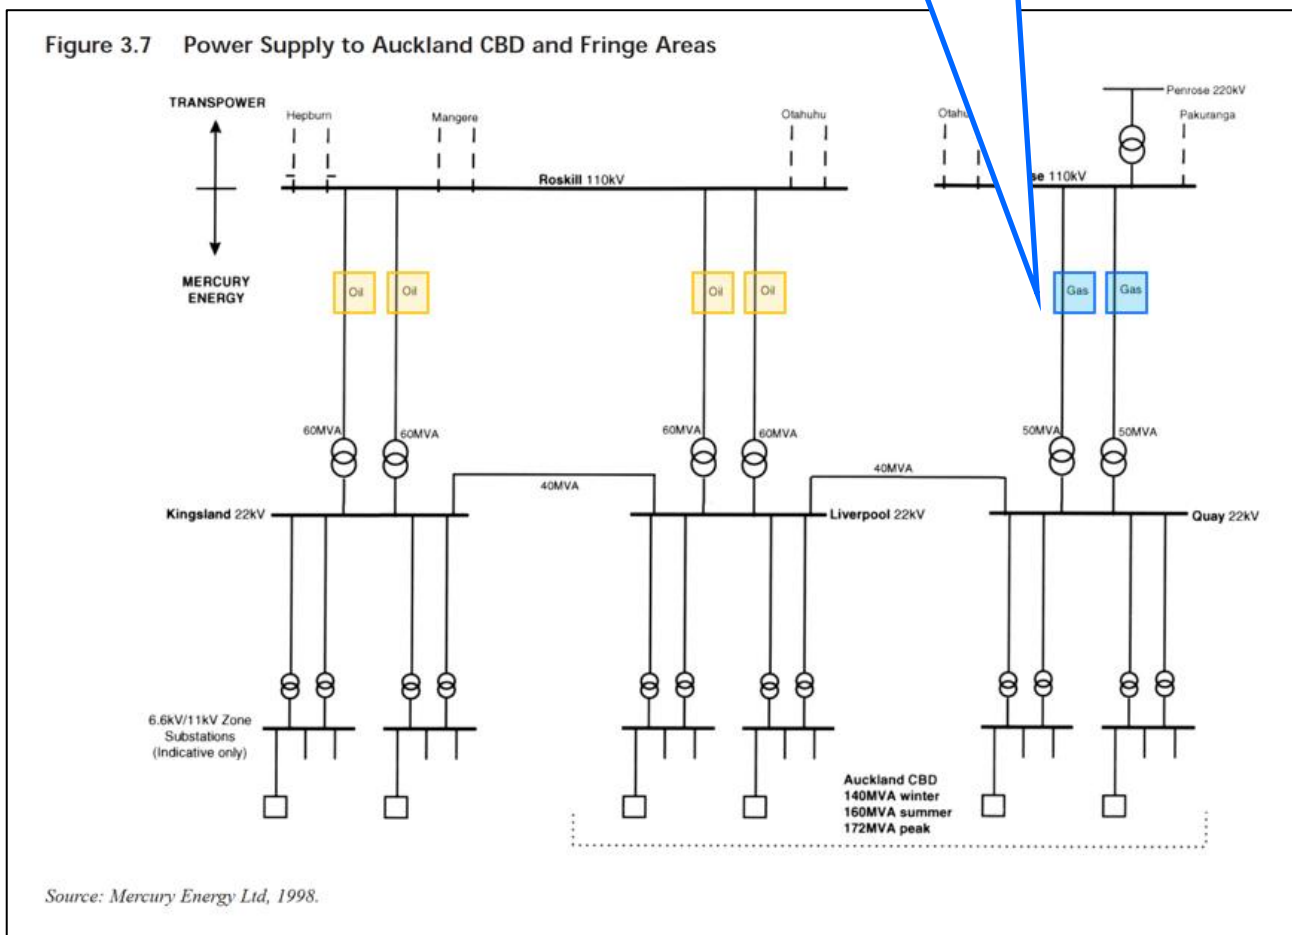
Figure 3.6 Mercury Energy Ltd Network 1997/98

Note the oil and gas cables which supply the CBD, especially Liverpool and Quay. These are the cables which should have been OK, but that failed.

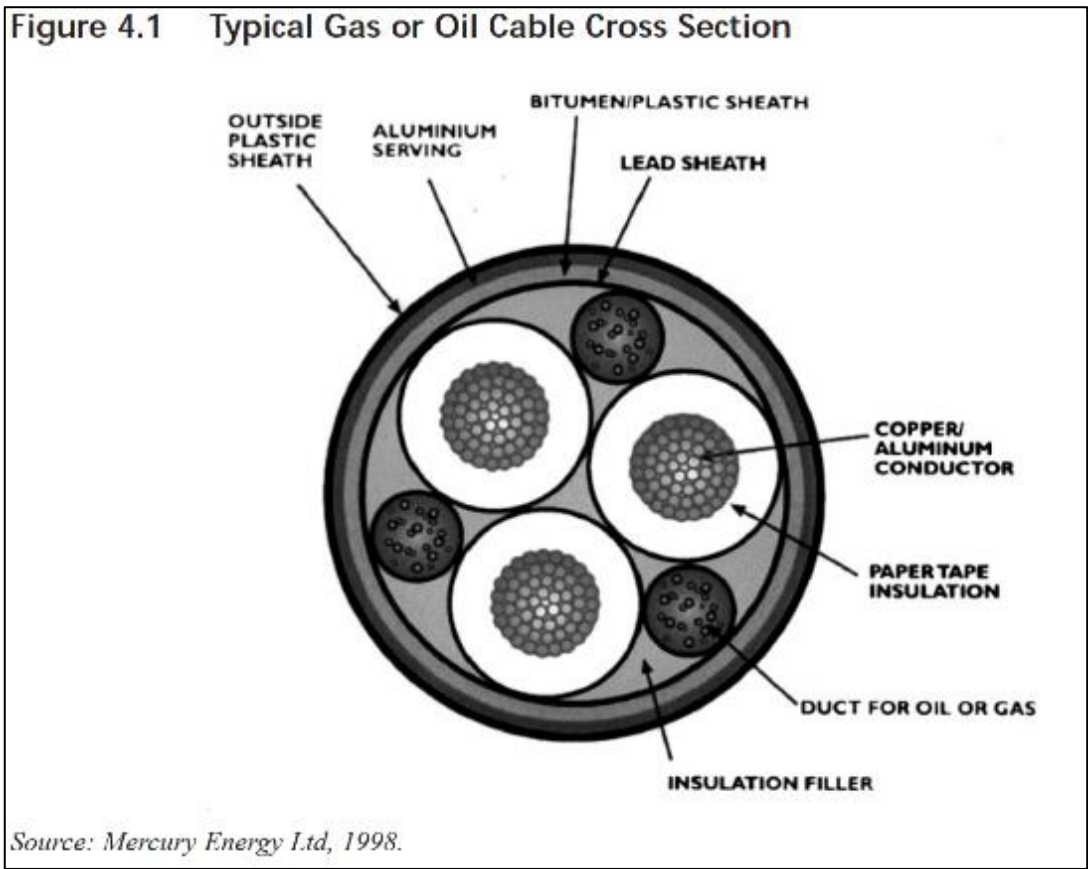
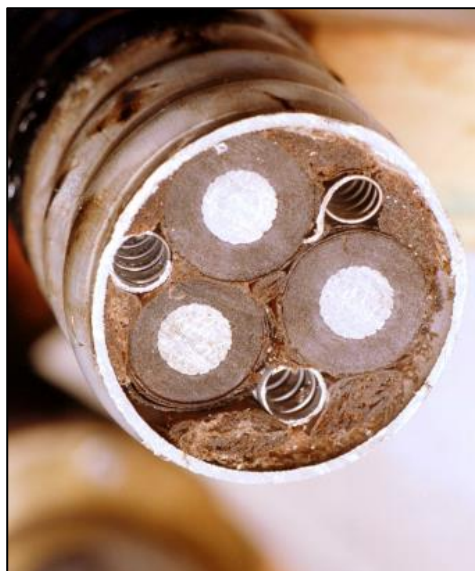
Gas filled and oil filled cables are routinely used for high voltage electricity transmission. Reliable operation requires careful installation to ensure there is no excessive build up of heat in the cable. Excessive heat build up causes expansion and may result in the mechanical failure at the joints.

In Auckland, it had been a hot dry summer, and the cables were carrying heavy electricity loads. The cables progressively failed over a number of days. The actual failure mode was thermal expansion leading to mechanical failure at the joints.

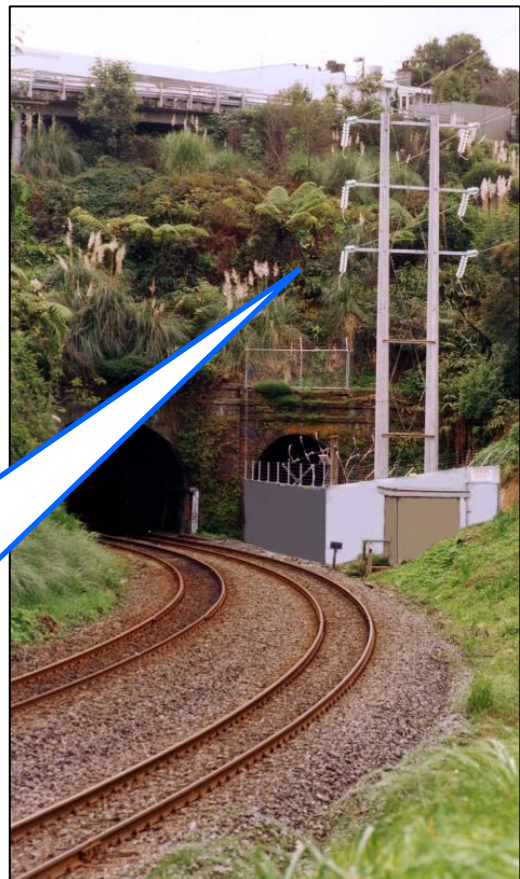
The temporary solution was to build an open-wire 110 kV transmission line through a disused rail tunnel.

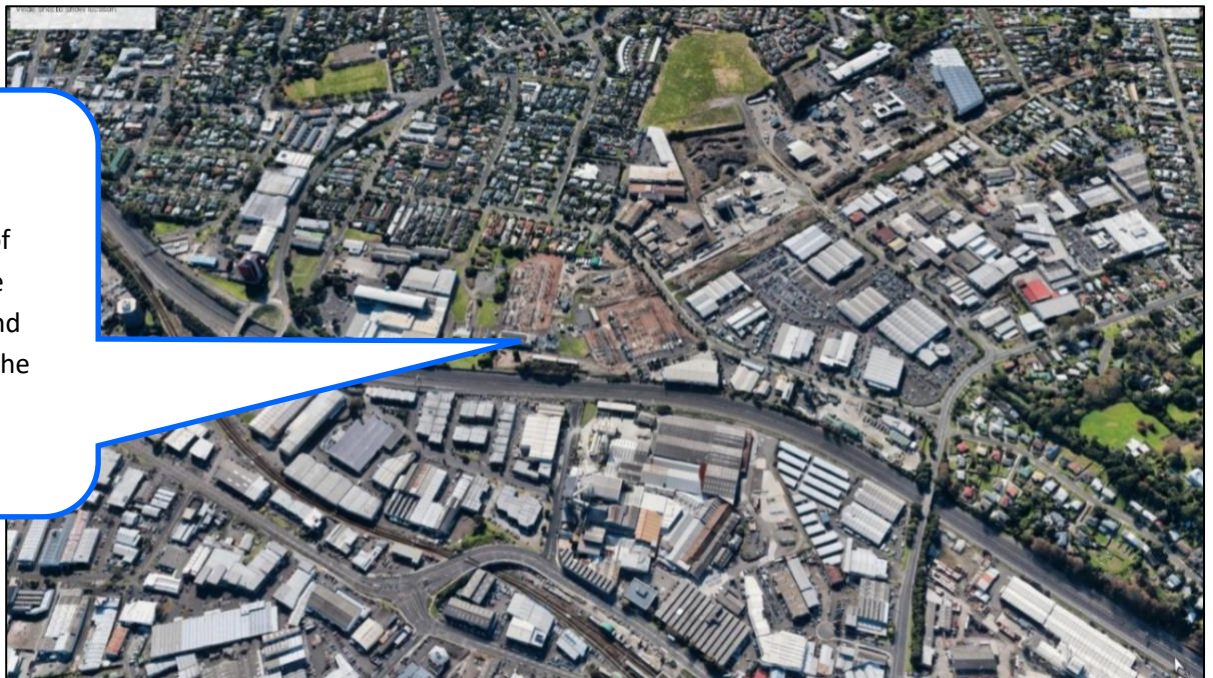
The dotted line shows the tunnel coming out of the Penrose substation and going underneath the motorway.

The tunnel comes out of the Penrose substation and heads under the motorway.

The long-term solution was to build the tunnel from Penrose to Hobson Street.

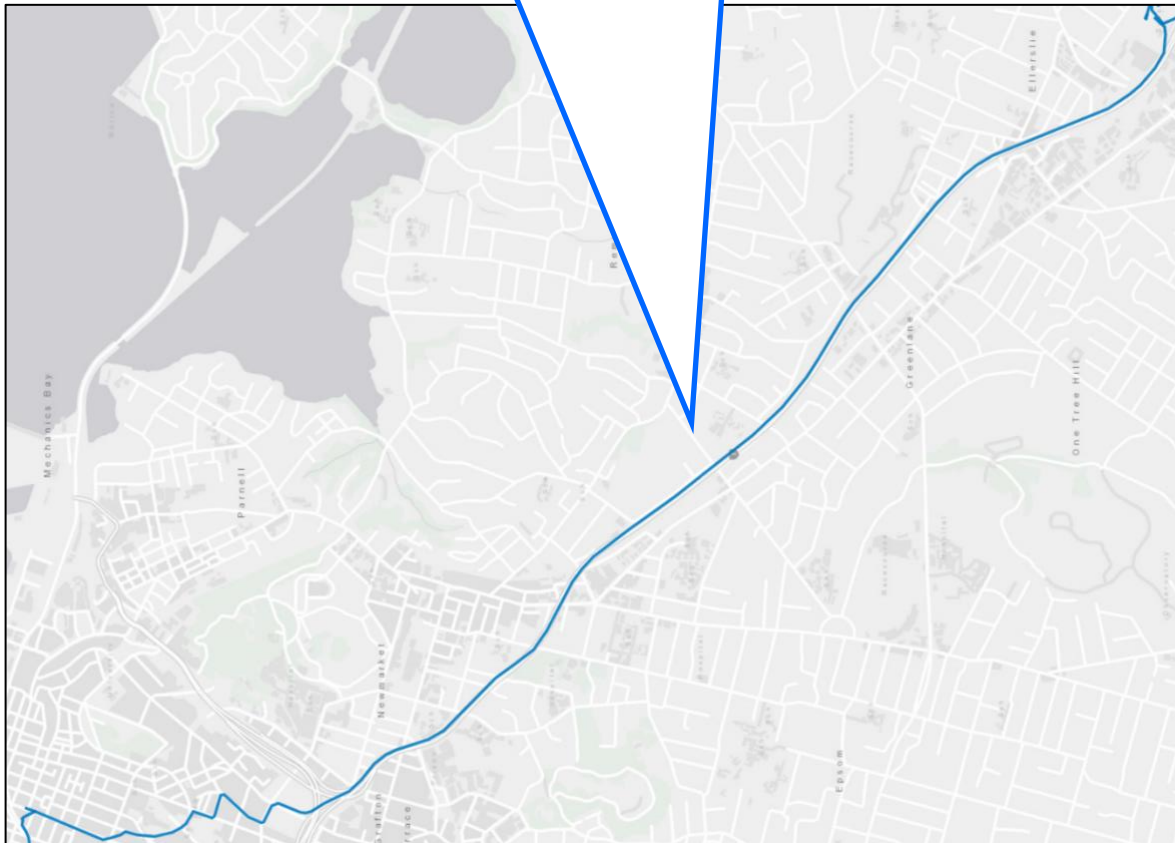
The Vector tunnel is shown by the blue line in this diagram.

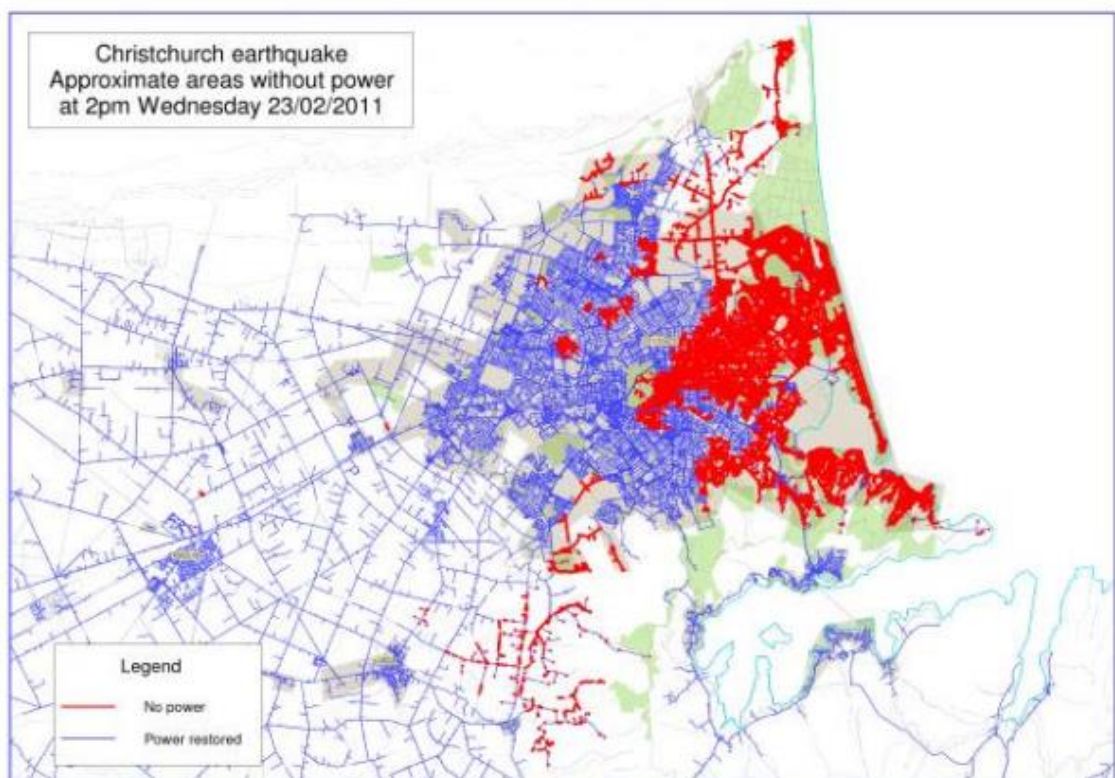
Figure 2: Electrical Outage Map one day after 22nd February Earthquake (courtesy Orion N.Z. Ltd).

- Fifty percent of the 66 kV cables were (damaged (30 km out of a total of 60 km), including underground.
- Four of 314 substations were severely damaged
- Fifteen percent of 11 kV cables were damaged (330 km out of a total of 2,200 km)
- Thousands of faults were identified
- Some damage to local substations (11kV/400 V) such as the Sumner substation.
- Some damage (cracked insulators and poles affected by liquefaction)
- One percent of LV cables were damaged
- Electrical system in badly damaged buildings
- Administration building including Control Centre badly damaged.

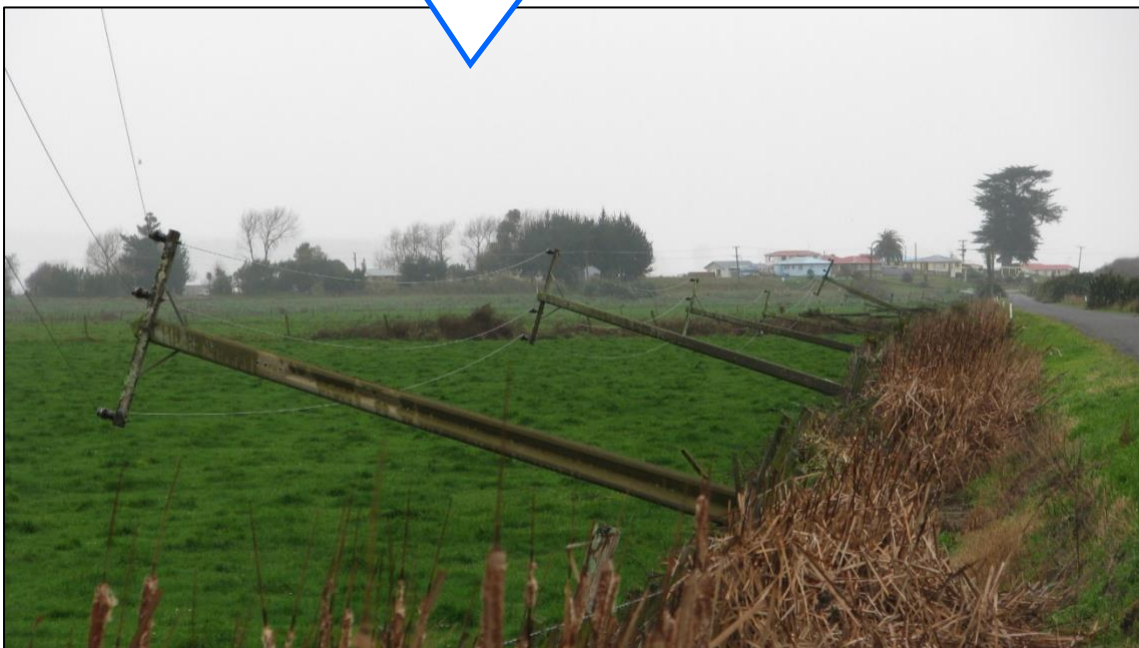
This is an example of a weather related incident where existing swampy wet soil followed by strong winds pushed the power lines over in Horowhenua.
