ENGINEERING FAILURES LESSONS TO BE LEARNT

August 2022

**engineering
new zealand**
te ao rangahau

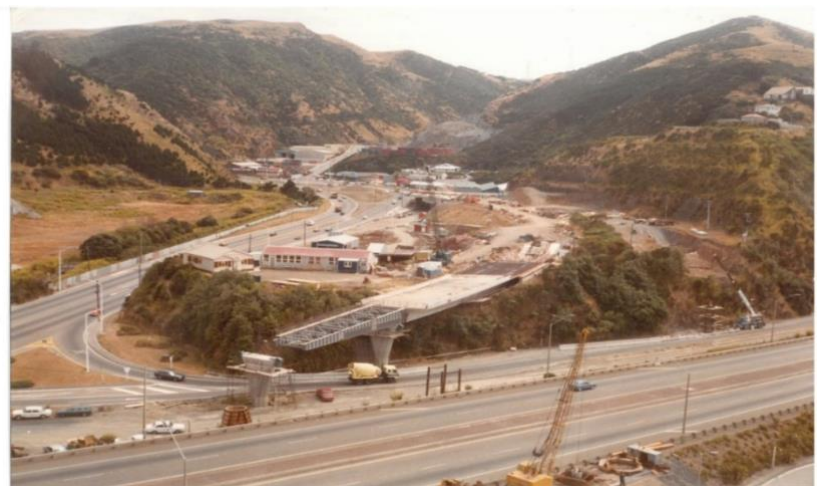
A large Ministry of Works team supervised the contractor, as the risk and consequences of failure were very high, as the bridge was being pushed over the Hutt Road without closing SH2. There was a lot of netting underneath the launch nose to make sure that nothing fell off during the launch process.

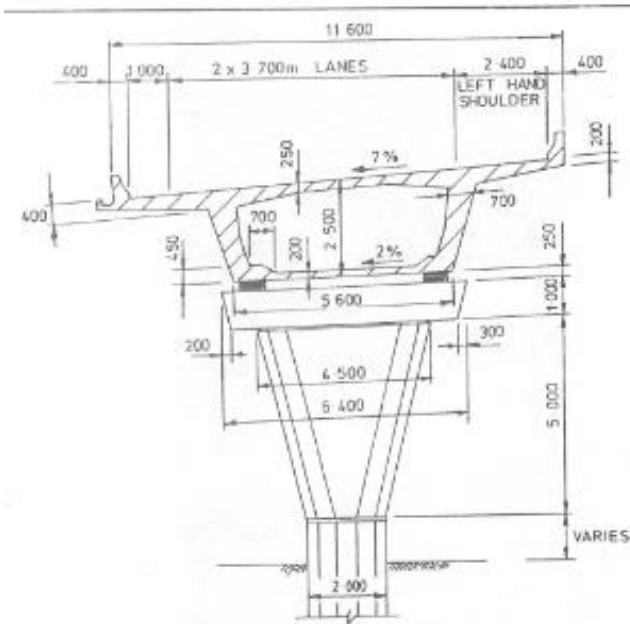
FIGURE 3 CROSS SECTION & PIER

Despite all these checks, one pier on the northbound bridge cracked at the beginning of the incremental launching process. Construction was delayed three months while the northbound piers were strengthened.

Cracking had occurred in the corners from the peak loads experienced during launching. The designers had to come up with a method of strengthening the piers in situ before launching could start again.

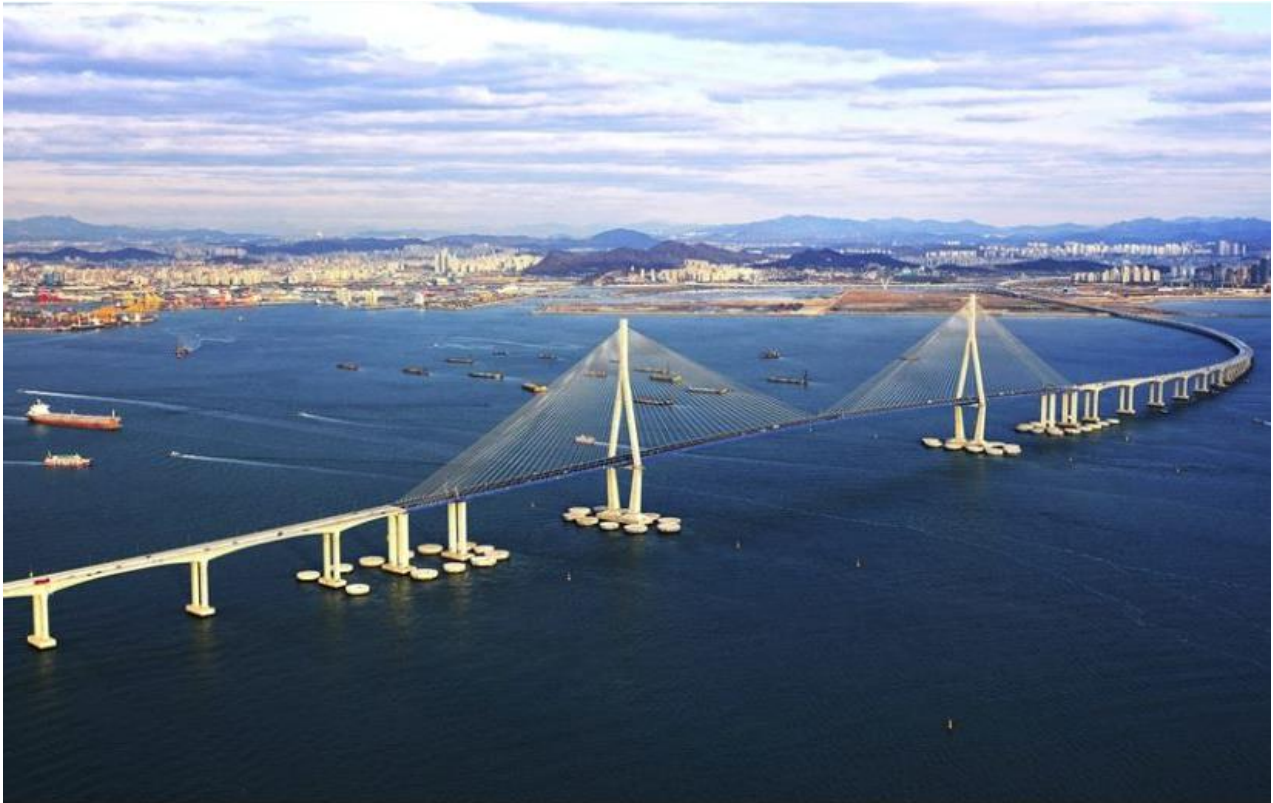
The bridge carries a six-lane freeway to the new Incheon Airport in Seoul, South Korea. It's an 800-metre main span cable stayed bridge. A key feature is the large diameter separate piles used to protect the main piers. They're erected not only around the main piers, but in alternative piers at the ends so that any ship that's lost in the fog will (hopefully) hit one of the sacrificial piers rather than damage the bridge.

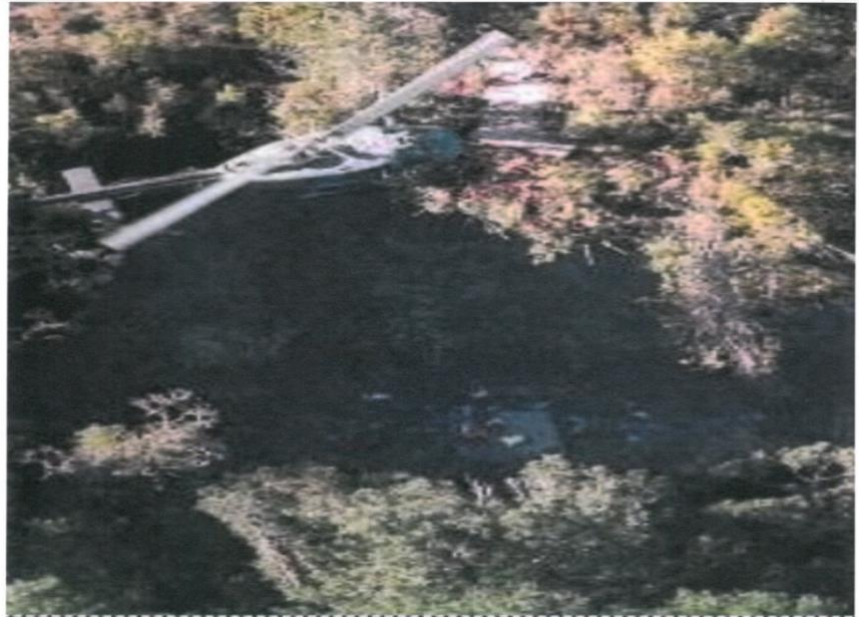
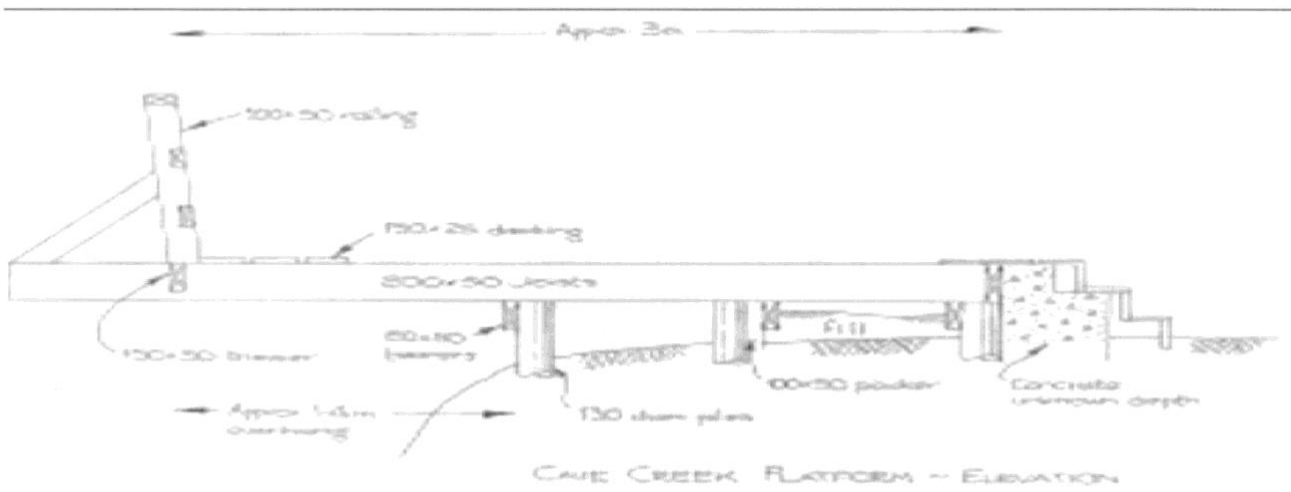
The viewing platform was made up of a timber platform with a cantilever jutting 40 metres into the gorge. It had 200 x 50 timber joists, which were designed to be fixed to bearers, which were then bolted to the piles. There were steel straps designed to strap the platform to the mass concrete steps.

- Steel straps were drawn to attach the platform to the concrete steps as a counterweight but were never installed.
- No building consent was applied for the structure. The Department of Conservation tried to apply for a building consent after the structure was built, but Council put a large number of conditions on the application. For whatever reason the application was then put in the bottom drawer.
