SAYANO- SHUSHENSKAYA HYDROPOWER PLANT DISASTER LESSONS TO BE LEARNT

September 2022

On August 17th, 2009, there was a catastrophic failure of unit 2 of the plant. This resulted in the death of 75 workers.

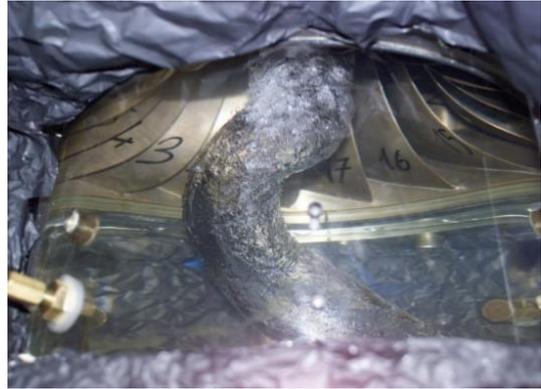
This is called a von Kármán vortex. It is essentially making all 1800 tons of rotating equipment bounce upward, inducing a vibration. Every machine goes through a rough zone. We try to go through it as fast as we can, and not too often.

von Kármán vortex – this photo is of what happens inside a turbine while it is in the rough zone

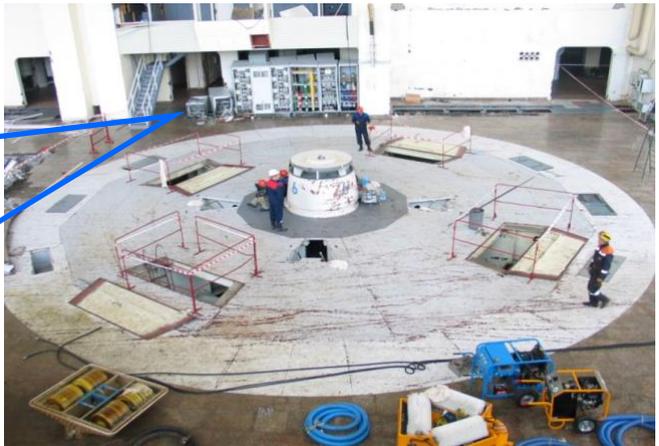
Unit 6 was shut down for maintenance at the time of the failure.

They were able to get it up and running about three months after the failure.

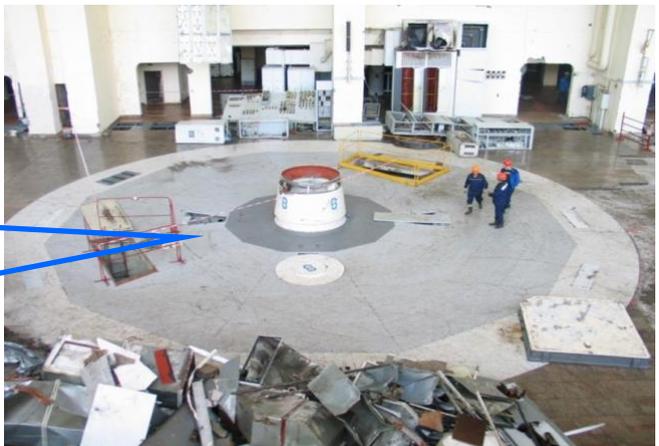
Unit 8 looked OK.

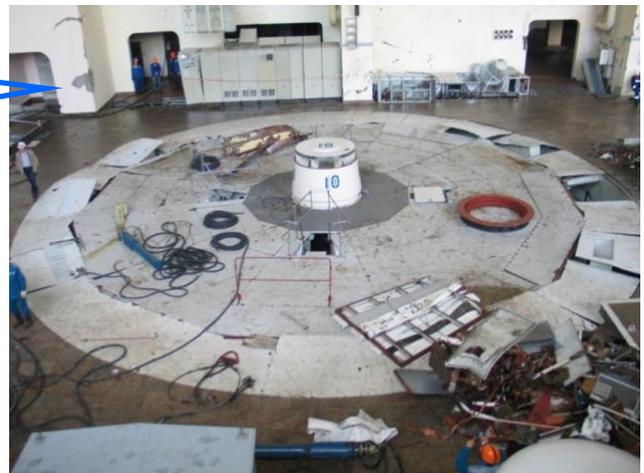
Unit 10 looks ok.

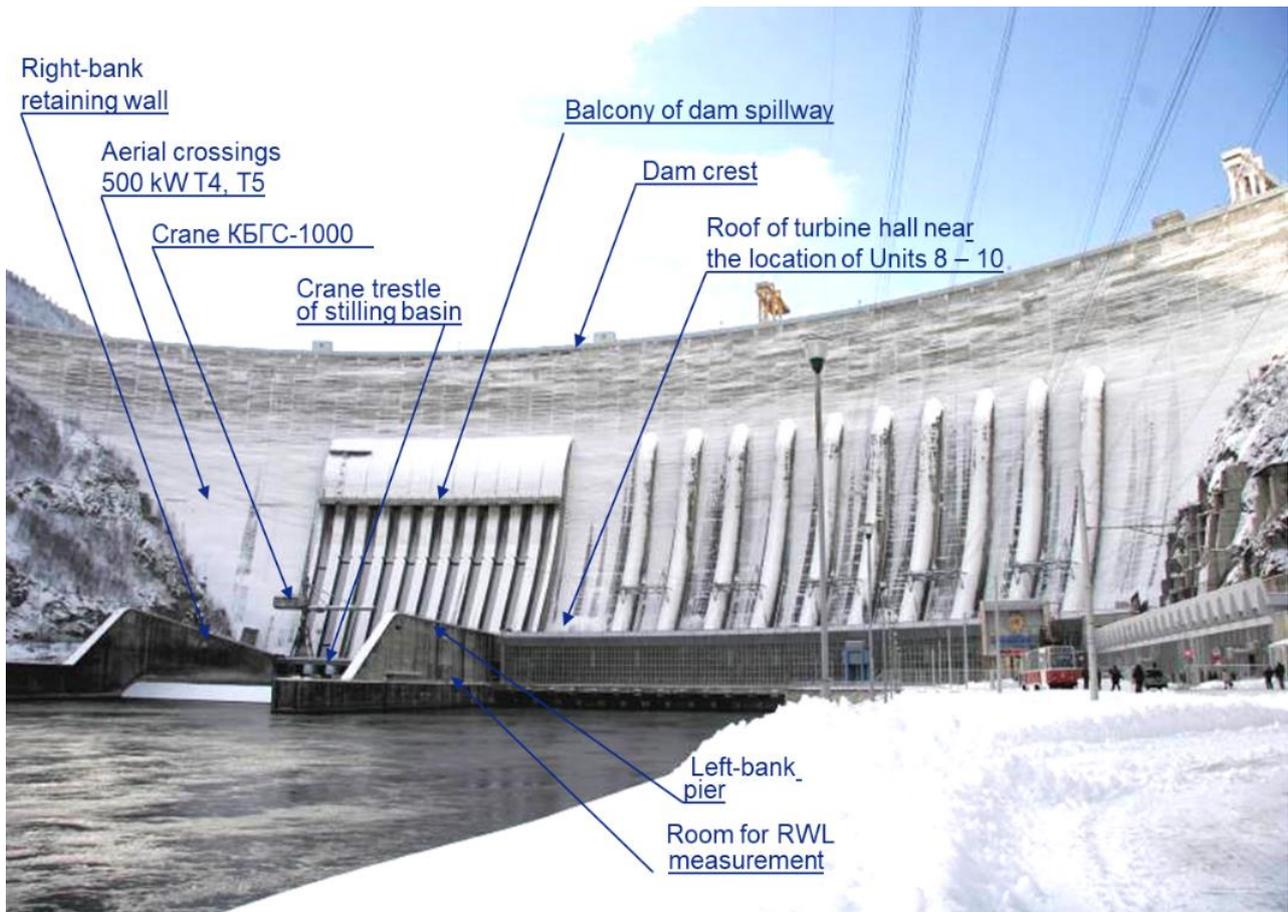
Below is a picture of the dam, with the spillway shoots on the left.

At these temperatures it was a battle to minimize the icing and keep the spillway open. Also the air intakes needed heating, as they kept freezing, and air is a crucial to any water flow.

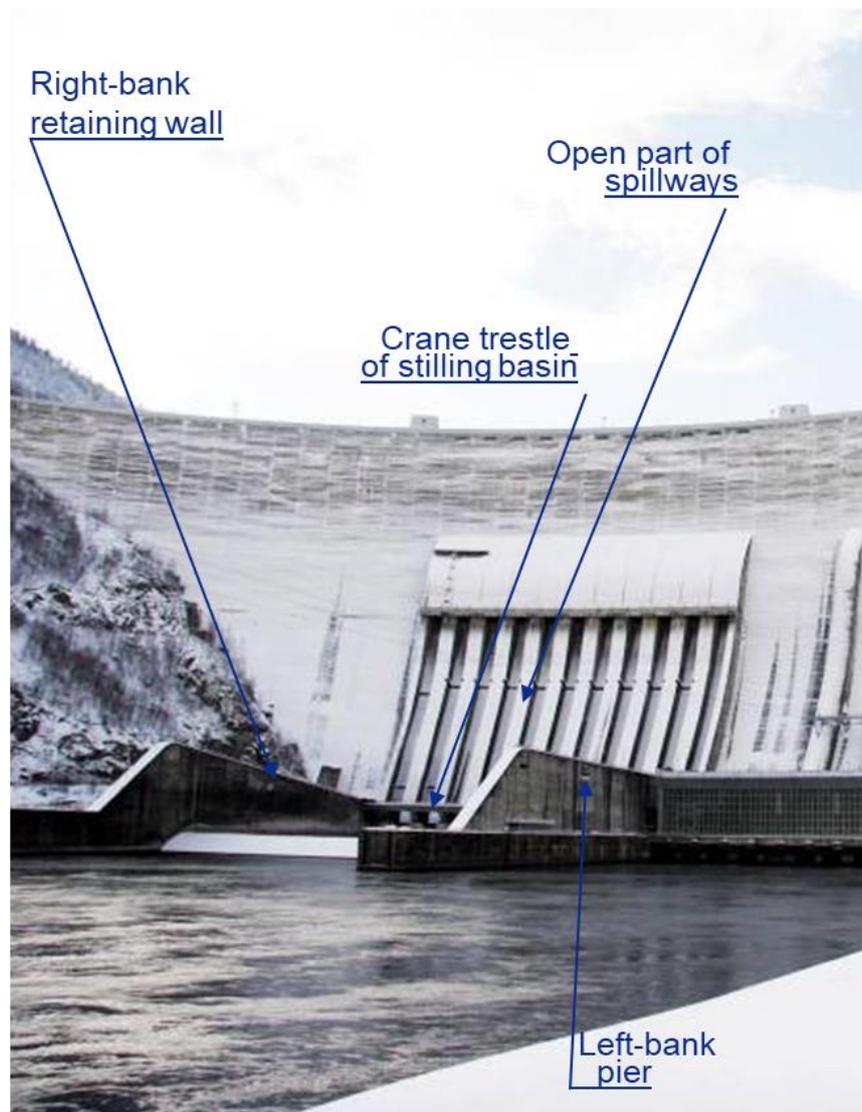
Crane trestle of Stilling Basin.

Following are some pictures showing the issues occurring due to ice build up.

- Air Intakes were covered by heat insulation screens.
- Grouting of visible leakage points on the spillway were fulfilled.
- The surfaces suffered from icing were regularly cleaned by anti-icing reagent.
- The powerhouse cover, water-intake cones and spouting chute were heated.
- Everyday cleaning of formed snow and ice was carried out.
- The powerhouse and structures within the ice formation zone were monitored every day.
