CAVE CREEK - 1995 PLATFORM COLLAPSE LESSONS TO BE LEARNT

February 2021

This document summarises the webinar developed and led by Gordon Hughes (FEngNZ), a structural engineer, for Engineering New Zealand in 2021.

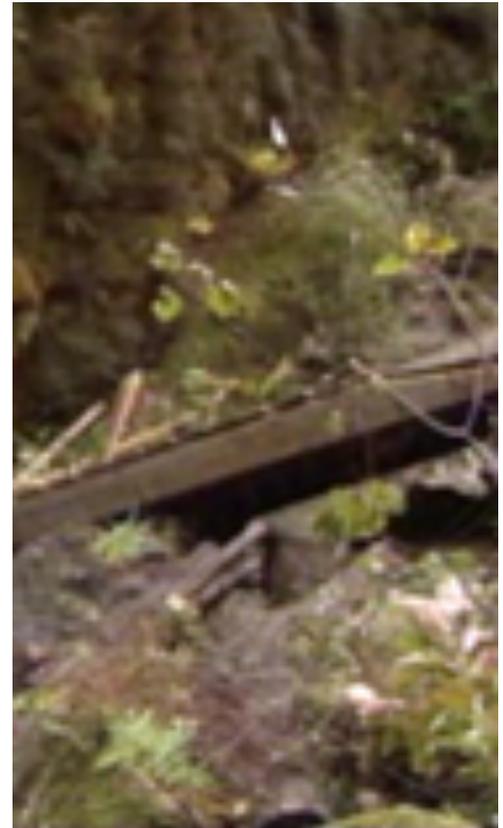
“We continued walking and, as the track became narrower, walked in pairs. I was in approximately the middle of the group as it reached the platform and stepped into a gap on the left-hand side of the platform at the front to have a look. I looked over and went to take a step back because I don't like heights. Suddenly, and with no warning except for yells of surprise, the platform was falling under our feet. It began sliding down at approximately 30 degrees and then tipped and fell vertically with everyone falling in front of it.”
