Structural damage arising from slope movements

Inspecting and assessing houses

September 2025

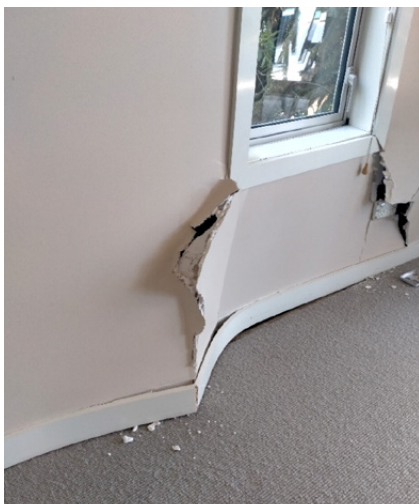
Figure 3: Photos from Mitchell Vranjes Structural Engineering Report illustrating the internal and external damage observed at northwestern corner.

The house was seriously affected by a slope movement in August 2022 associated with discrete localised movement within the Tahunanui Slump. The house presented with damage to most walls, both those perpendicular to the slope and those parallel to the slope. Figures 3 and 4 show the damage observed.

- rupture of the perimeter foundation and buckling of the internal linings at the northern end of the western wall that was perpendicular to the slope
- racking of the walls/doors on the northern wall that was parallel to the slope
- significant cracks and separations in the internal plasterboard linings up to 30mm wide
- cracks and separations in the timber flooring.

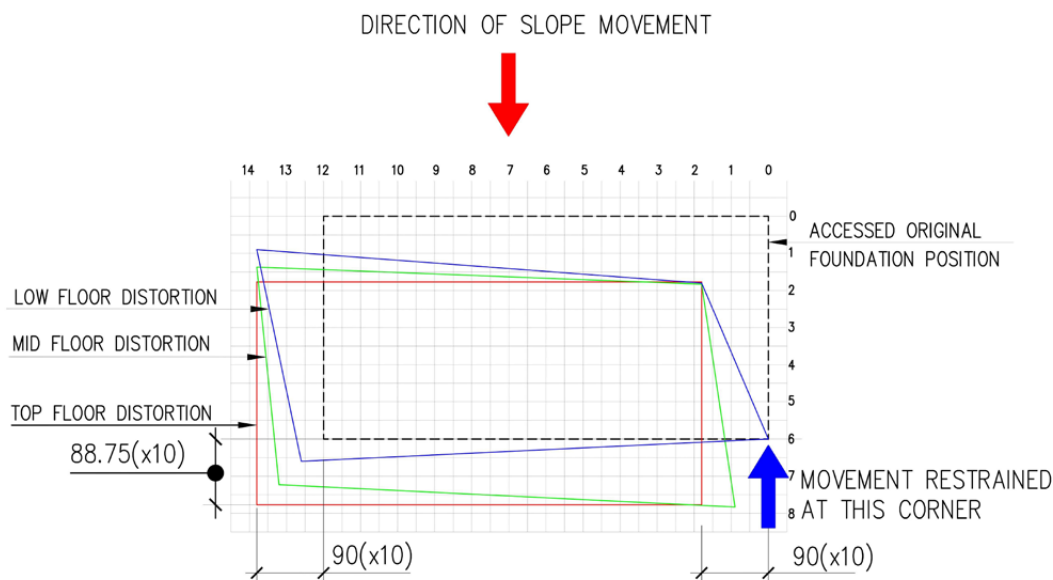
Figure 5: Measured positions of the corners of the house (10x distorted)

Figure 5 shows the recorded measurements of the plan position of the corners of the house on a distorted scale. The northwest corner of the house had a lean towards the north of 85mm and a lean to the east of 87mm. The blue arrow shows where the house foundation was restrained, and the red arrow shows the slope movement direction.

Some localised floor level variations that were likely caused by the slope movement were observed. This was discernible mostly in the northwest corner of the lounge. However, the damage mostly arose from the plan distortion of the house. The house foundation had been restrained from movement at the northwest corner but elsewhere had been freer to move downhill with the slope movement.

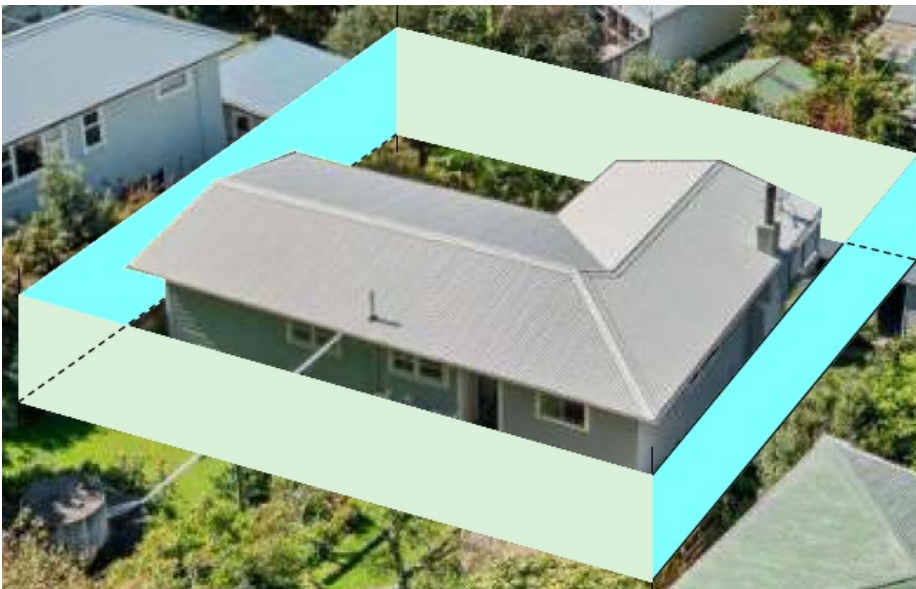
Figure 7: Possible method to measure plan shape at diaphragm levels

One way to complete this is to create a series of vertical laser planes around the house that are square to each other as shown in Figure 7.

Horizontal measurements can be taken from the laser planes to the house at each diaphragm level (eg floors and ceilings) and the foundation level along each wall, possibly at the corners and mid length. The plan shape at each level can then be determined and compared with those at other levels.

In addition to floor level surveys and measurement of wall inclinations, the plan shape of the structure can be measured at key levels up the structure.
